Central Services - Demolition

CP24092

PRE-DEMOLITION HAZARDOUS MATERIALS SURVEY REPORT **CENTRAL SERVICES**

**Subject: Pre-Demolition Hazardous Materials Survey Report
Michigan State University
Central Services
570 Red Cedar Road
East Lansing, MI 48824**

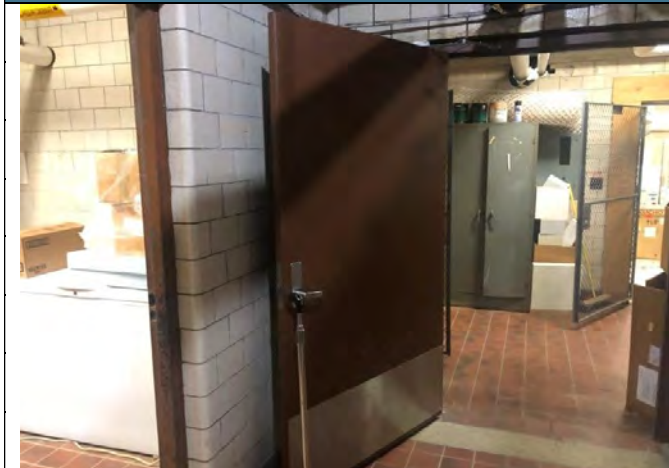
Photograph #1

Homogenous Material Description
HA-1: Metal fire door & frame
Asbestos Present (Yes/No/Assumed)
Assumed
Total Quantity Present
97 Doors
Additional Notes

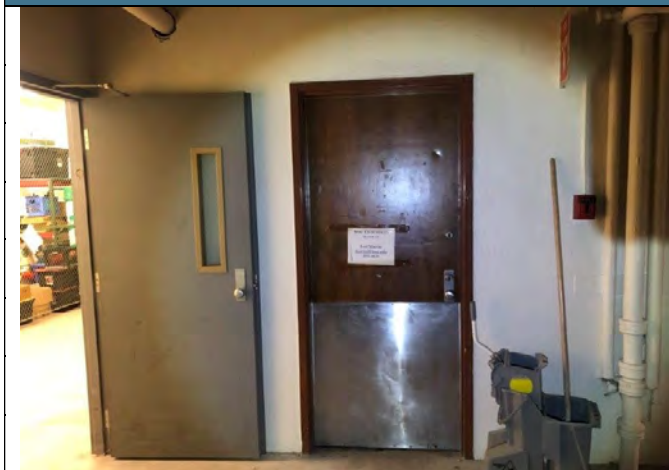
Photograph #2

Homogenous Material Description
HA-2: Wood fire door & frame
Asbestos Present (Yes/No/Assumed)
Assumed
Total Quantity Present
19 Doors
Additional Notes

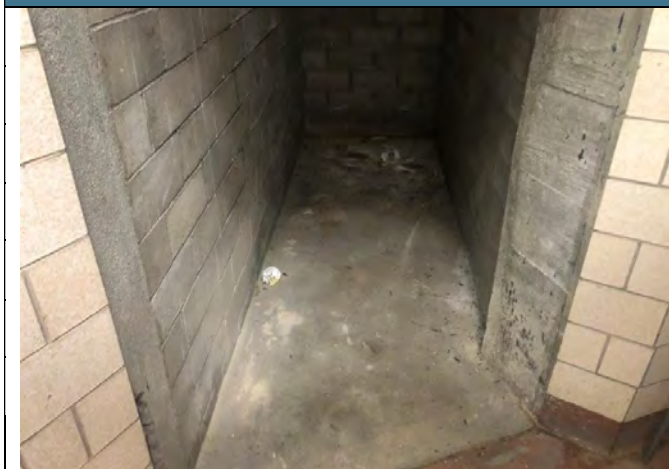
Photograph #3

Homogenous Material Description
HA-3: Concrete foundation / deck
Asbestos Present (Yes/No/Assumed)
No
Total Quantity Present
69470 SF
Additional Notes

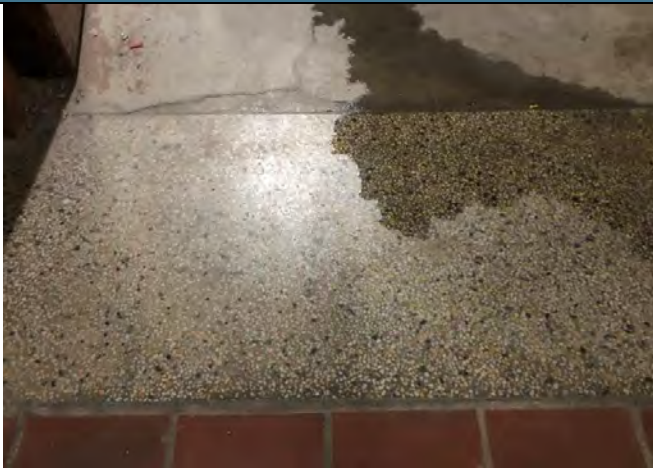
Photograph #4

Homogenous Material Description
HA-4: Terrazzo flooring
Asbestos Present (Yes/No/Assumed)
No
Total Quantity Present
3122 SF
Additional Notes

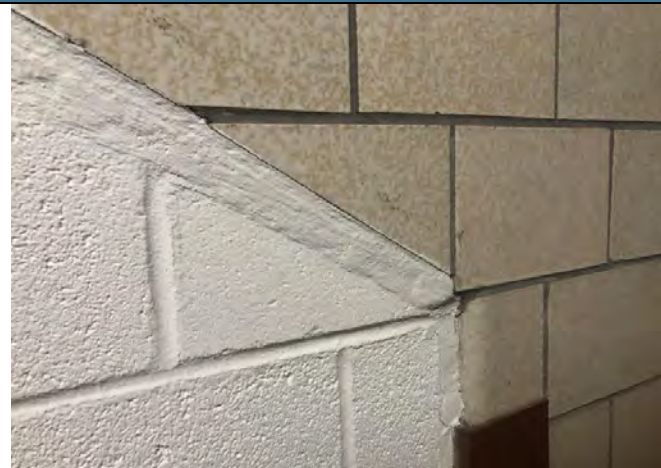
Photograph #7

Homogenous Material Description
HA-7: Skim coat on CMU block
Asbestos Present (Yes/No/Assumed)
No
Total Quantity Present
341 SF
Additional Notes

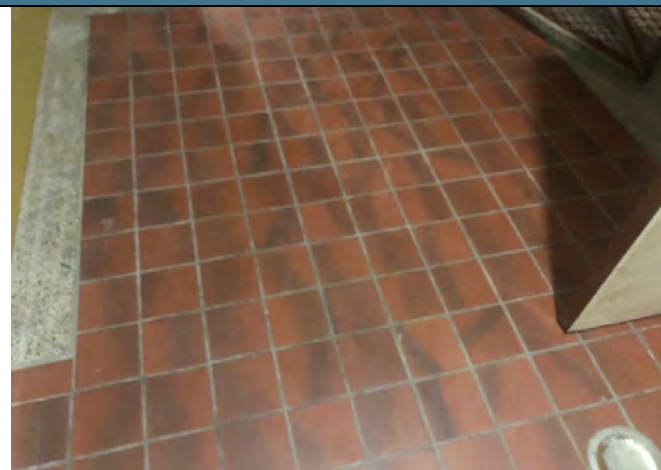
Photograph #8

Homogenous Material Description
HA-8: Red ceramic floor tile, grout, mortar
Asbestos Present (Yes/No/Assumed)
No
Total Quantity Present
28014 SF
Additional Notes

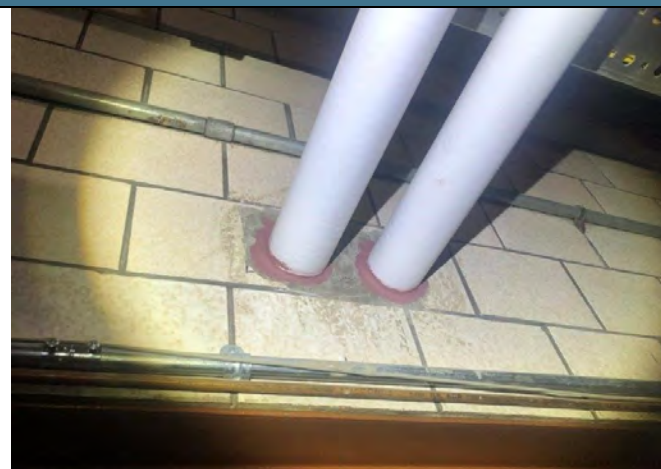
Photograph #9

Homogenous Material Description
HA-9: Red penetration caulk
Asbestos Present (Yes/No/Assumed)
No
Total Quantity Present
225 LF
Additional Notes

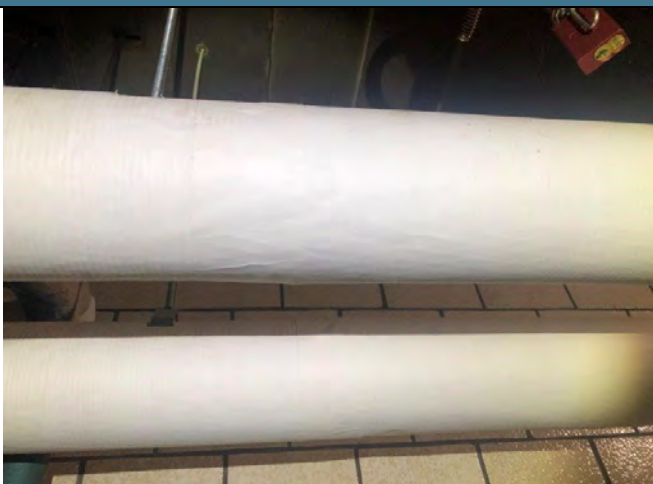
Homogenous Material Description
HA-12: White paper wrapped fiberglass pipe insulation
Asbestos Present (Yes/No/Assumed)
No
Total Quantity Present
3410 LF
Additional Notes

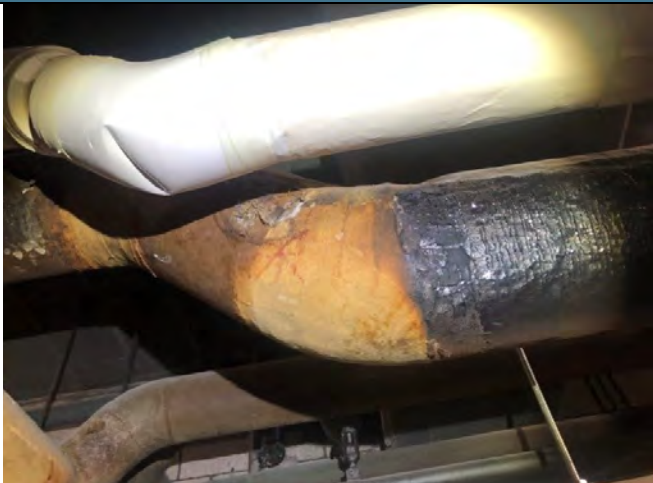
Homogenous Material Description
HA-16: Canvas covered pipe fittings, brown paper wrapped pipe insulation lines
Asbestos Present (Yes/No/Assumed)
Yes, 30% Chrysotile
Total Quantity Present
283 Fittings
Additional Notes

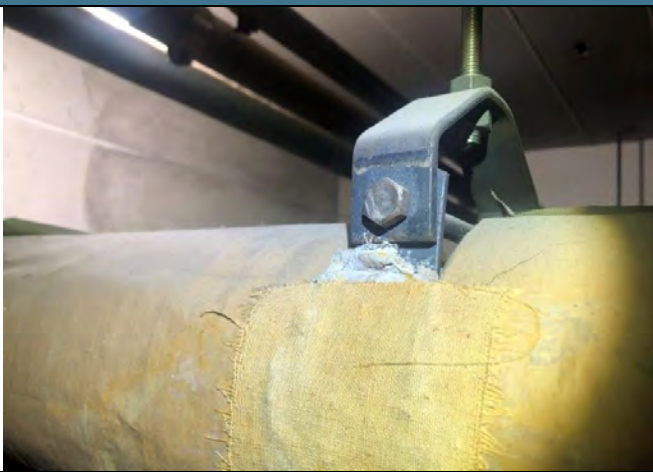
Homogenous Material Description
HA-17: Hanger mud
Asbestos Present (Yes/No/Assumed)
Yes, 50% Chrysotile
Total Quantity Present
78 Fittings
Additional Notes

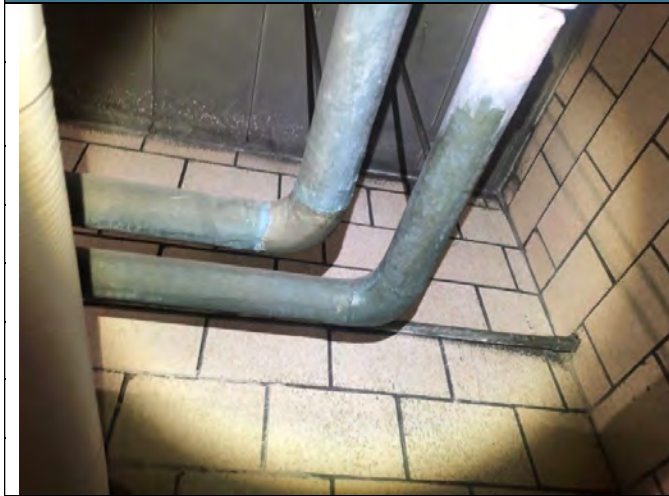
Homogenous Material Description
HA-19: Canvas covered mudded fittings on wool felt pipe insulation lines
Asbestos Present (Yes/No/Assumed)
Yes, 50% Chrysotile
Total Quantity Present
159 Fittings
Additional Notes

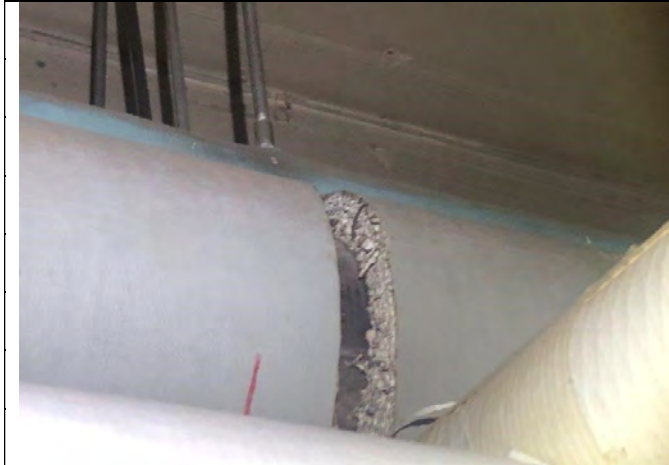
Homogenous Material Description
HA-20: Aircell pipe insulation
Asbestos Present (Yes/No/Assumed)
Yes, 45% Chrysotile
Total Quantity Present
468 LF
Additional Notes

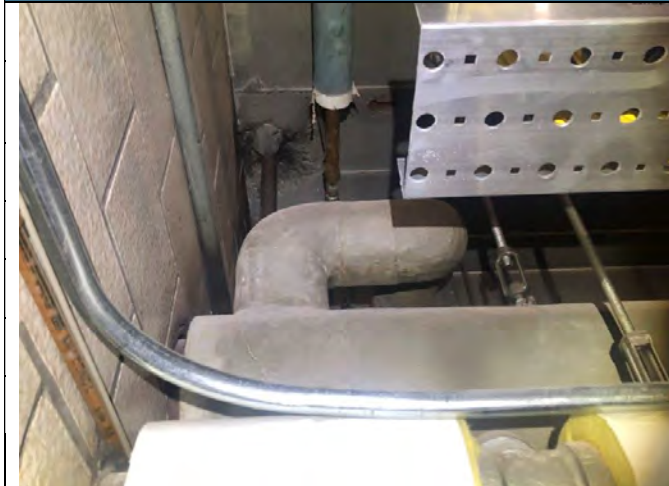
Homogenous Material Description
HA-21: Canvas covered mudded fittings, on aircell pipe insulation lines
Asbestos Present (Yes/No/Assumed)
Yes, 45% Chrysotile
Total Quantity Present
93 Fittings
Additional Notes

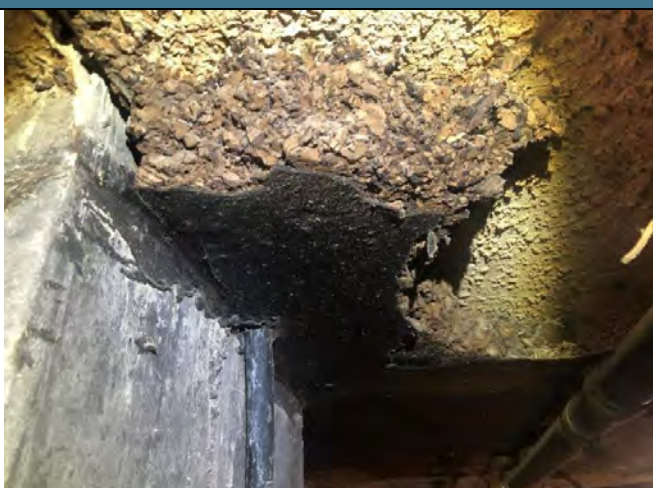
Homogenous Material Description
HA-24: Remnants of original cork ceiling insulation with outer black paper layer adhered to concrete ceiling (assoc. with HA-32)
Asbestos Present (Yes/No/Assumed)
Yes, 2% Chrysotile
Total Quantity Present
50 SF
Additional Notes
Basement Mechanical Room. Associated with HA-32.

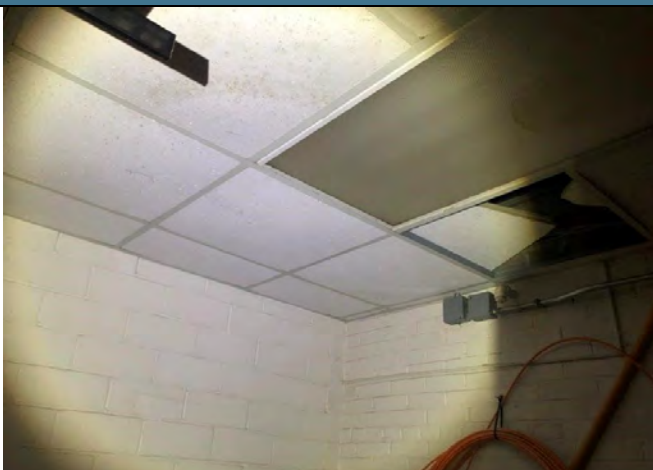
Homogenous Material Description
HA-29: Ceiling panel – pinhole/fissure
Asbestos Present (Yes/No/Assumed)
No
Total Quantity Present
7480 SF
Additional Notes

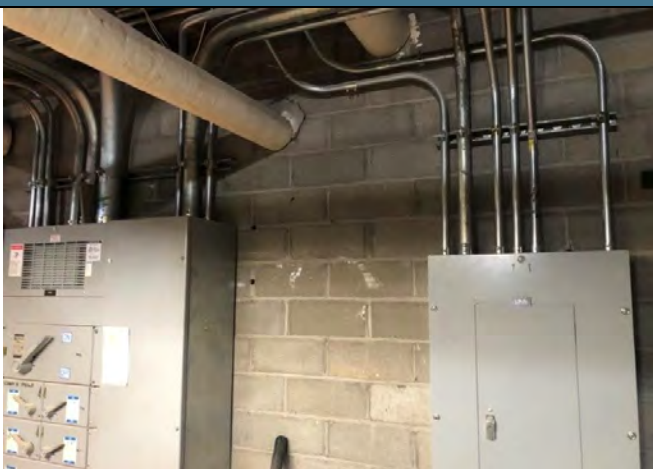
Homogenous Material Description
HA-30: Brick mortar – 12"x4" concrete brick
Asbestos Present (Yes/No/Assumed)
No
Total Quantity Present
2350 SF
Additional Notes

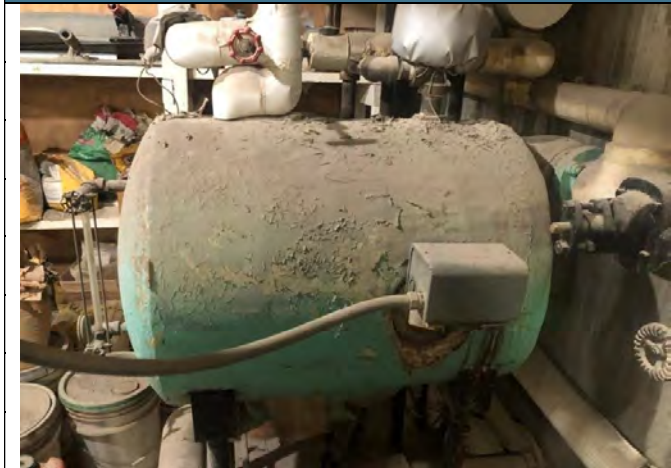
Homogenous Material Description
HA-34: Tank insulation
Asbestos Present (Yes/No/Assumed)
Yes, 30% Chrysotile
Total Quantity Present
1 Tank
Additional Notes

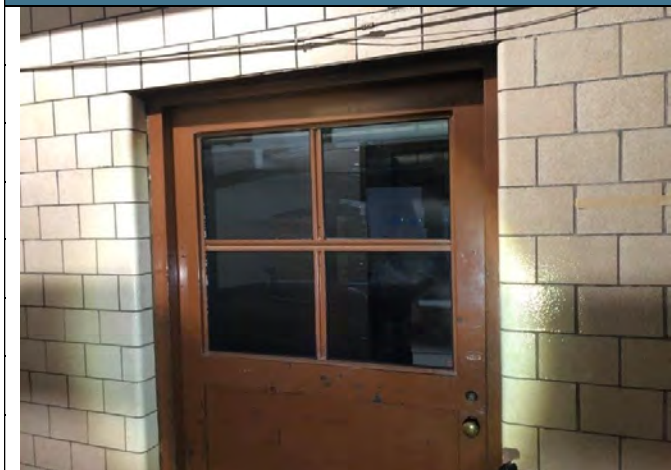
Homogenous Material Description
HA-35: Black window glaze
Asbestos Present (Yes/No/Assumed)
No
Total Quantity Present
2 Windows
Additional Notes

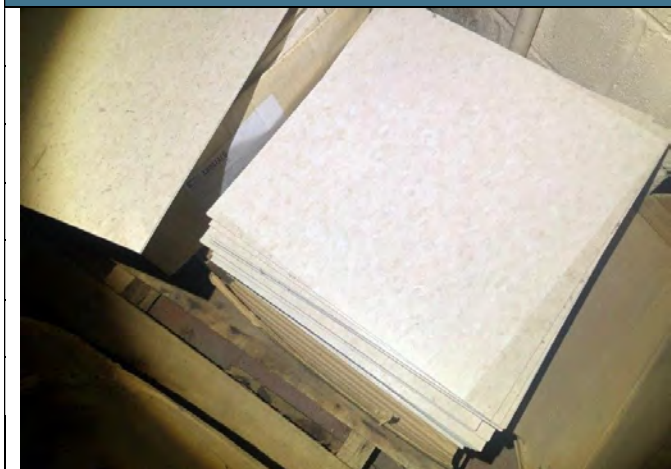
Homogenous Material Description
HA-36: 12" brown mottle
Asbestos Present (Yes/No/Assumed)
No
Total Quantity Present
4 boxes
Additional Notes

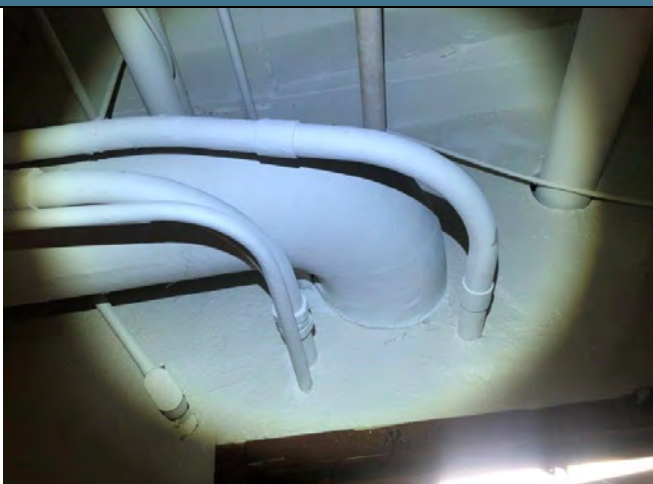
Homogenous Material Description
HA-45: Canvas covered mudded fittings, on magnesia pipe insulation lines
Asbestos Present (Yes/No/Assumed)
Yes, 30% Chrysotile
Total Quantity Present
200 LF
Additional Notes

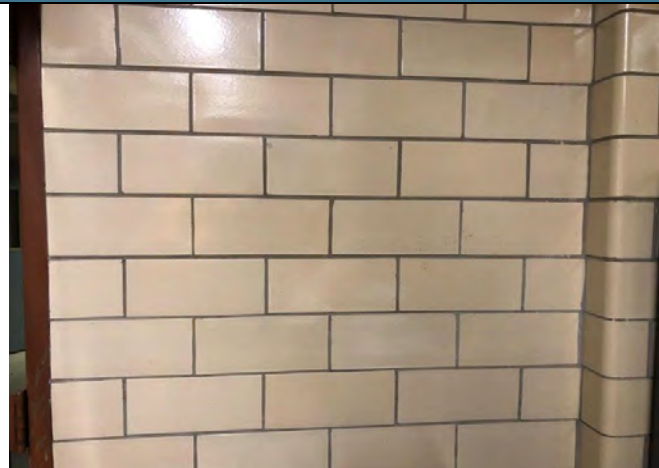
Homogenous Material Description
HA-46: Beige ceramic block mortar
Asbestos Present (Yes/No/Assumed)
No
Total Quantity Present
11475 SF
Additional Notes

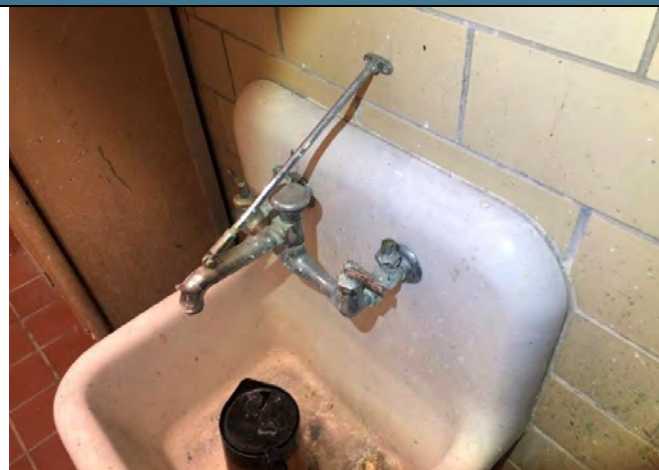
Homogenous Material Description
HA-47: White caulk on restroom fixtures
Asbestos Present (Yes/No/Assumed)
No
Total Quantity Present
35 LF
Additional Notes

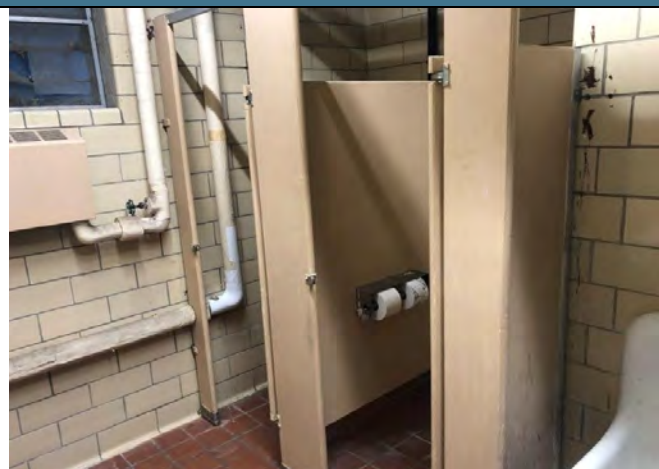
Homogenous Material Description
HA-48: Bathroom partition insulation, paper
Asbestos Present (Yes/No/Assumed)
No
Total Quantity Present
95 SF
Additional Notes

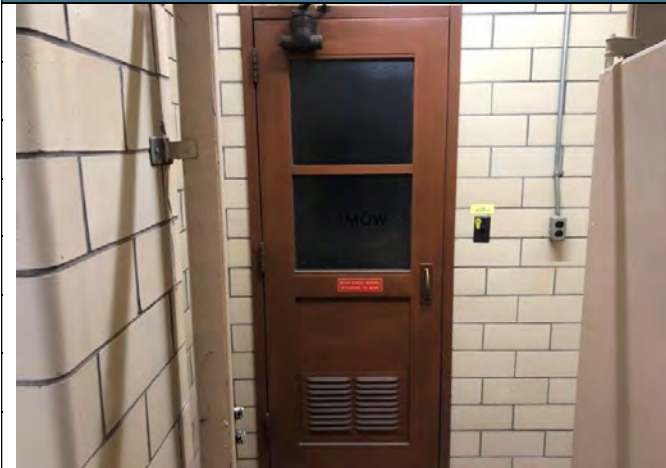
Homogenous Material Description
HA-49: Window glaze – beige, in door windows
Asbestos Present (Yes/No/Assumed)
Point Count: Trace Chrysotile
Total Quantity Present
11 Windows
Additional Notes

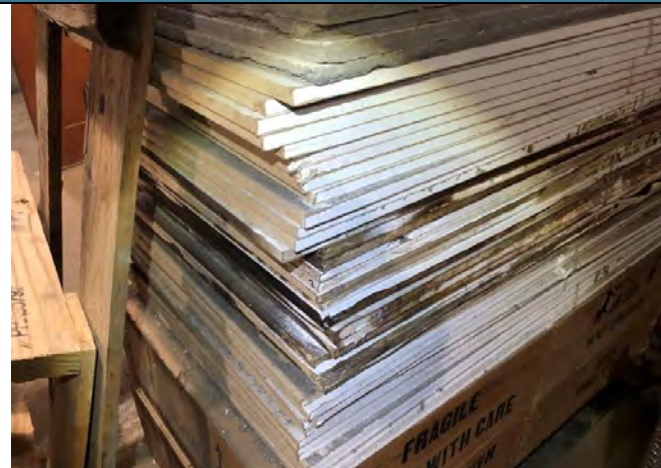
Homogenous Material Description
HA-55: vinyl covered wallboard ceiling panel
Asbestos Present (Yes/No/Assumed)
No
Total Quantity Present
956 SF
Additional Notes

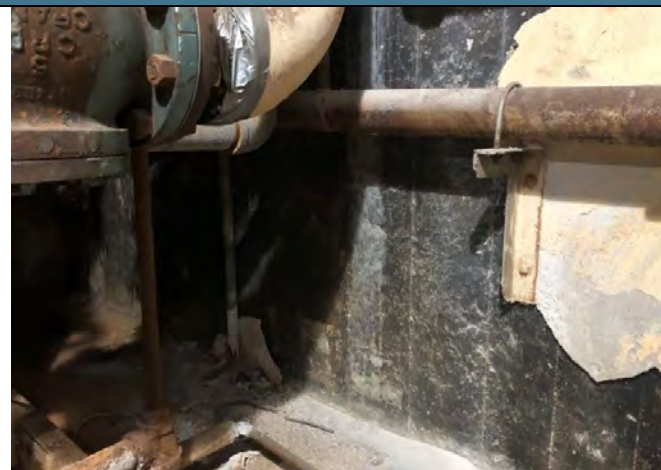
Homogenous Material Description
HA-56: Waterproofing spray-on
Asbestos Present (Yes/No/Assumed)
No
Total Quantity Present
1360 SF
Additional Notes

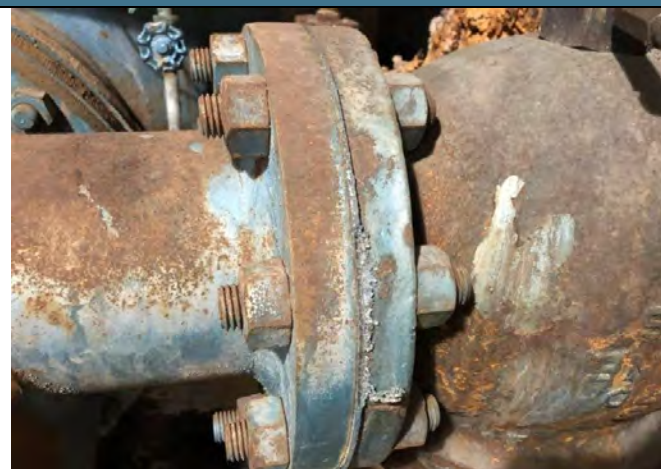
Homogenous Material Description
HA-57: Gasket material – steel pipes
Asbestos Present (Yes/No/Assumed)
Yes, 10% Chrysotile
Total Quantity Present
44 Gaskets
Additional Notes

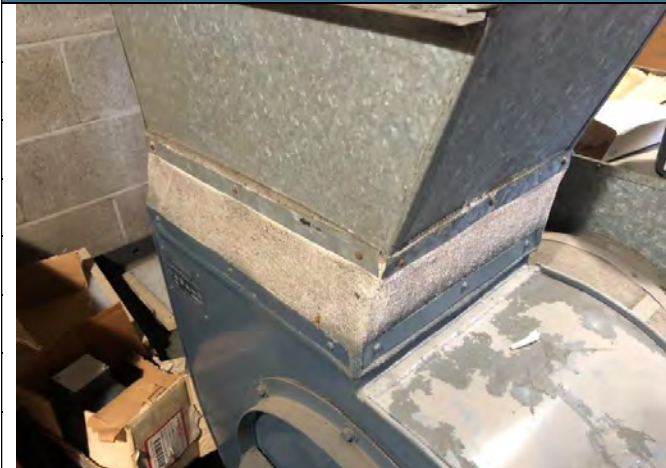
Homogenous Material Description
HA-64: Vibration dampener – white canvas
Asbestos Present (Yes/No/Assumed)
Yes, 20% Chrysotile
Total Quantity Present
40 SF
Additional Notes

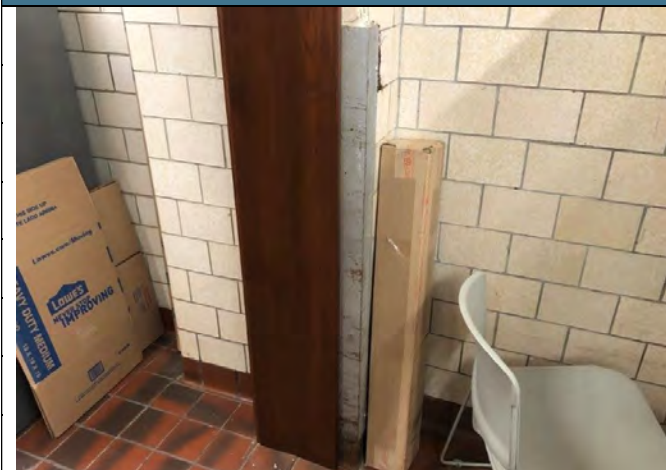
Homogenous Material Description
HA-65: steel corner guard adhesive
Asbestos Present (Yes/No/Assumed)
Yes, 3% Chrysotile
Total Quantity Present
165 SF
Additional Notes

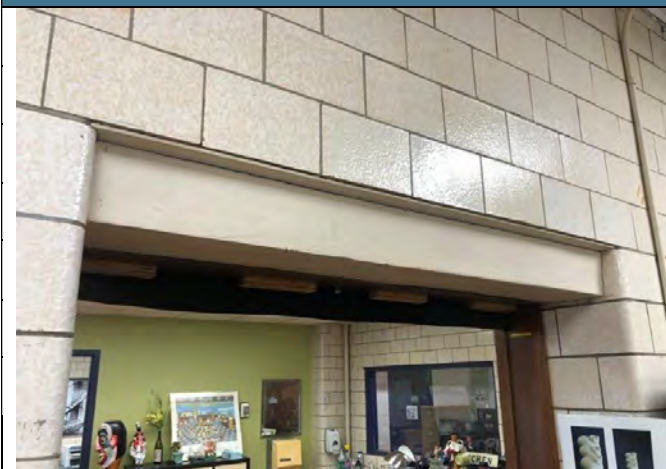
Homogenous Material Description
HA-66: Textured plaster, door frame
Asbestos Present (Yes/No/Assumed)
No
Total Quantity Present
5 SF
Additional Notes

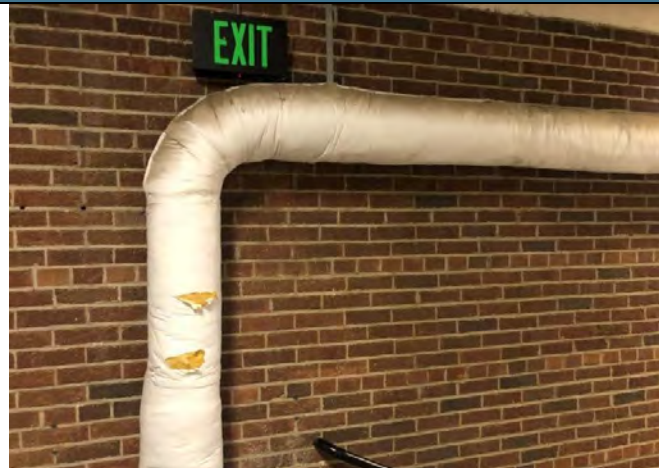
Homogenous Material Description
HA-70: Plastic wrapped fiberglass insulation
Asbestos Present (Yes/No/Assumed)
No
Total Quantity Present
1100 SF
Additional Notes

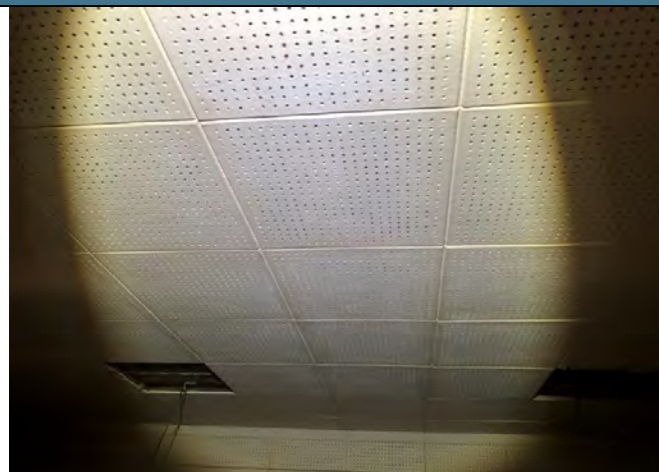
Homogenous Material Description
HA-71: Ceiling tile, pinholes
Asbestos Present (Yes/No/Assumed)
No
Total Quantity Present
560 SF
Additional Notes

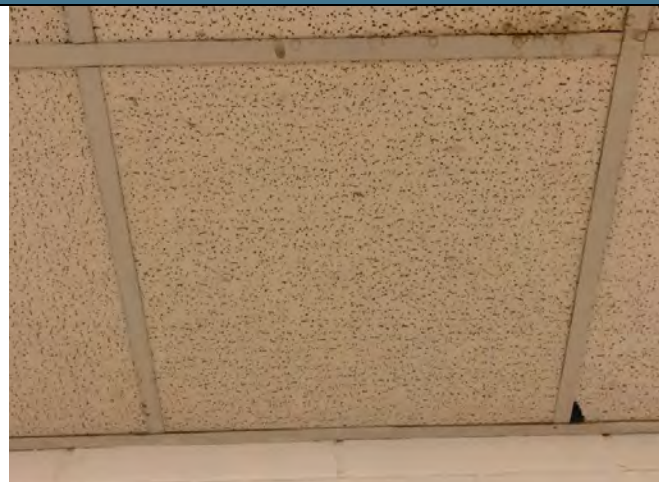
Homogenous Material Description
HA-72: Ceiling panel – yellowish pinhole/fissure, grey composite material
Asbestos Present (Yes/No/Assumed)
No
Total Quantity Present
40 SF
Additional Notes

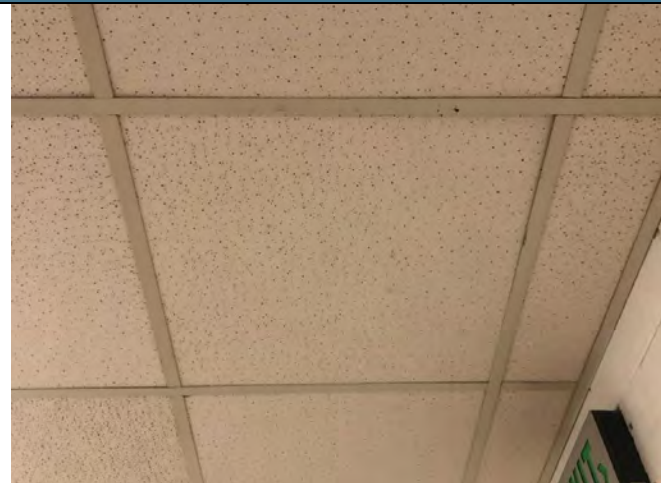
Homogenous Material Description
HA-73: White pinhole ceiling panel, beige composite material
Asbestos Present (Yes/No/Assumed)
No
Total Quantity Present
5323 SF
Additional Notes

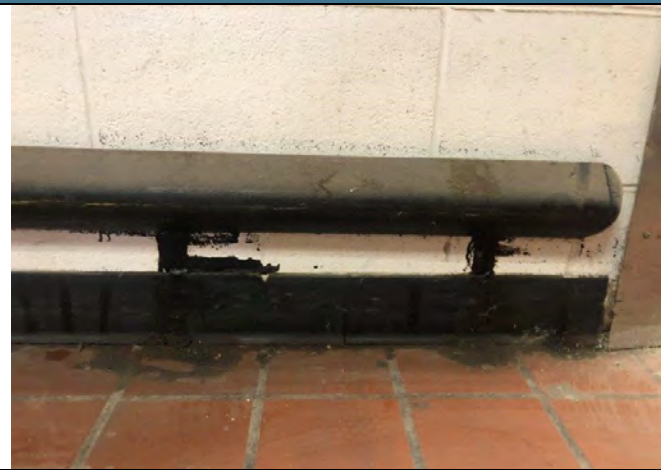
Homogenous Material Description
HA-74: Black adhesive behind rubber guard
Asbestos Present (Yes/No/Assumed)
No
Total Quantity Present
245 SF
Additional Notes

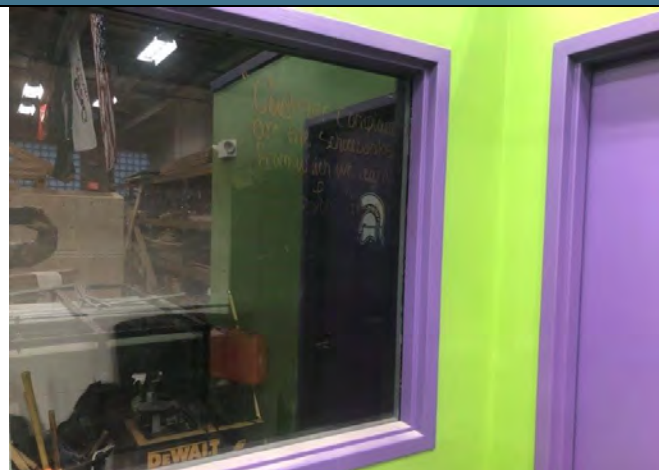
Homogenous Material Description
HA-77: black window glaze, office window
Asbestos Present (Yes/No/Assumed)
No
Total Quantity Present
15 LF
Additional Notes

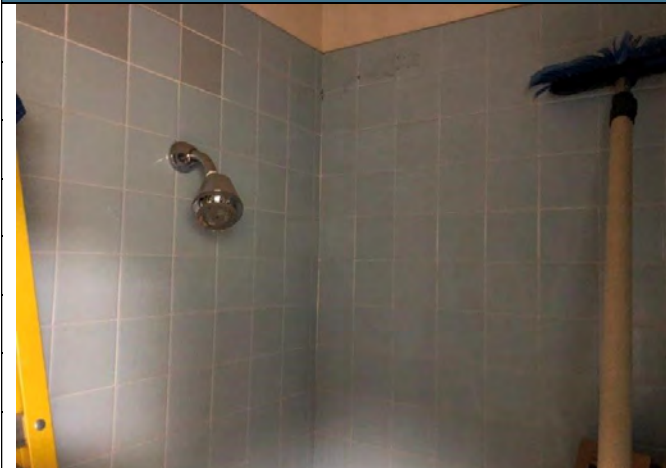
Homogenous Material Description
HA-82: 4" blue ceramic wall tile, grout, mortar
Asbestos Present (Yes/No/Assumed)
No
Total Quantity Present
40 SF
Additional Notes

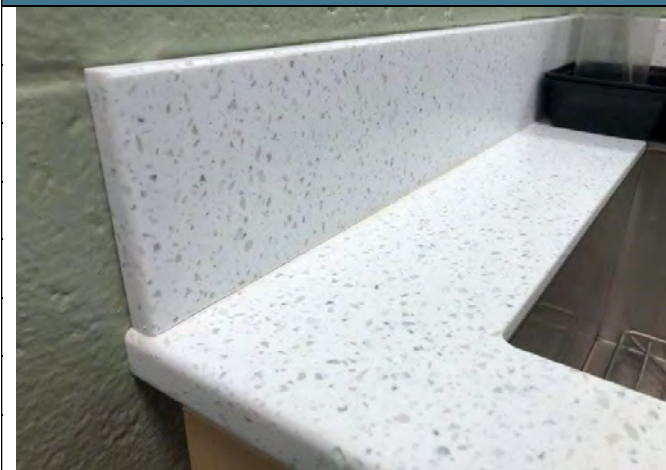
Homogenous Material Description
HA-83: White caulk on backsplash
Asbestos Present (Yes/No/Assumed)
No
Total Quantity Present
20 LF
Additional Notes

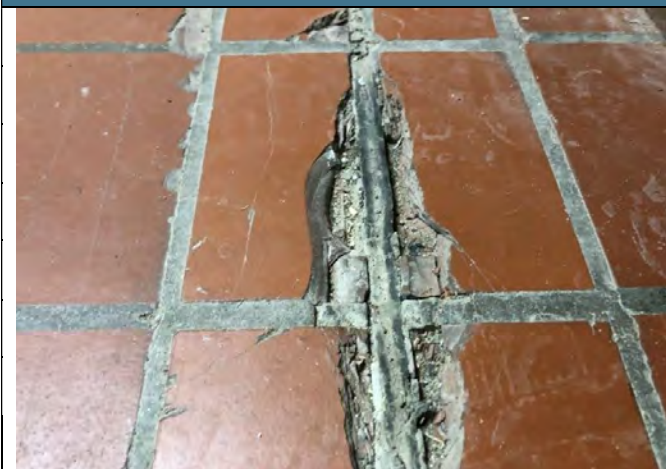
Homogenous Material Description
HA-84: Concrete slab expansion joint
Asbestos Present (Yes/No/Assumed)
No
Total Quantity Present
15 LF
Additional Notes

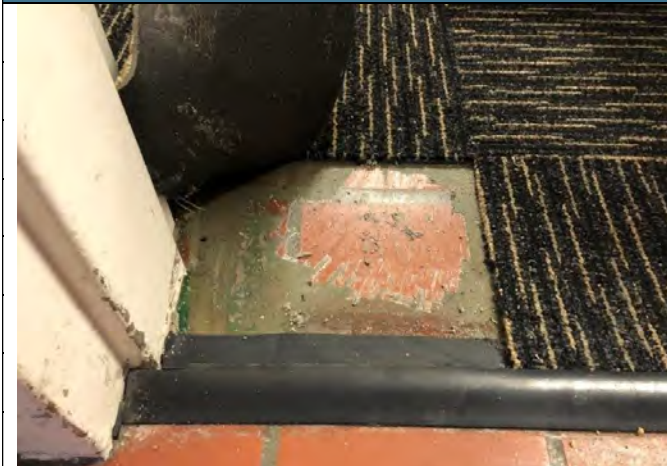
Homogenous Material Description
HA-85: Carpet mastic, green
Asbestos Present (Yes/No/Assumed)
No
Total Quantity Present
325 SF
Additional Notes

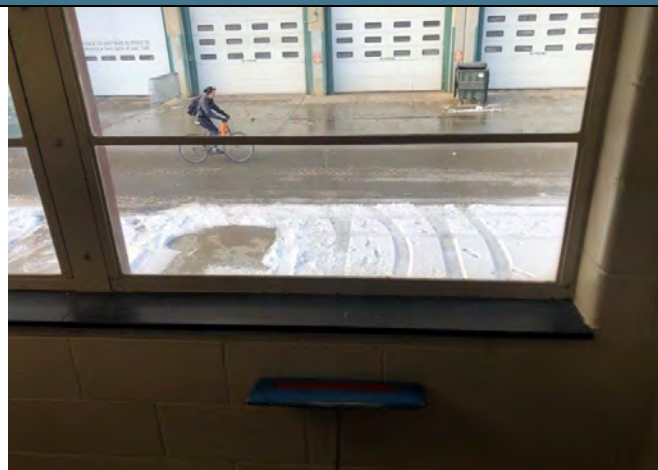
Homogenous Material Description
HA-86: Transite window sill
Asbestos Present (Yes/No/Assumed)
Assumed
Total Quantity Present
20 SF
Additional Notes

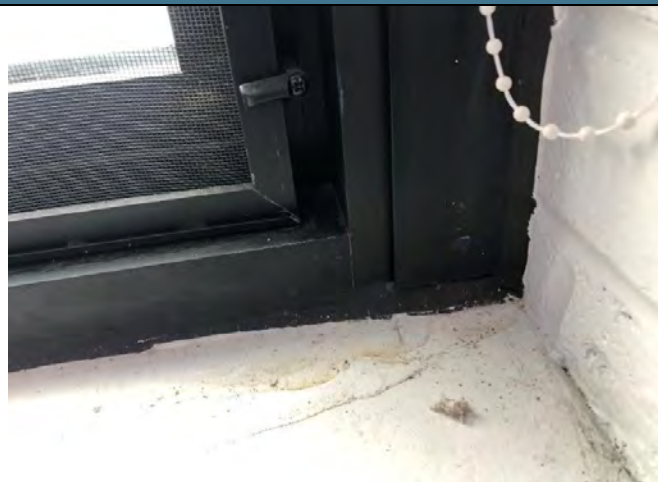
Homogenous Material Description
HA-87: Black caulk, perimeter of aluminum window frame
Asbestos Present (Yes/No/Assumed)
No
Total Quantity Present
690 LF
Additional Notes

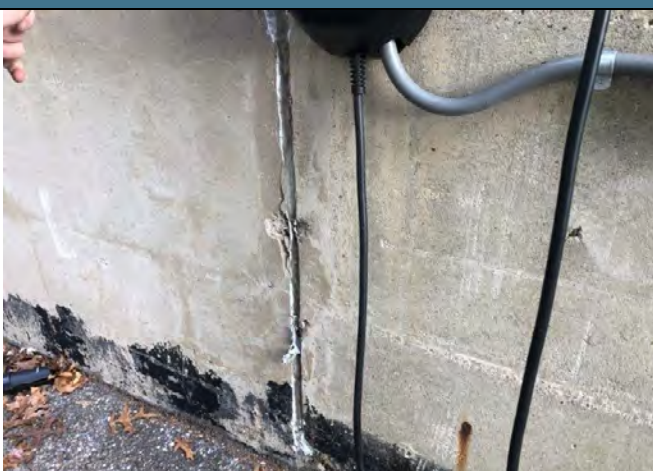
Homogenous Material Description
HA-90: Grey foundation expansion joint
Asbestos Present (Yes/No/Assumed)
Yes, 8% Chrysotile
Total Quantity Present
5 LF
Additional Notes

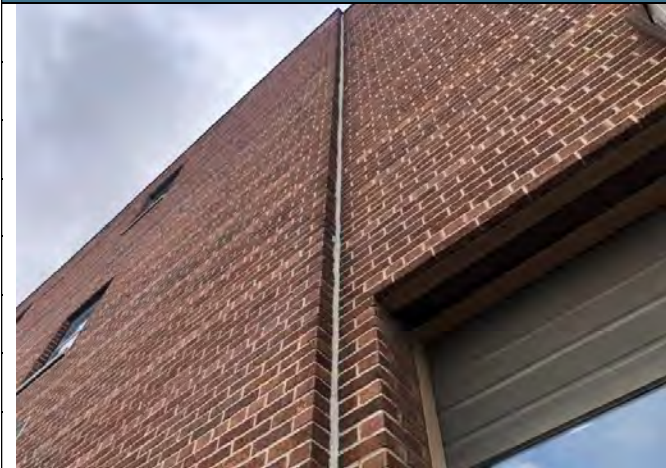
Homogenous Material Description
HA-91: Red brick expansion joint
Asbestos Present (Yes/No/Assumed)
Yes, 2% Chrysotile
Total Quantity Present
300 LF
Additional Notes

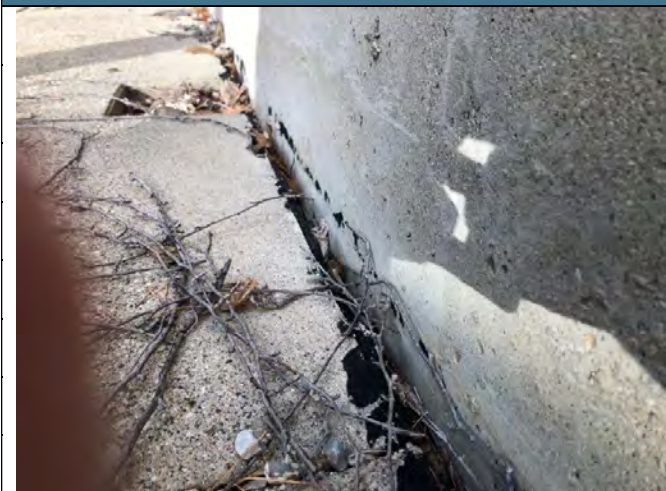
Homogenous Material Description
HA-92: Black expansion joint between foundation wall and walkway
Asbestos Present (Yes/No/Assumed)
No
Total Quantity Present
260 LF
Additional Notes

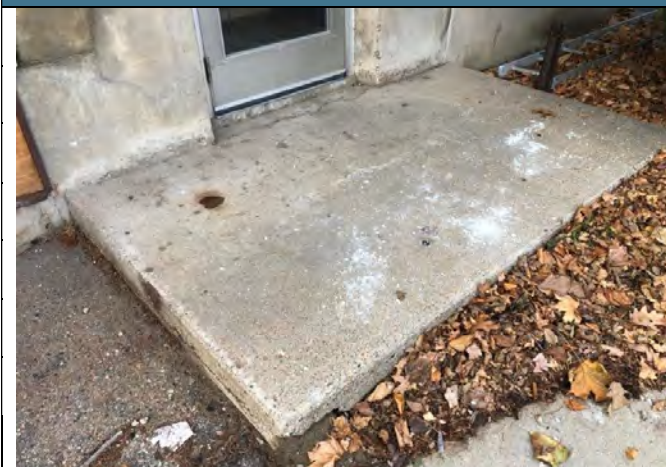
Homogenous Material Description
HA-93: Exterior concrete
Asbestos Present (Yes/No/Assumed)
No
Total Quantity Present
1578 SF
Additional Notes

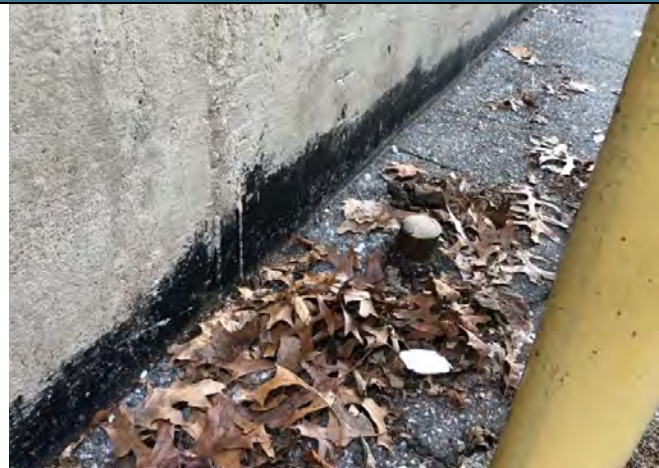
Homogenous Material Description
HA-94: Black spray-on waterproofing
Asbestos Present (Yes/No/Assumed)
No
Total Quantity Present
715 LF
Additional Notes

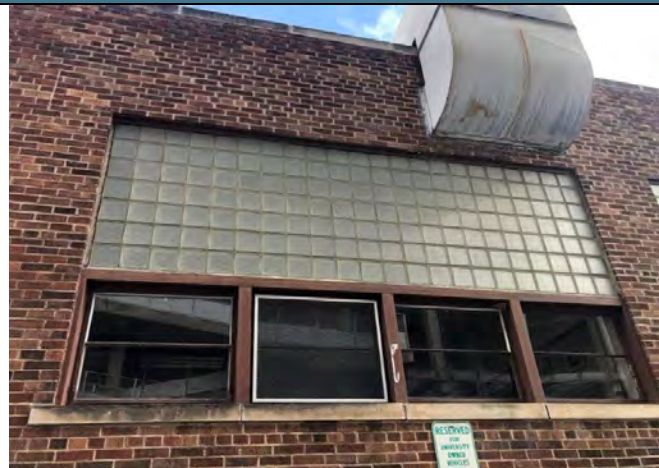
Homogenous Material Description
HA-95: Glass block mortar
Asbestos Present (Yes/No/Assumed)
No
Total Quantity Present
1050 LF
Additional Notes

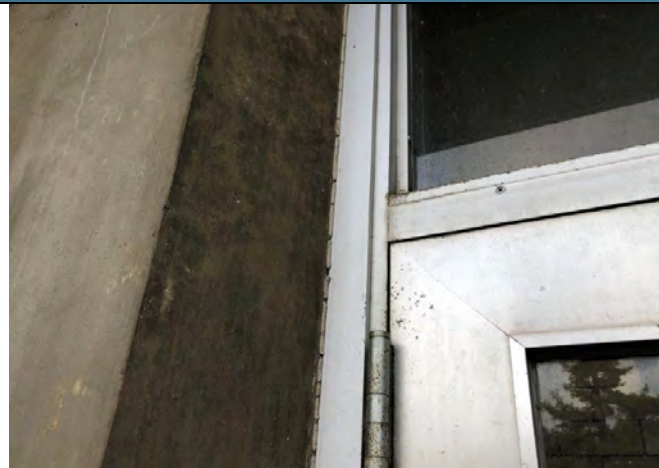
Homogenous Material Description
HA-100: Grey caulk, perimeter of door frames
Asbestos Present (Yes/No/Assumed)
Yes, 7% Chrysotile
Total Quantity Present
70 LF
Additional Notes

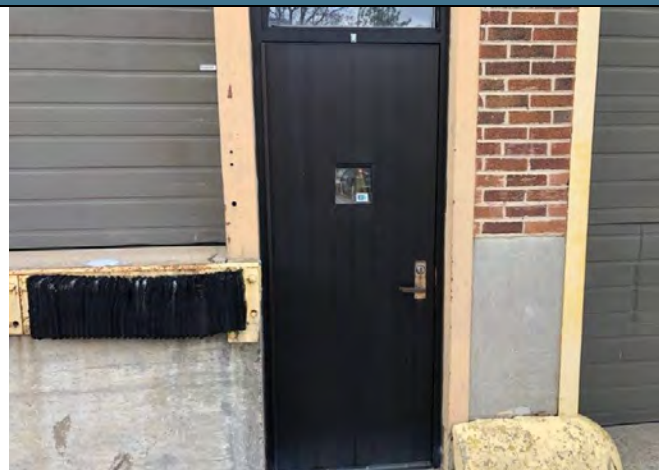
Homogenous Material Description
HA-101: Black caulk, perimeter of door frames
Asbestos Present (Yes/No/Assumed)
No
Total Quantity Present
45 LF
Additional Notes

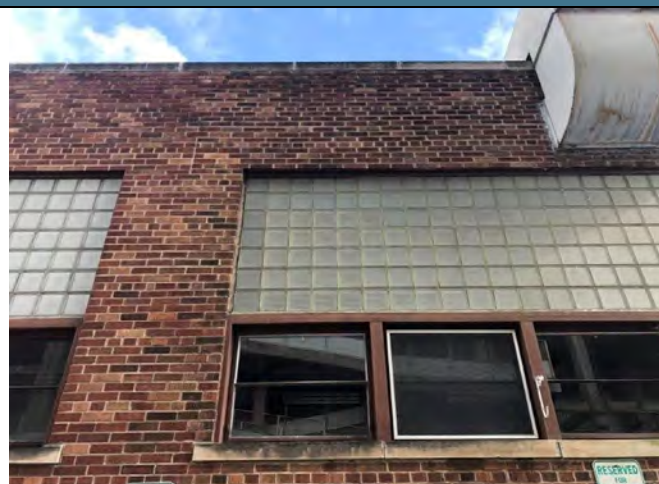
Homogenous Material Description
HA-102: Grey, caulk, perimeter of steel multi-pane windows
Asbestos Present (Yes/No/Assumed)
Yes, 5% Chrysotile
Total Quantity Present
725 LF
Additional Notes

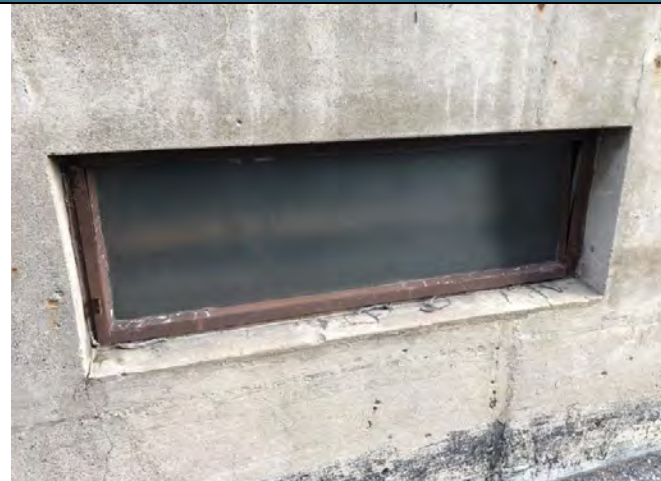
Homogenous Material Description
HA-103: Grey caulk, perimeter of steel basement windows
Asbestos Present (Yes/No/Assumed)
Yes, 6% Chrysotile
Total Quantity Present
350 LF
Additional Notes

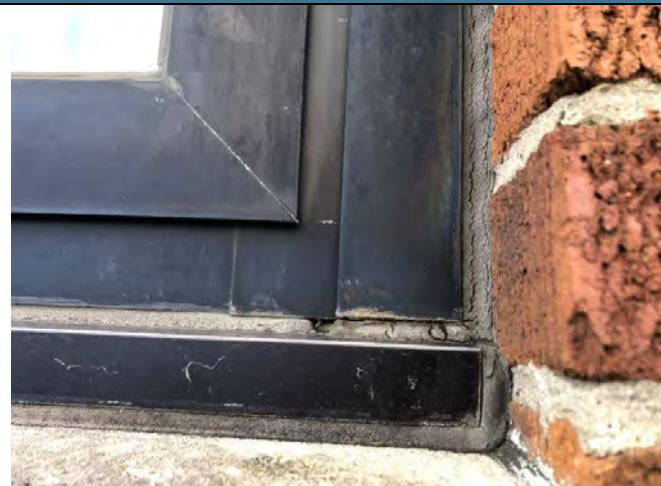
Homogenous Material Description
HA-104: Grey caulk, perimeter of aluminum windows
Asbestos Present (Yes/No/Assumed)
No
Total Quantity Present
530 LF
Additional Notes

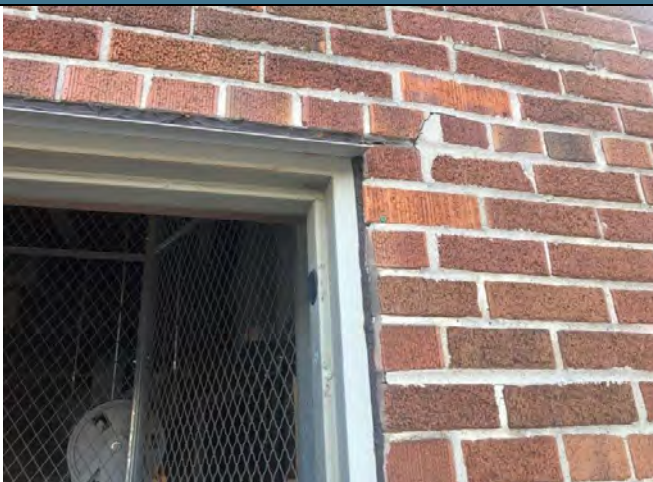
Homogenous Material Description
HA-111: dark grey caulk, perimeter of door frame
Asbestos Present (Yes/No/Assumed)
No
Total Quantity Present
20 LF
Additional Notes

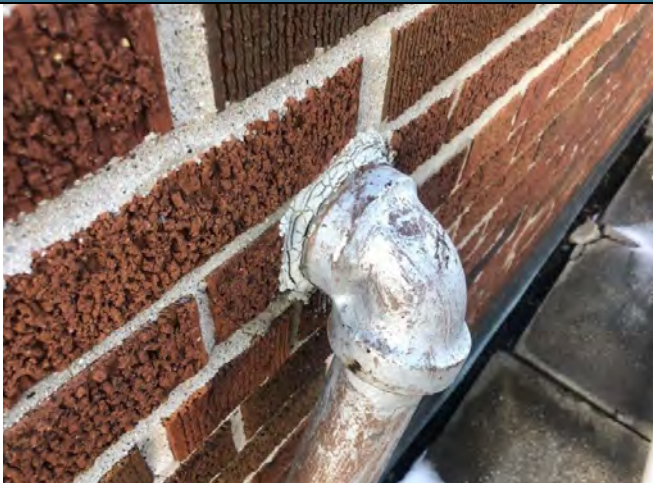
Homogenous Material Description
HA-112: Light grey caulk, penthouse penetrations
Asbestos Present (Yes/No/Assumed)
No
Total Quantity Present
5 LF
Additional Notes

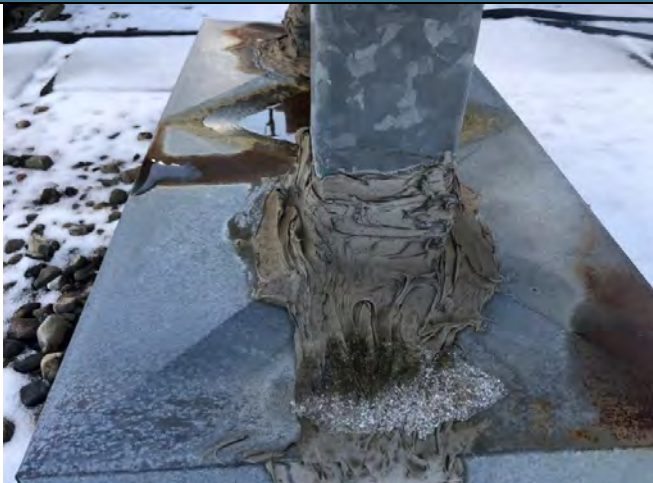
Homogenous Material Description
HA-115: Grey caulk, on penetrations, fencing base
Asbestos Present (Yes/No/Assumed)
No
Total Quantity Present
50 SF
Additional Notes

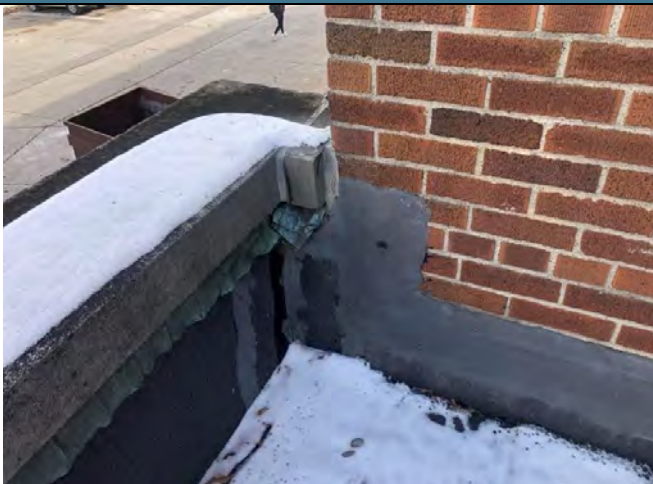
Homogenous Material Description
HA-116: Grey caulk, seams of concrete capstone
Asbestos Present (Yes/No/Assumed)
No
Total Quantity Present
200 LF
Additional Notes

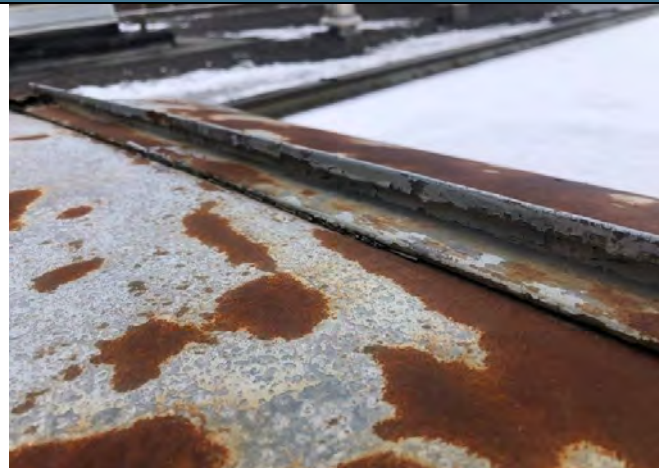
Homogenous Material Description
HA-118: Grey caulk, on HVAC seams
Asbestos Present (Yes/No/Assumed)
No
Total Quantity Present
20 LF
Additional Notes

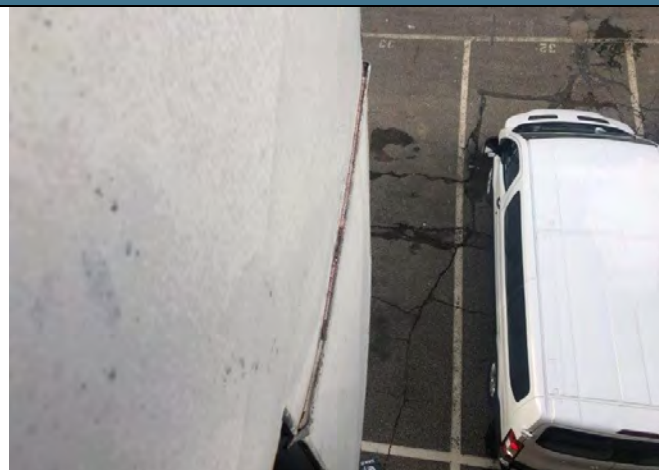
Homogenous Material Description
HA-119: Pink caulk, on HVAC seams
Asbestos Present (Yes/No/Assumed)
No
Total Quantity Present
30 LF
Additional Notes

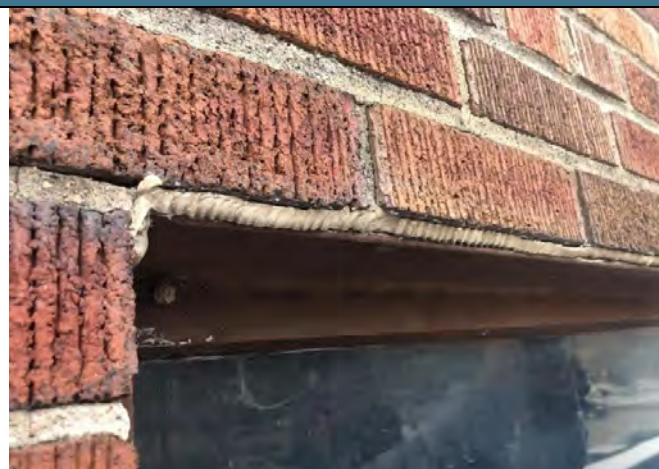
Homogenous Material Description
HA-120: white caulk, on window angle iron
Asbestos Present (Yes/No/Assumed)
No
Total Quantity Present
5 LF
Additional Notes

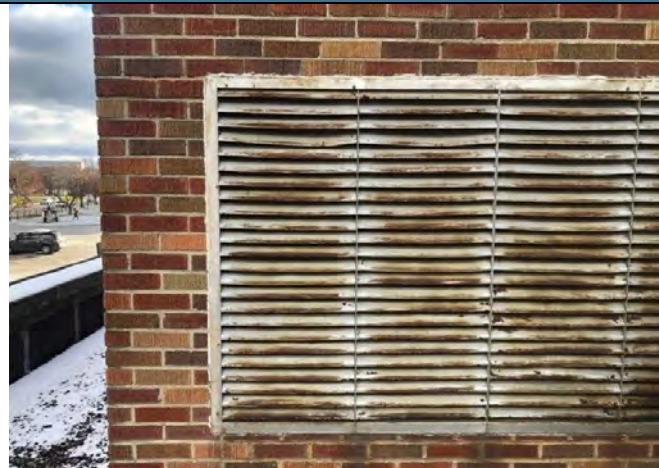
Homogenous Material Description
HA-121: grey caulk, on vent perimeter
Asbestos Present (Yes/No/Assumed)
Yes, 5% Chrysotile
Total Quantity Present
35 LF
Additional Notes

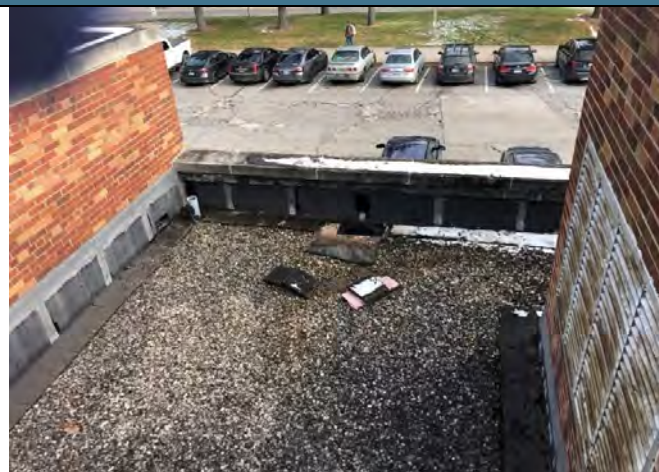
Homogenous Material Description
HA-122: Black caulk, on parapet walls
Asbestos Present (Yes/No/Assumed)
Yes, 5% Chrysotile
Total Quantity Present
800 SF
Additional Notes
