ADDENDUM  
PAGE 1 OF 1

# **PRE-DEMOLITION HAZARDOUS MATERIALS SURVEY REPORT**

## **CENTRAL SERVICES**

570 Red Cedar Road  
East Lansing, MI 48823

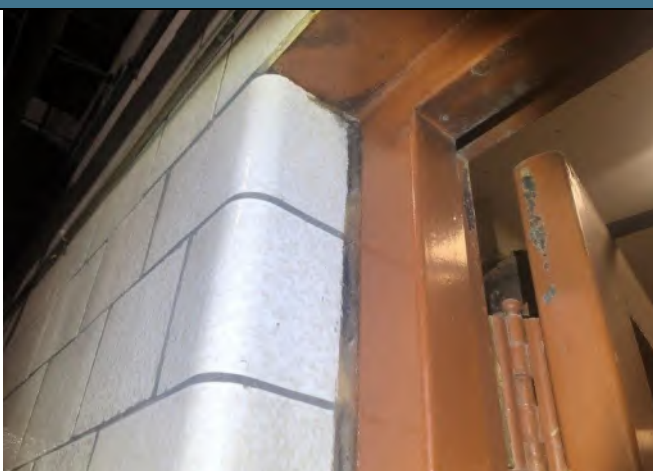
### Photograph #11

Homogenous Material Description
HA-11: Dark brown caulk on door frames
Asbestos Present (Yes/No/Assumed)
Yes, 2% Chrysotile
Total Quantity Present
880 LF
Additional Notes

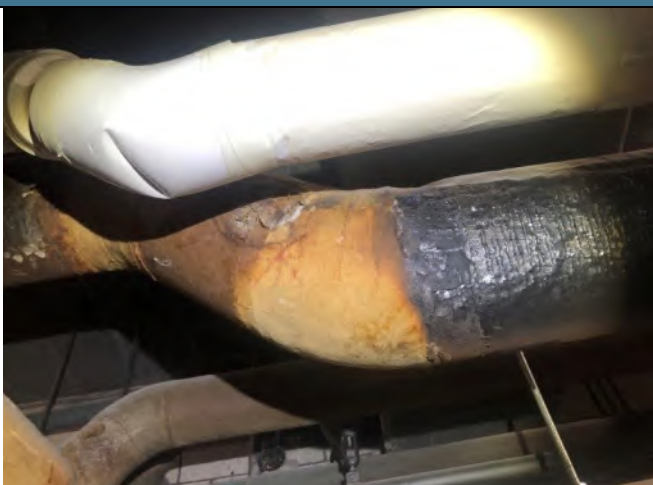
### Photograph #16

Homogenous Material Description
HA-16: Canvas covered pipe fittings, brown paper wrapped pipe insulation lines
Asbestos Present (Yes/No/Assumed)
Yes, 30% Chrysotile
Total Quantity Present
283 Fittings
Additional Notes

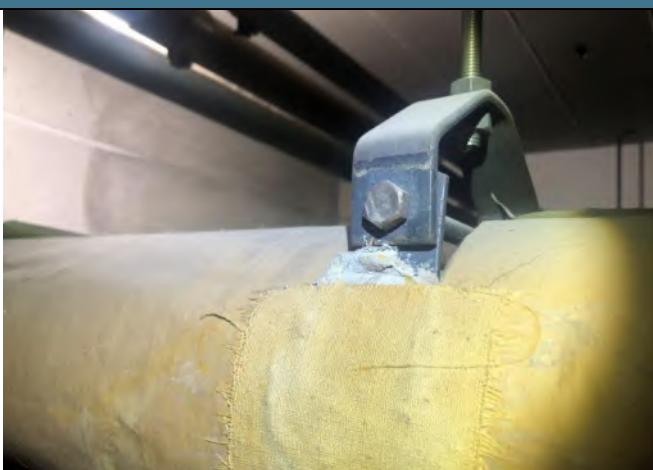
### Photograph #17

Homogenous Material Description
HA-17: Hanger mud
Asbestos Present (Yes/No/Assumed)
Yes, 50% Chrysotile
Total Quantity Present
78 Fittings
Additional Notes

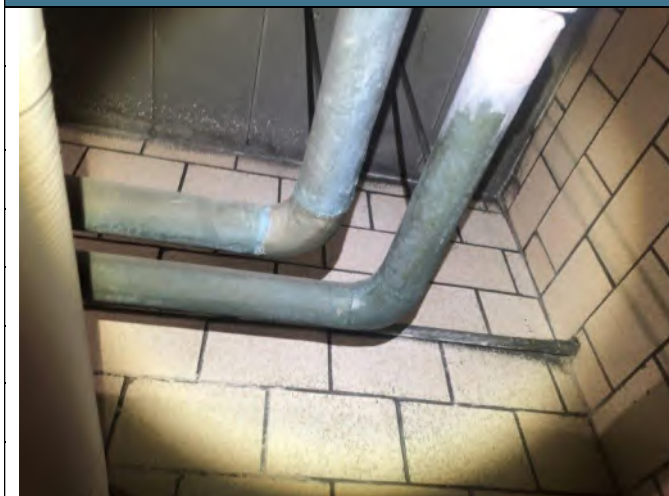
### Photograph #19

Homogenous Material Description
HA-19: Canvas covered mudded fittings on wool felt pipe insulation lines
Asbestos Present (Yes/No/Assumed)
Yes, 50% Chrysotile
Total Quantity Present
159 Fittings
Additional Notes

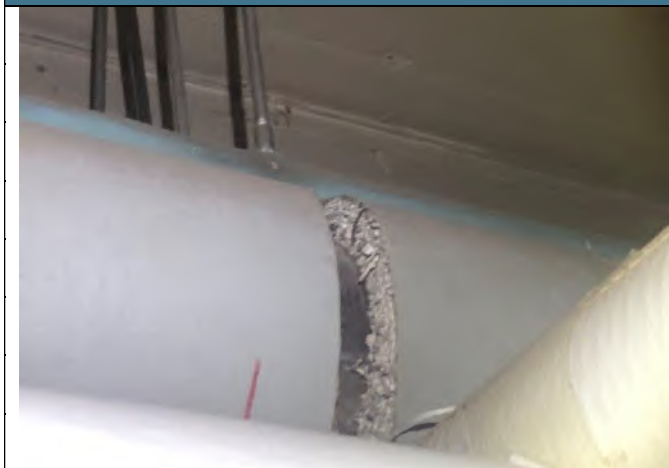
### Photograph #20

Homogenous Material Description
HA-20: Aircell pipe insulation
Asbestos Present (Yes/No/Assumed)
Yes, 45% Chrysotile
Total Quantity Present
468 LF
Additional Notes

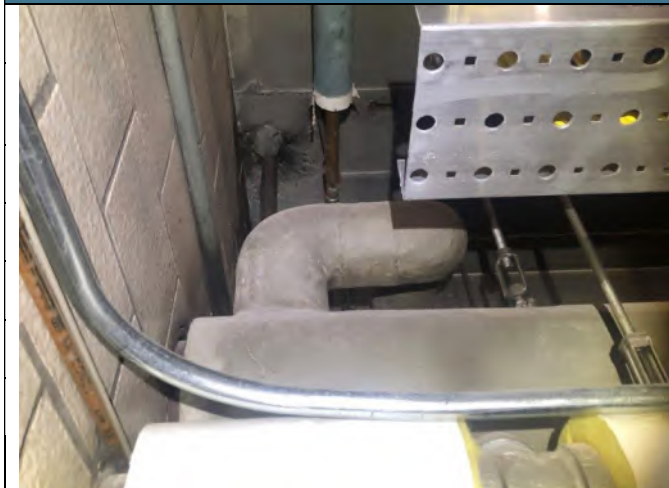
### Photograph #21

Homogenous Material Description
HA-21: Canvas covered mudded fittings, on aircell pipe insulation lines
Asbestos Present (Yes/No/Assumed)
Yes, 45% Chrysotile
Total Quantity Present
93 Fittings
Additional Notes

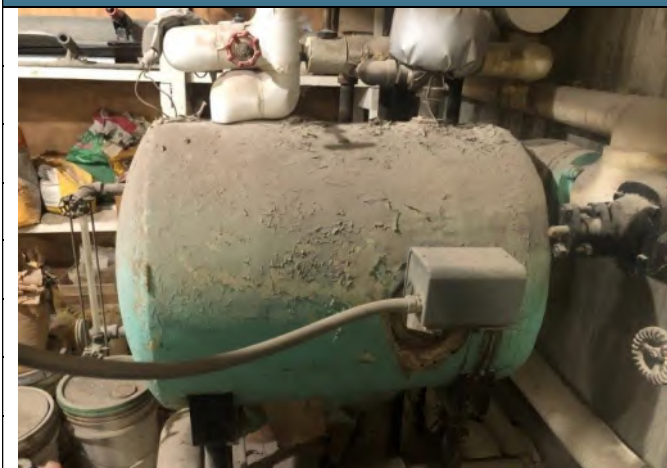
### Photograph #34

Homogenous Material Description
HA-34: Tank insulation
Asbestos Present (Yes/No/Assumed)
Yes, 30% Chrysotile
Total Quantity Present
1 Tank
Additional Notes

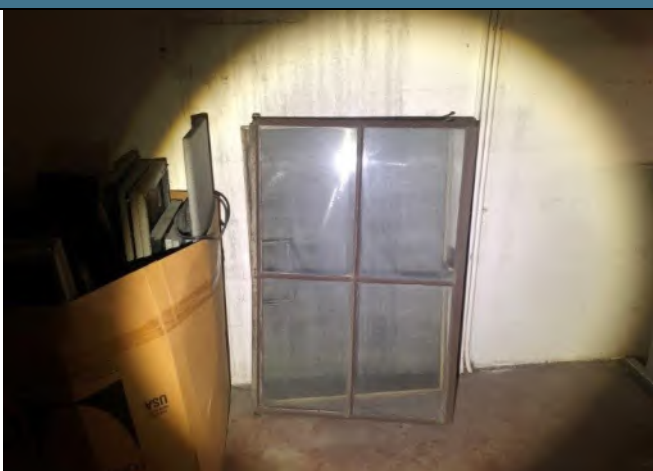
### Photograph #38

Homogenous Material Description
HA-38: Window glaze, stack
Asbestos Present (Yes/No/Assumed)
Yes, 3% Chrysotile
Total Quantity Present
1 Window
Additional Notes

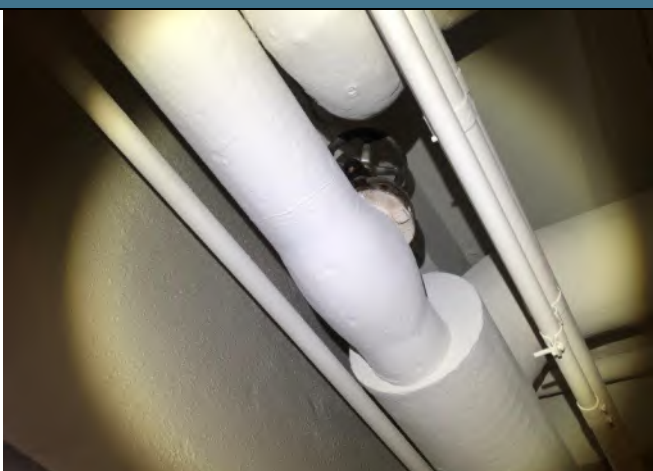
### Photograph #44

Homogenous Material Description
HA-44: Magnesia pipe insulation
Asbestos Present (Yes/No/Assumed)
Yes, 30% Chrysotile
Total Quantity Present
985 LF
Additional Notes

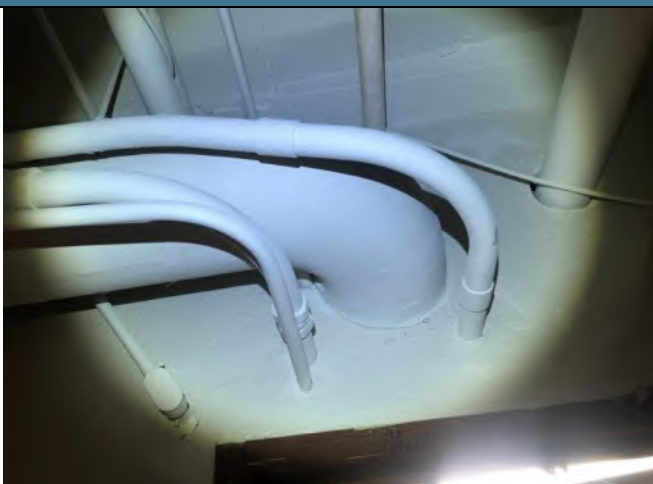
### Photograph #45

Homogenous Material Description
HA-45: Canvas covered mudded fittings, on magnesia pipe insulation lines
Asbestos Present (Yes/No/Assumed)
Yes, 30% Chrysotile
Total Quantity Present
200 LF
Additional Notes

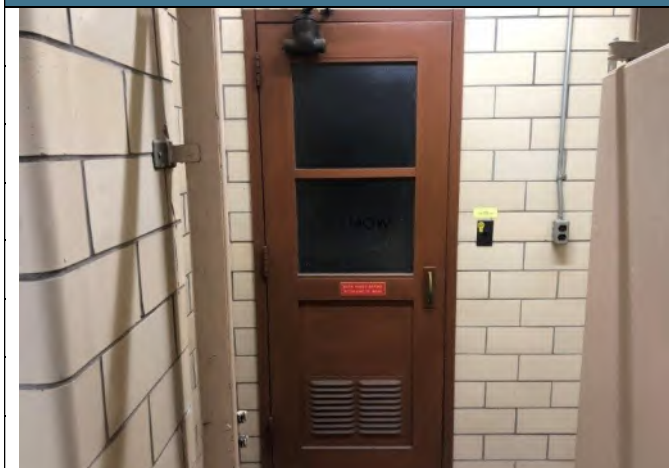
### Photograph #49

Homogenous Material Description
HA-49: Window glaze – beige, in door windows
Asbestos Present (Yes/No/Assumed)
Point Count: Trace Chrysotile
Total Quantity Present
11 Windows
Additional Notes

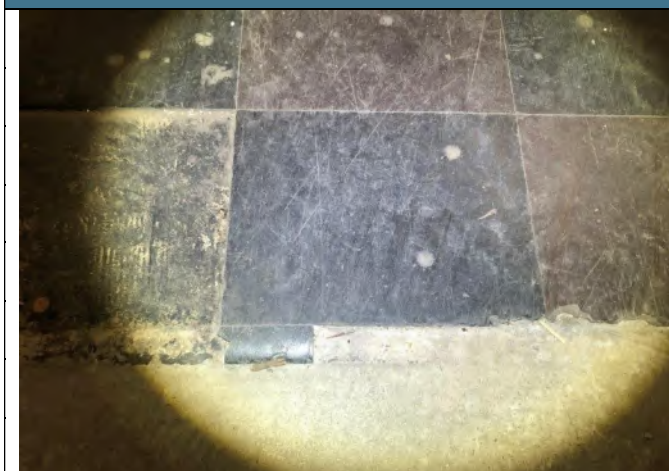
### Photograph #50

Homogenous Material Description
HA-50: 9" black floor tile, black mastic
Asbestos Present (Yes/No/Assumed)
Yes, FT: 2% Chrysotile Mastic: ND
Total Quantity Present
210 SF
Additional Notes

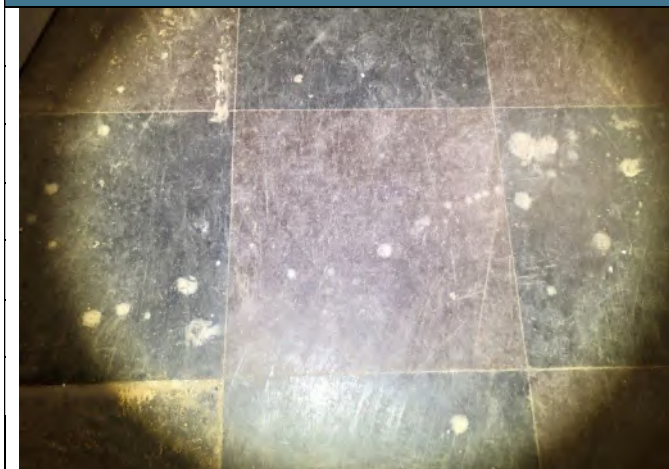
### Photograph #51

Homogenous Material Description
HA-51: 9" dark brown tile, black mastic
Asbestos Present (Yes/No/Assumed)
Yes, FT: 2% Chrysotile Mastic: ND
Total Quantity Present
210 SF
Additional Notes

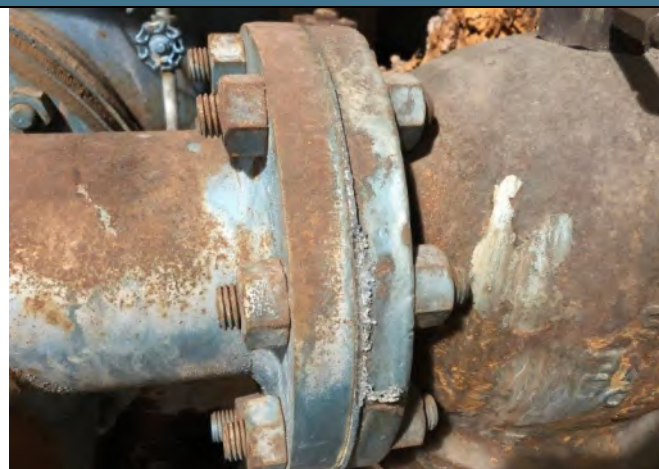
### Photograph #57

Homogenous Material Description
HA-57: Gasket material – steel pipes
Asbestos Present (Yes/No/Assumed)
Yes, 10% Chrysotile
Total Quantity Present
44 Gaskets
Additional Notes

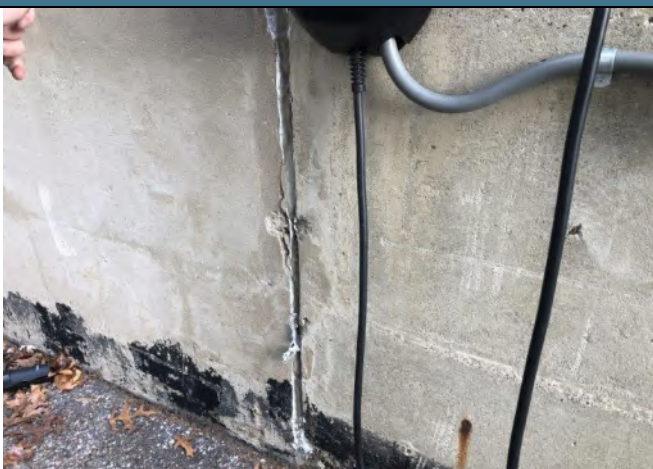
### Photograph #90

Homogenous Material Description
HA-90: Grey foundation expansion joint
Asbestos Present (Yes/No/Assumed)
Yes, 8% Chrysotile
Total Quantity Present
5 LF
Additional Notes

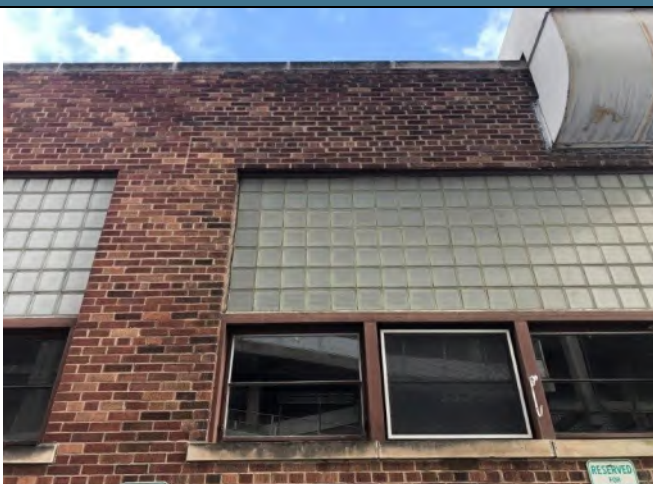
### Photograph #102

Homogenous Material Description
HA-102: Grey, caulk, perimeter of steel multi-pane windows
Asbestos Present (Yes/No/Assumed)
Yes, 5% Chrysotile
Total Quantity Present
725 LF
Additional Notes

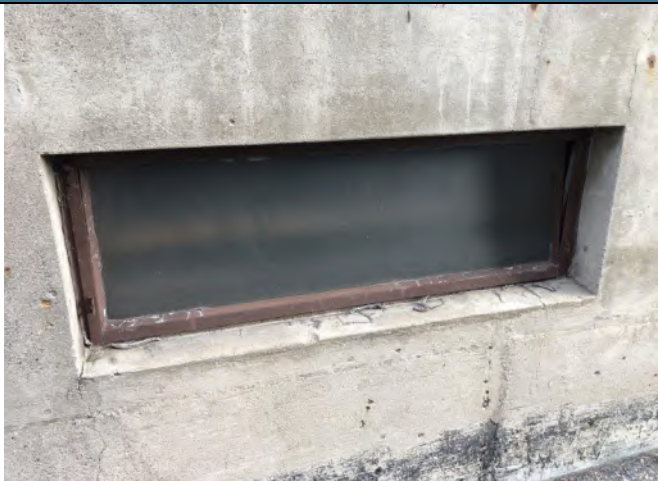
### Photograph #103

Homogenous Material Description
	HA-103: Grey caulk, perimeter of steel basement windows
	Asbestos Present (Yes/No/Assumed)
	Yes, 6% Chrysotile
	Total Quantity Present
	350 LF
	Additional Notes

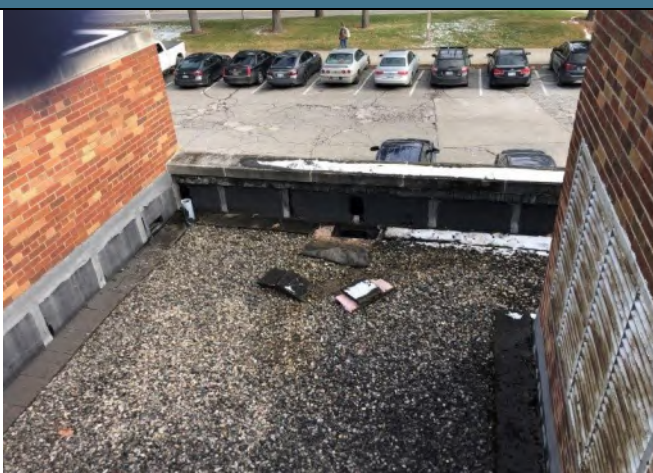
### Photograph #122

Homogenous Material Description
HA-122: Black caulk, on parapet walls
Asbestos Present (Yes/No/Assumed)
Yes, 5% Chrysotile
Total Quantity Present
800 SF
Additional Notes

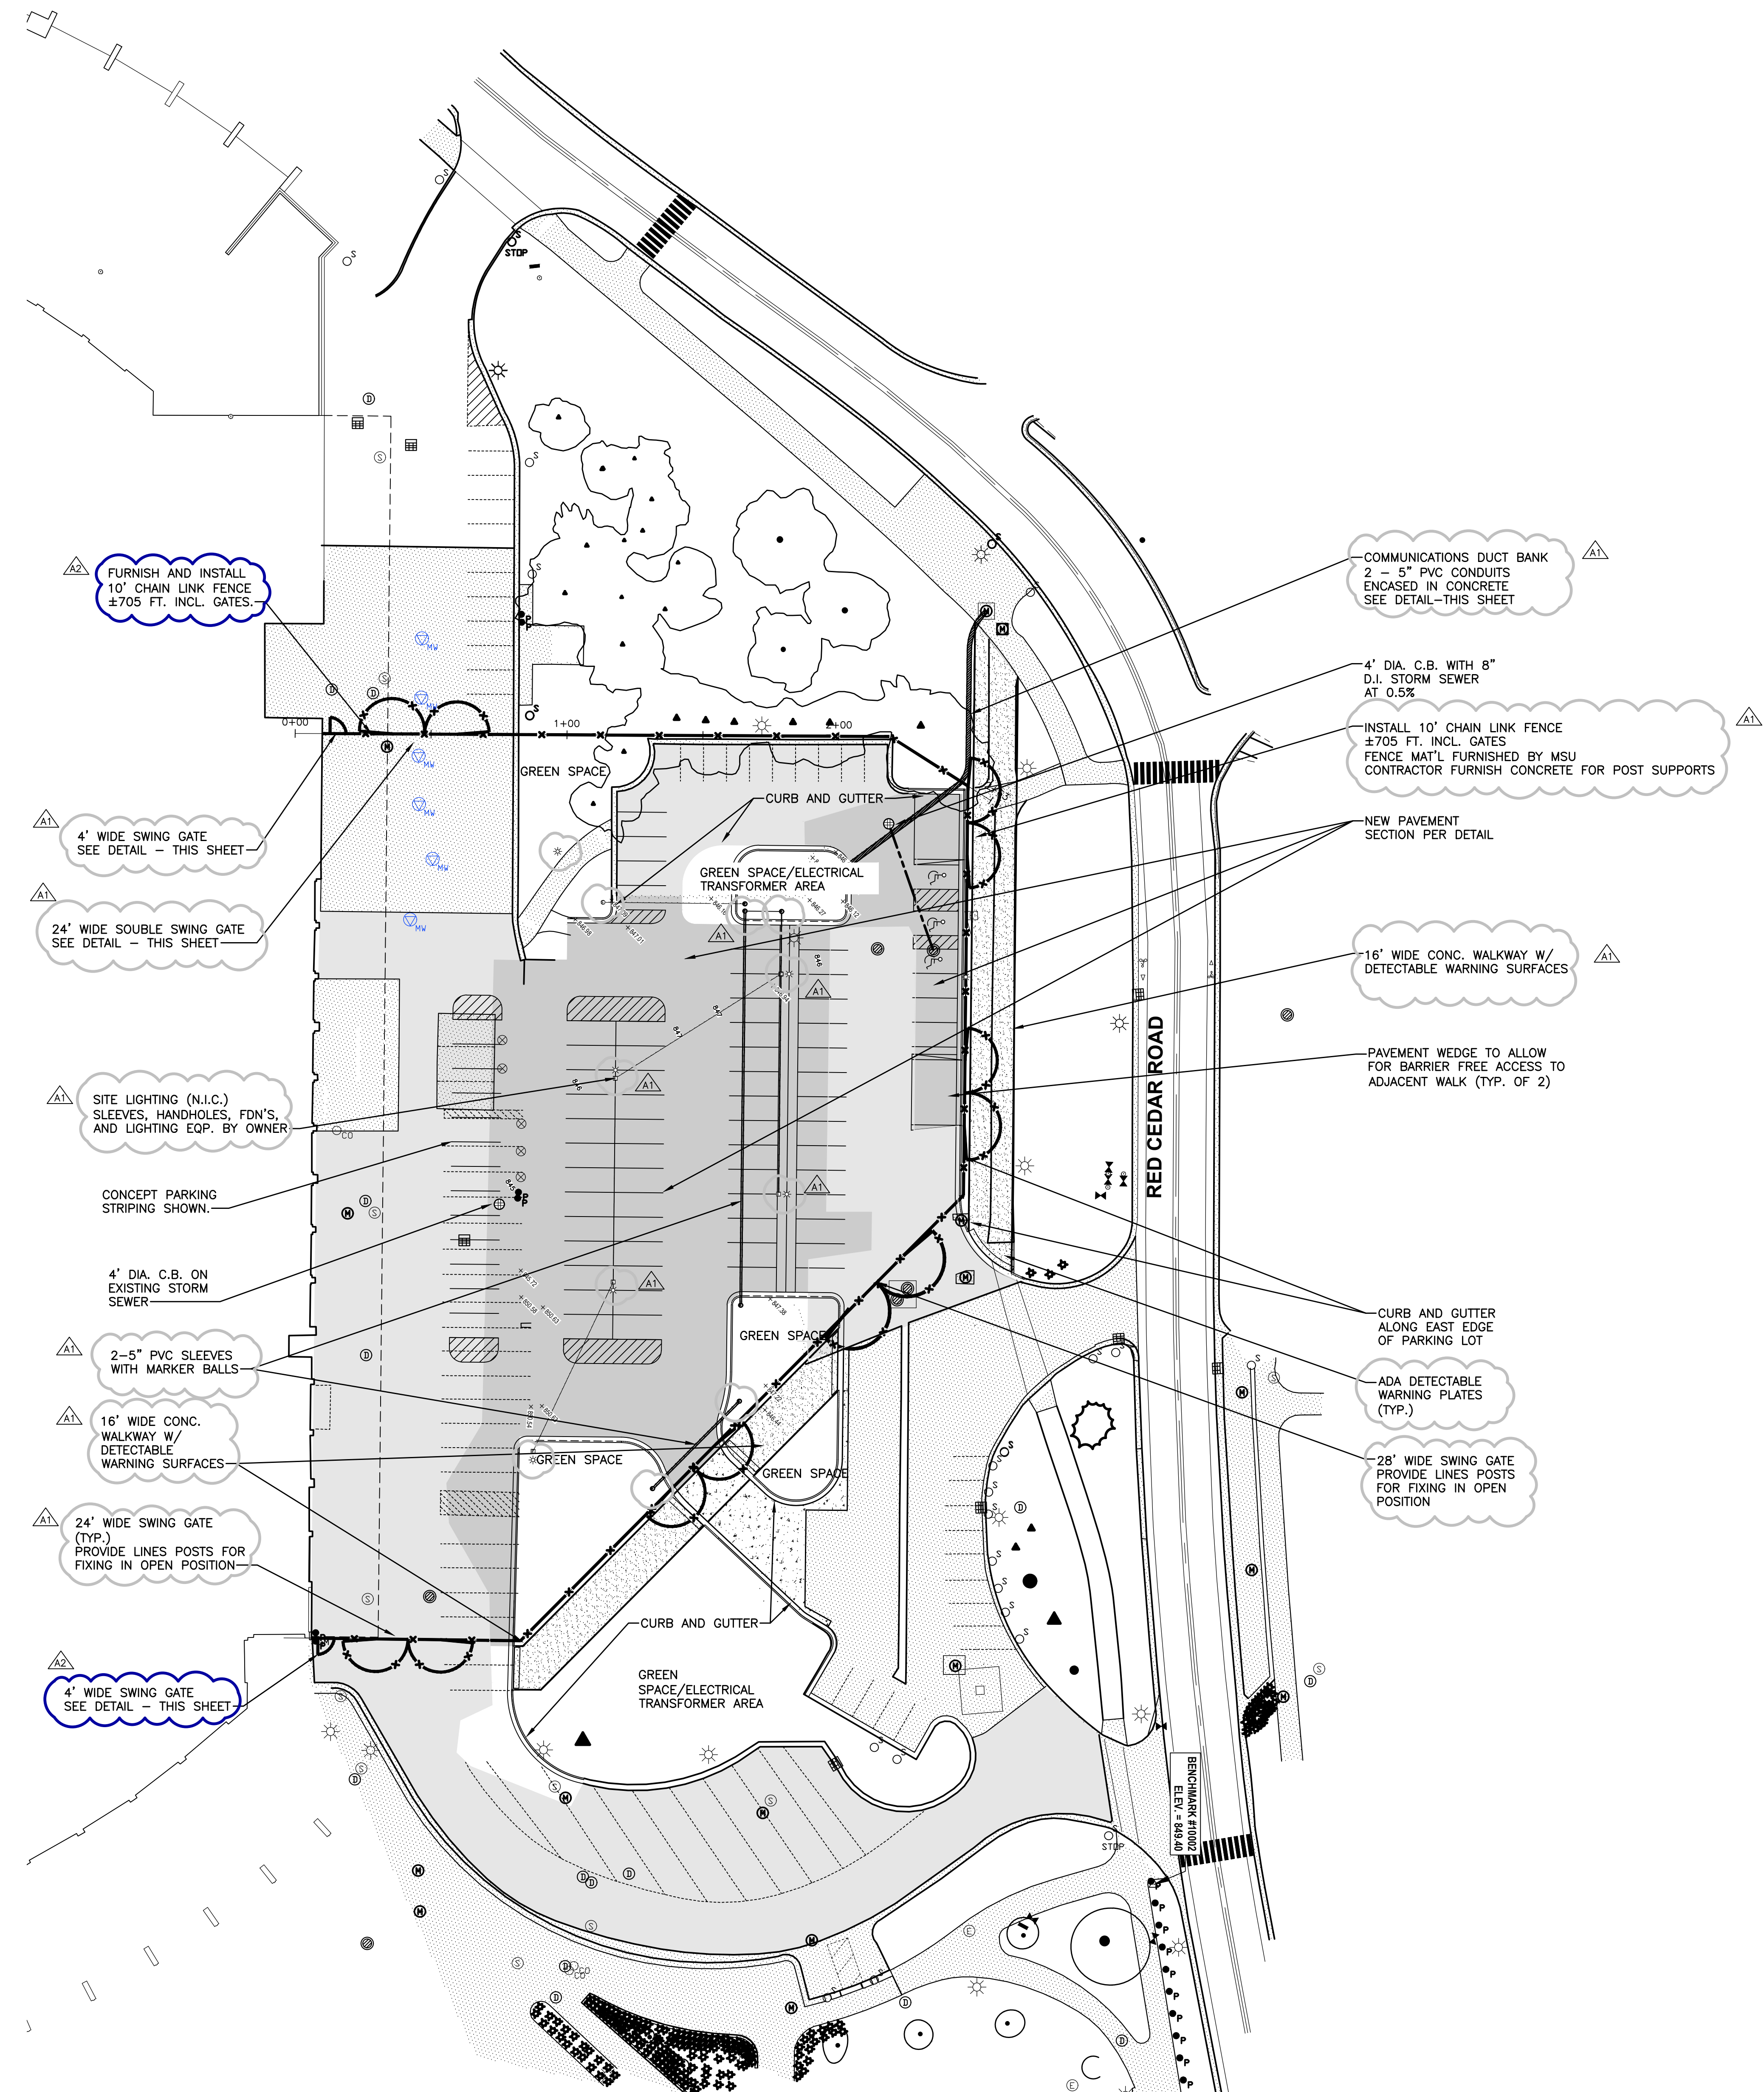
**FINAL SITE LAYOUT PLAN**  
SCALE: 1" = 30'  
0 15 30 60  
NORTH

- A. Permanent fencing to be furnished and installed by contractor.
- B. Man Gate information added to gate at south end of project.
- C. Updated Revisions in Title Block
