TITLE OF PROJECT: Human Ecology – Replace Roofs and Complete Masonry Restoration

ADDENDUM NO: 01

August 6, 2021
Project No. 21-054

RE: BUILDING ENVELOPE STUDY
Human Ecology Building
552 W Circle Dr.
East Lansing, MI 48823

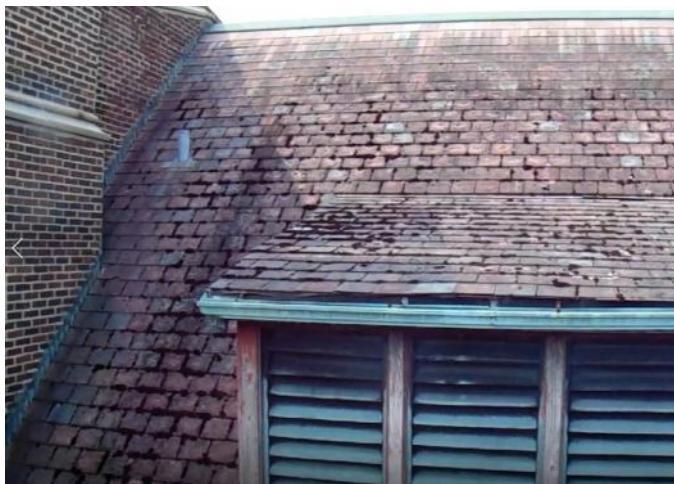
Photo 1: Area 1 - stained/weathered/moss growth between asbestos tiles

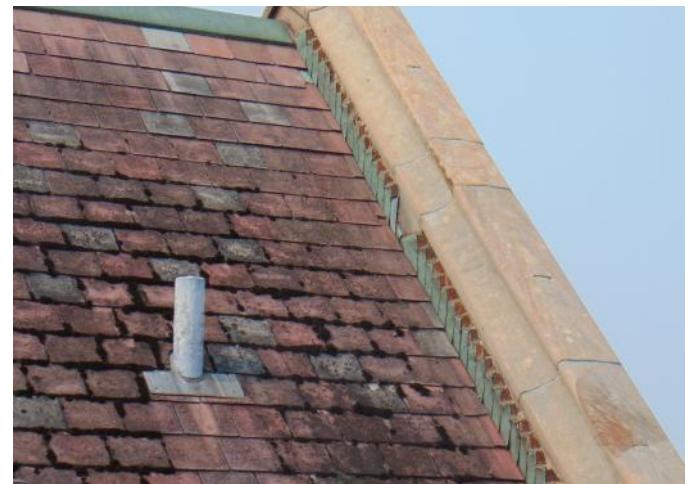
Photo 2: Area 1 - stained/weathered/moss growth between asbestos tiles

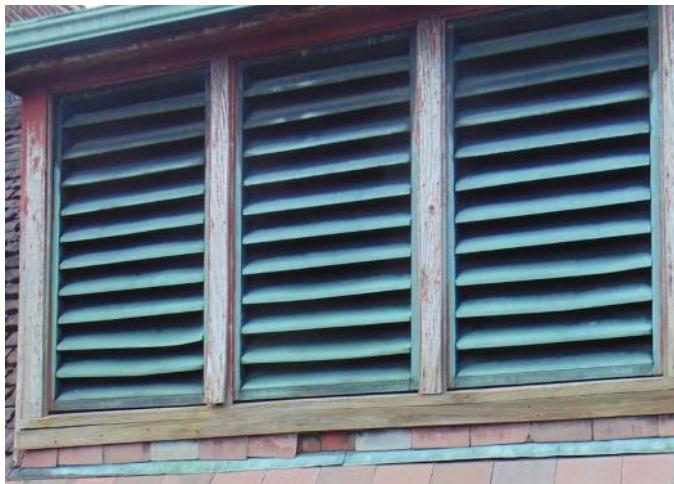
Photo 3: Area 1 - weathered lumber around louvers - missing asbestos tiles

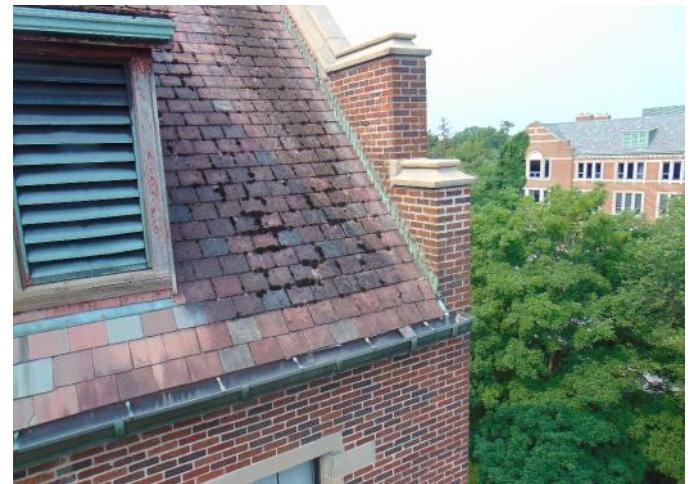
Photo 4: Area 1 - stained/weathered/moss growth between asbestos tiles

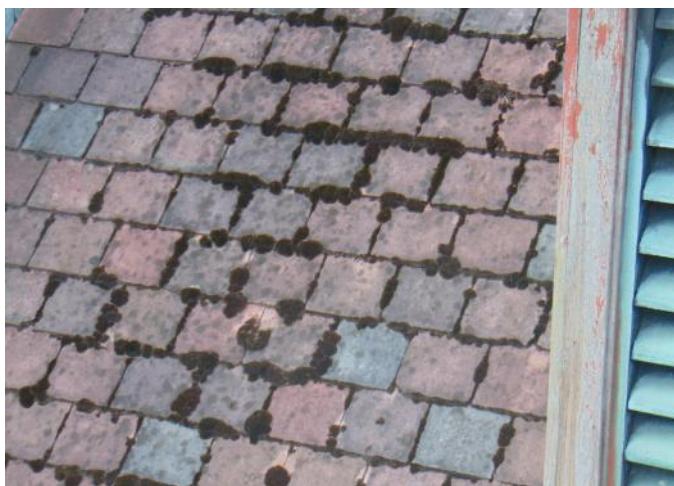
Photo 5: Area 1 - stained/weathered/moss growth between asbestos tiles

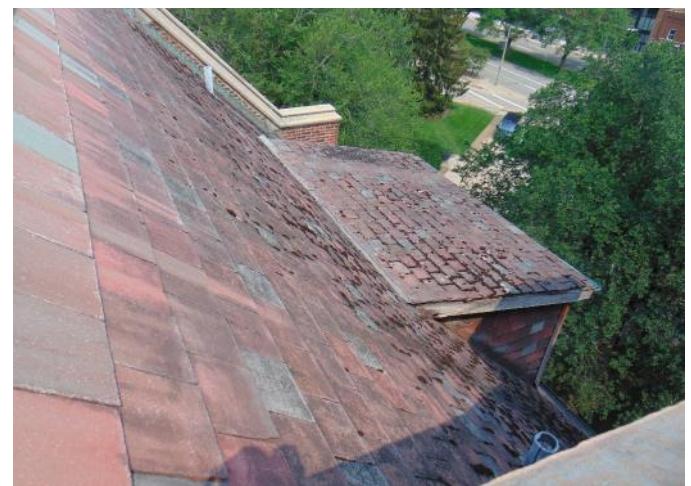
Photo 6: Area 1 - slope of dormer roof is inadequate to provide required drainage of a tile

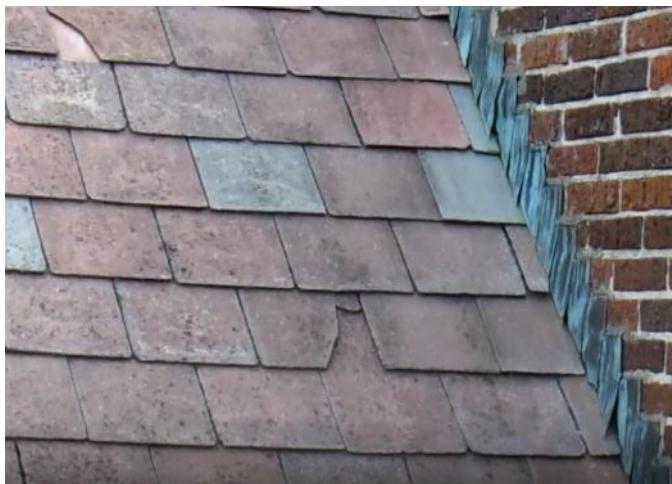
4. There are numerous broken asbestos tiles on the south facing, as they have become brittle with age (Photos 7, 11, and 12).
5. The copper step flashing is bent away from the wall (Photos 7 and 12).

Photo 7: Area 1 - broken asbestos tiles - bent step flashing

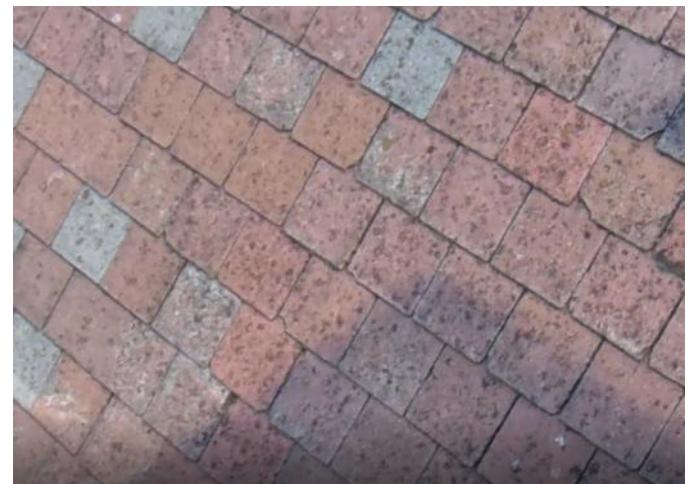
Photo 8: Area 1 - stained/weathered/broken asbestos tiles

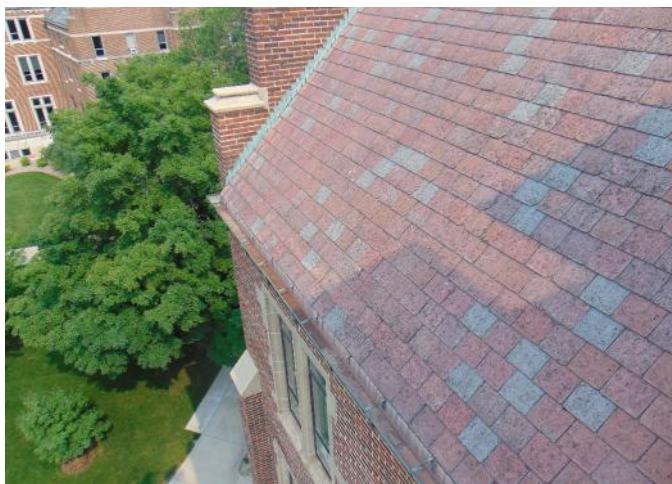
Photo 9: Area 1 - stained/weathered asbestos tiles

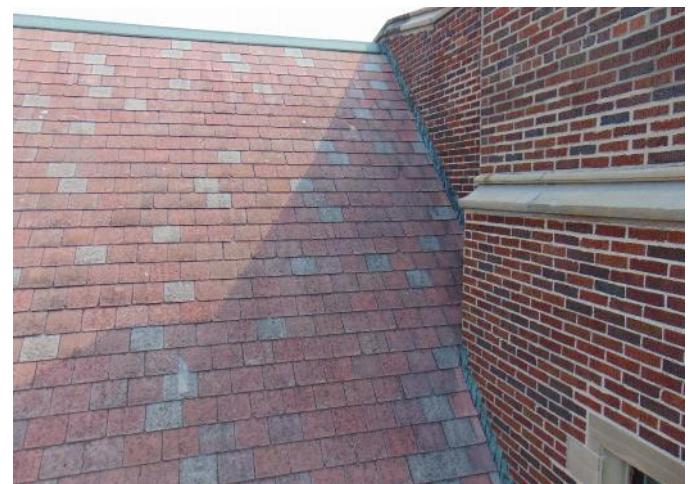
Photo 10: Area 1 - stained/weathered asbestos tiles

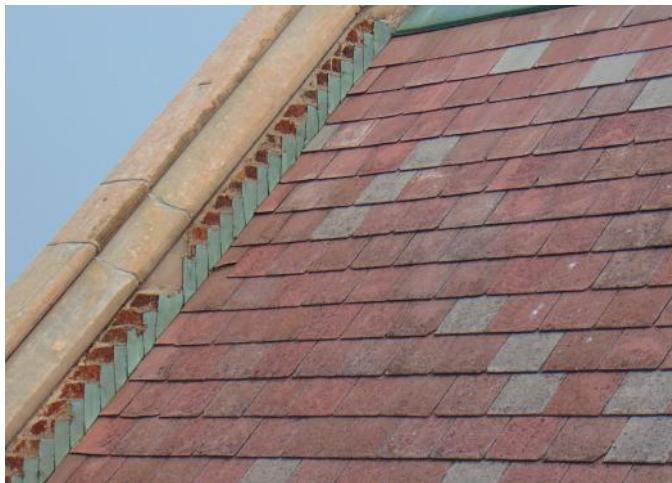
Photo 11: Area 1 - stained/weathered/broken asbestos tiles

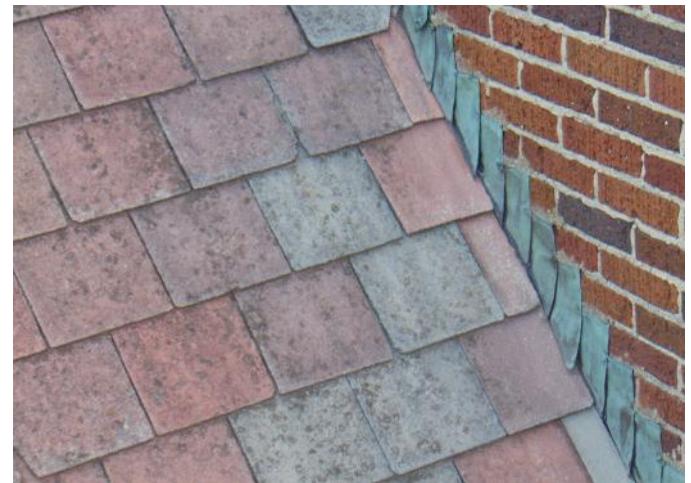
Photo 12: Area 1 - stained/weathered/broken asbestos tiles - bent step flashing

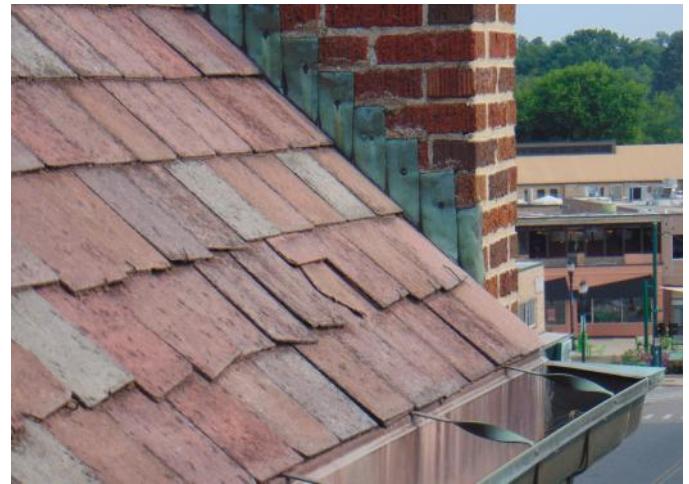
Photo 14: Area 5 - stained/weathered/broken asbestos tiles

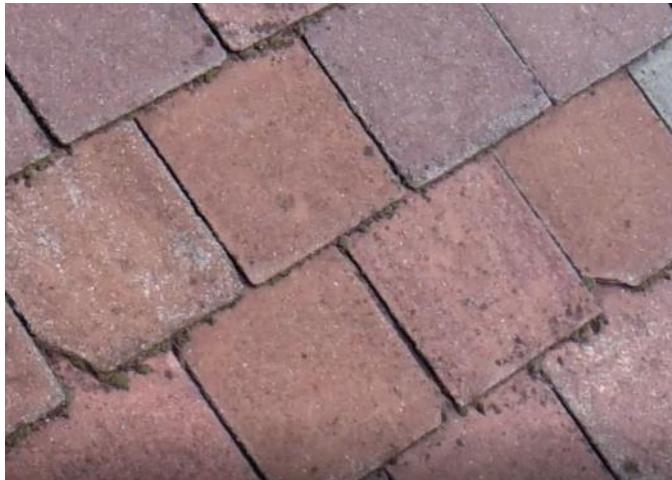
Photo 15: Area 5 - stained/weathered/broken asbestos tiles

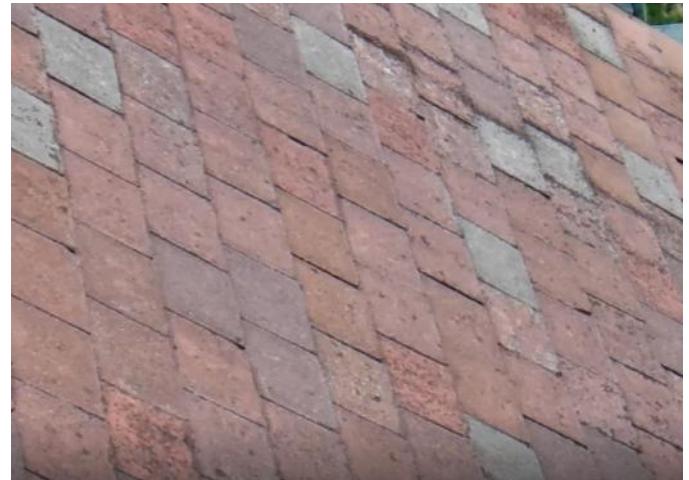
Photo 16: Area 5 - stained/weathered/broken asbestos tiles

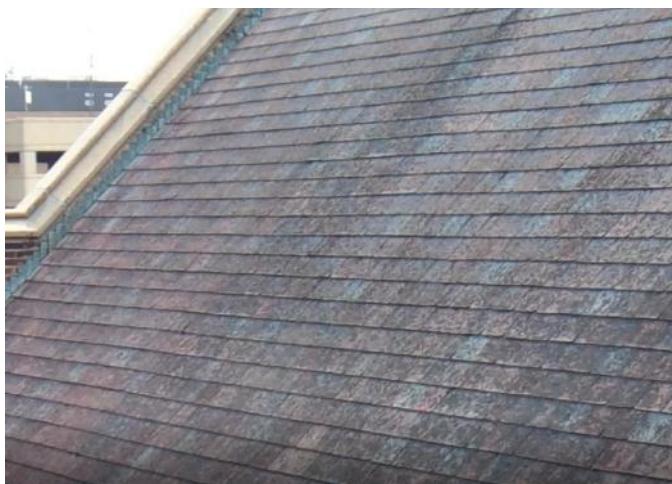
Photo 17: Area 5 - west facing - stained/weathered/broken asbestos tiles

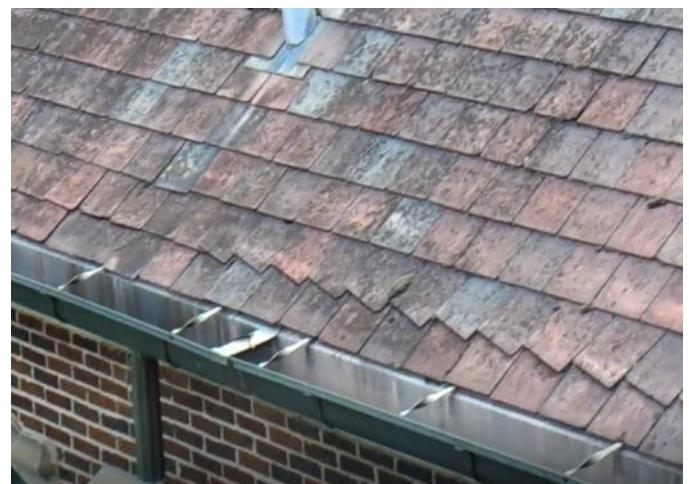
Photo 18: Area 5 -stained/weathered/broken asbestos tiles

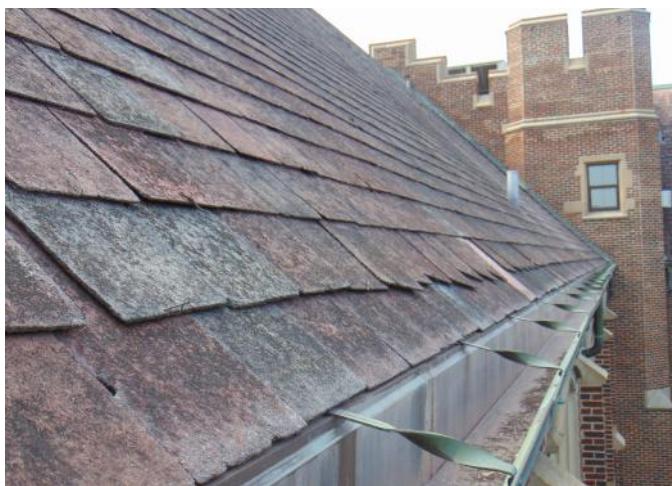
Photo 19: Area 5 - stained/weathered/broken asbestos tiles

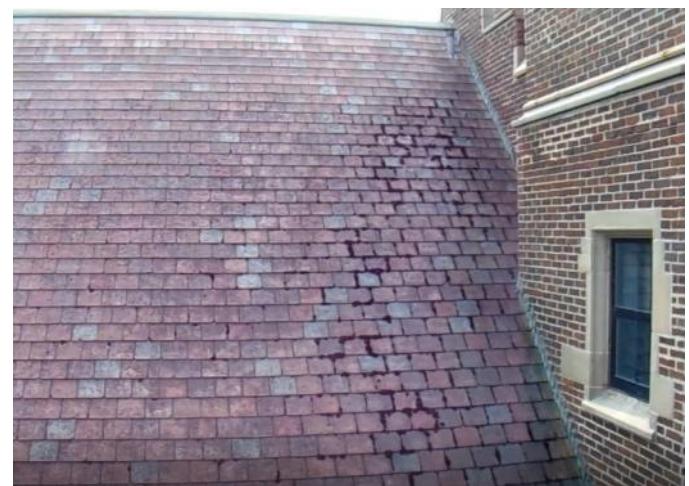
Photo 20: Area 5 - stained/weathered/moss growing between asbestos tiles

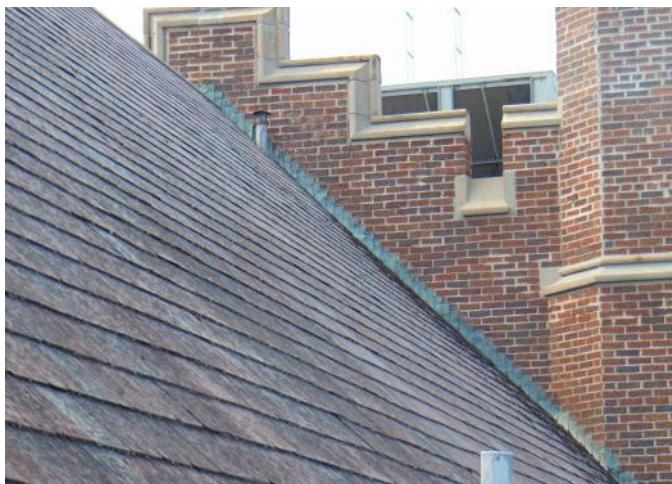
Photo 21: Area 5 - stained/weathered/broken asbestos tiles

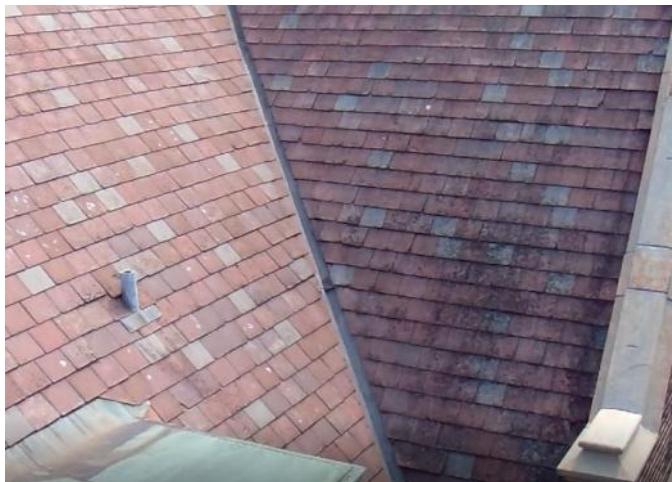
Photo 27: Area 11 - stained/weathered/broken asbestos tiles

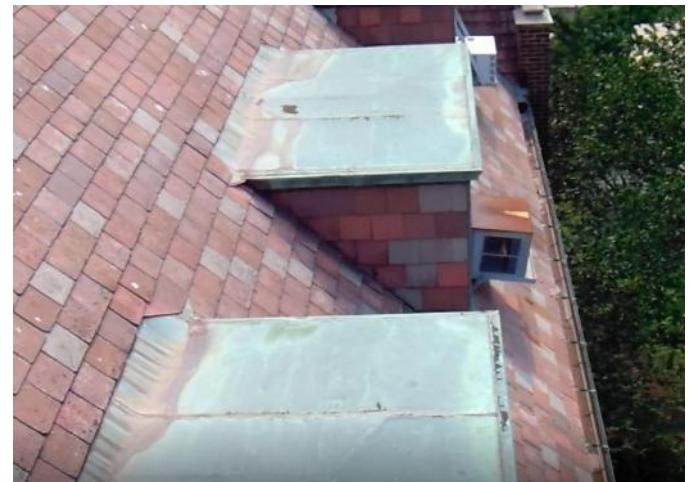
Photo 28: Area 11 - stained/pitting copper on dormer cap roofs

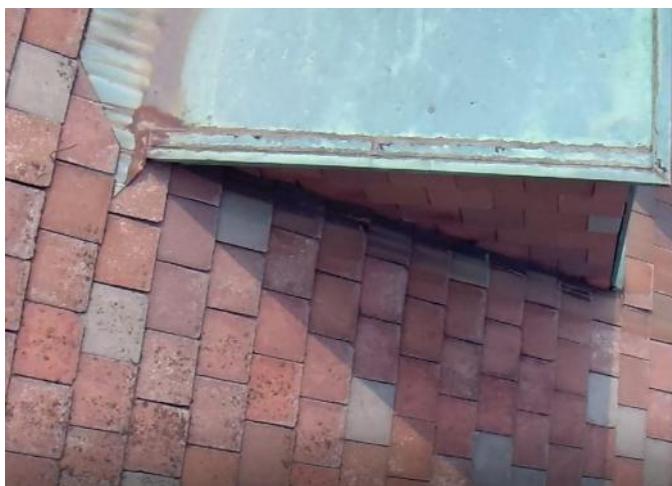
Photo 29: Area 11 - stained/pitting copper on dormer cap roofs

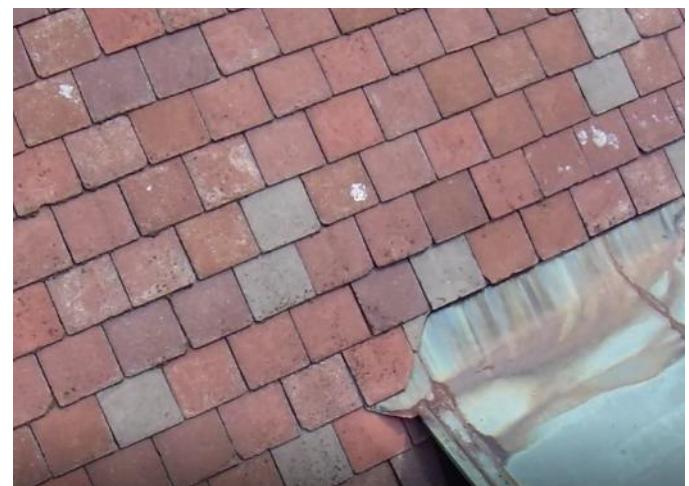
Photo 30: Area 11 - stained/weathered/broken asbestos tiles

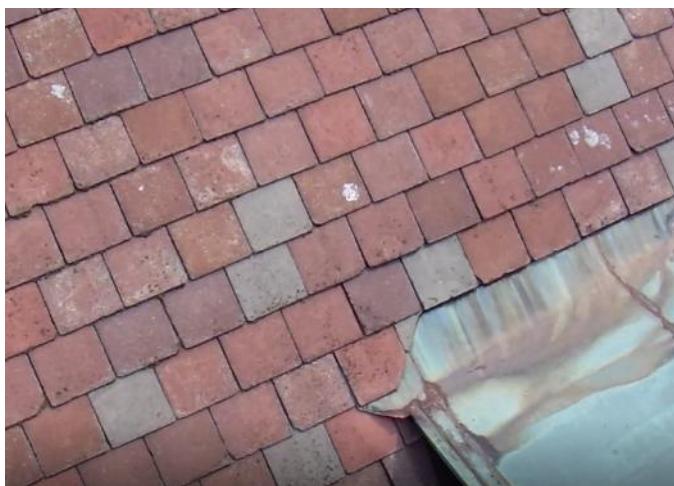
Photo 31: Area 11 - stained/weathered/broken asbestos tiles

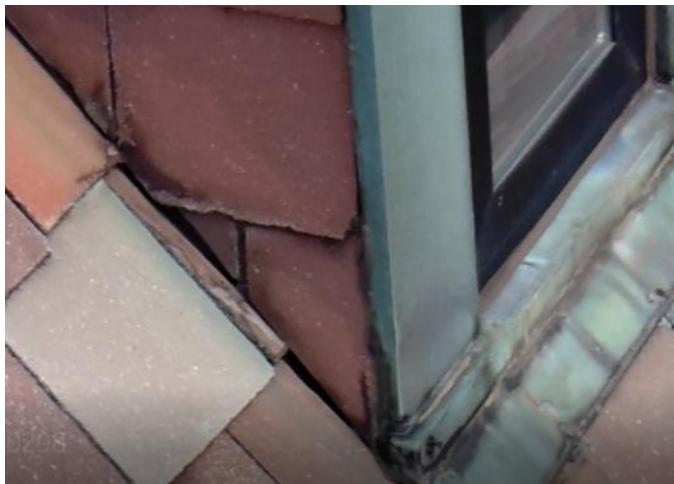
Photo 33: Area 11 - stained/pitted copper trim at dormer windows

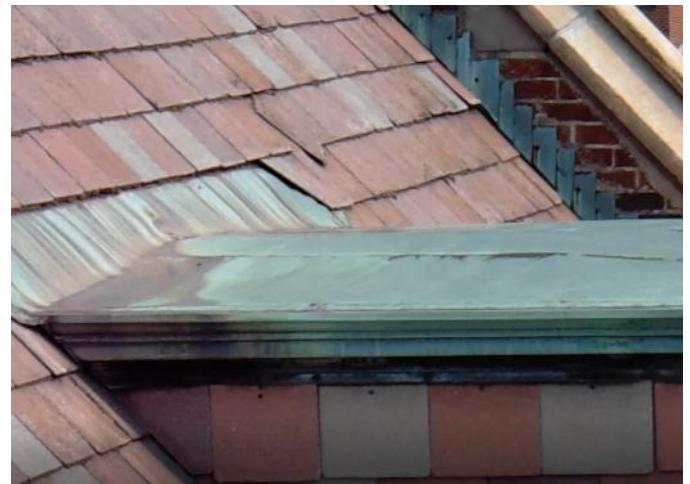
Photo 34: Area 11 - stained/weathered/broken asbestos tiles - stained/pitted copper

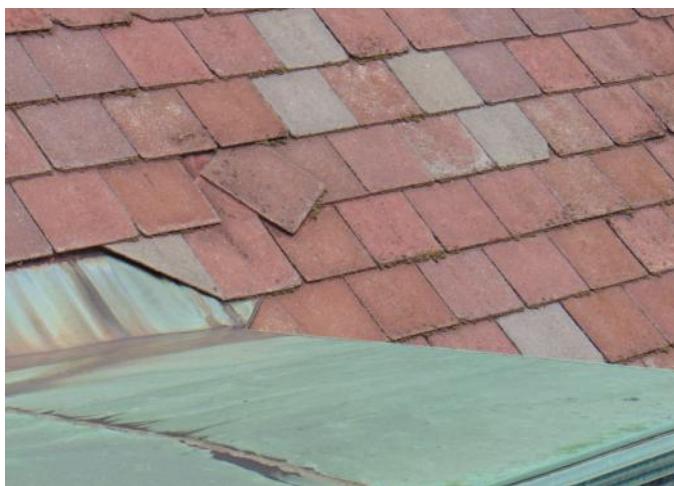
Photo 35: Area 11 - loose/broken asbestos tiles

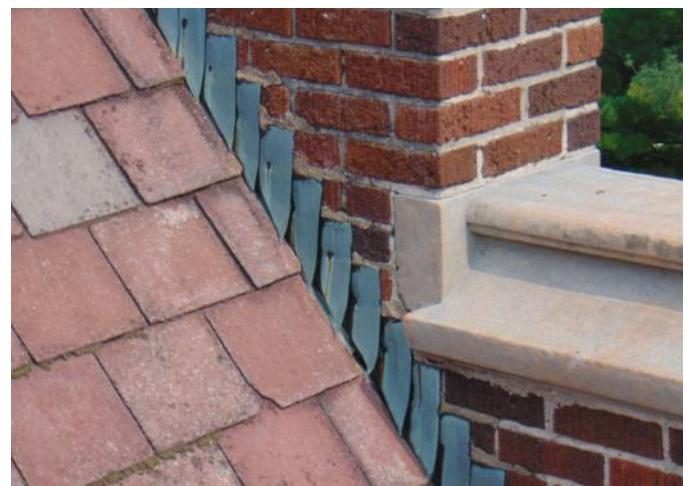
Photo 36: Area 11 - stained/weathered/broken asbestos tiles - bent step flashing

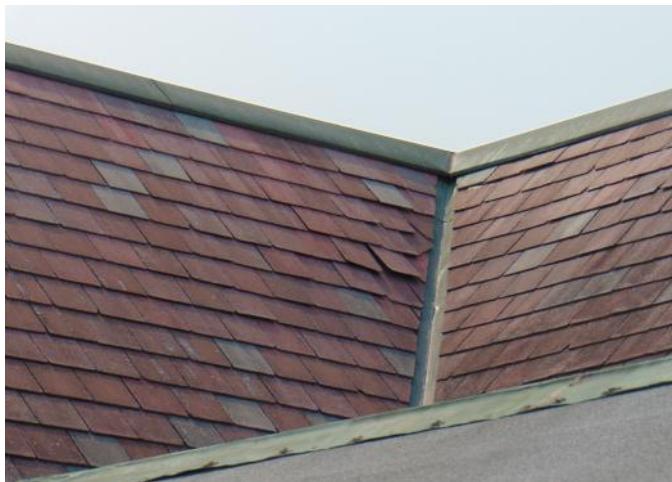
Photo 39: Area 11 - loose/missing asbestos tiles

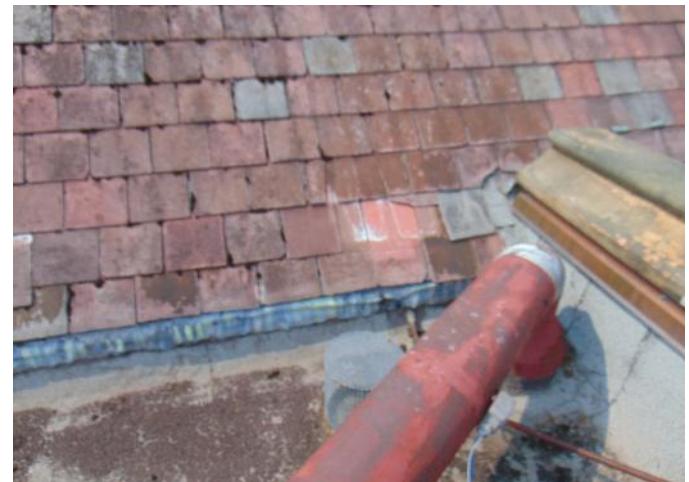
Photo 40: Area 11 - north facing - moss growing between asbestos tiles

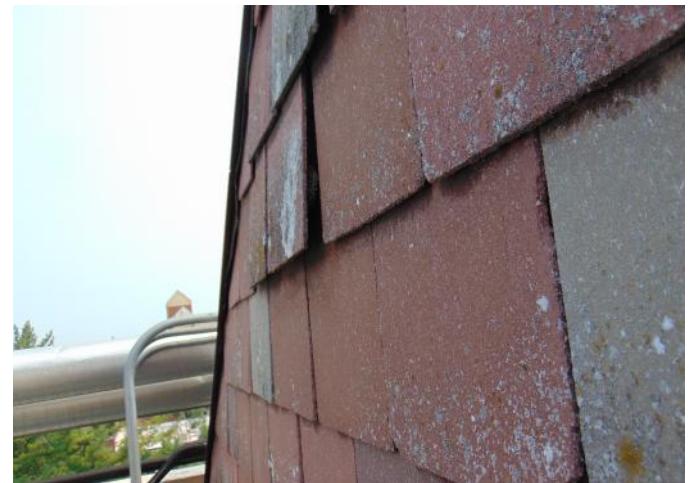
Photo 42: Area 11 - north facing - loose tiles on dormer wall

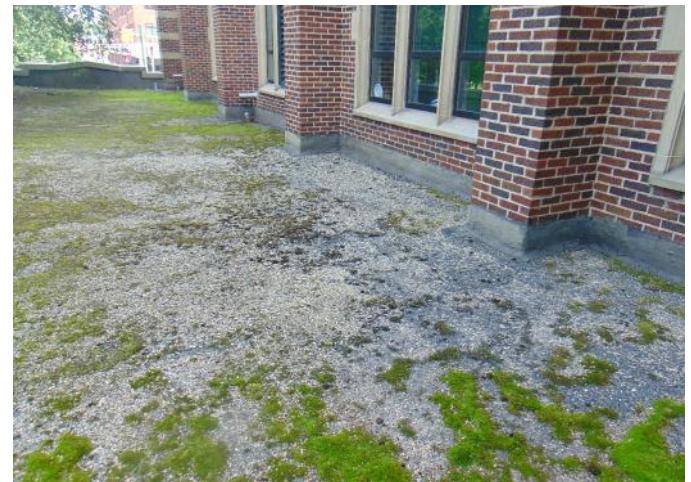
Photo 4: Area 2 - vegetation/surface wear

The low-slope coal-tar pitch built-up roofs should be replaced with a 3-ply modified bitumen roof consistent with MSU roofing standards. We estimate these roofs will cost approximately \$25 to \$30 per square foot. The total cost of the low slope roofs should be budgeted between \$75,000 to \$90,000.

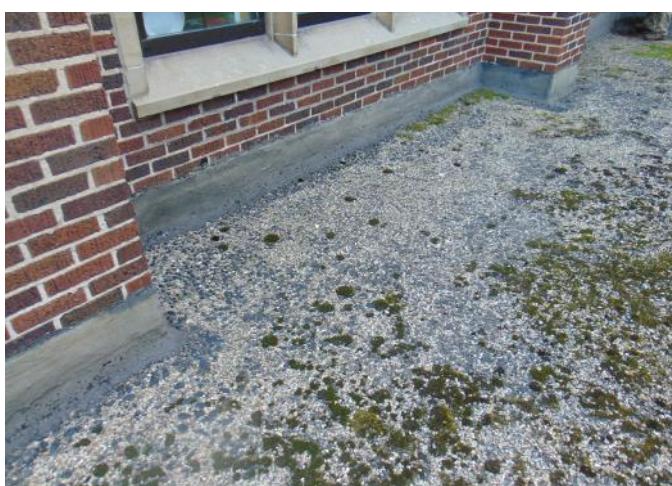
Photo 5: Area 2 -base flashing surface wear

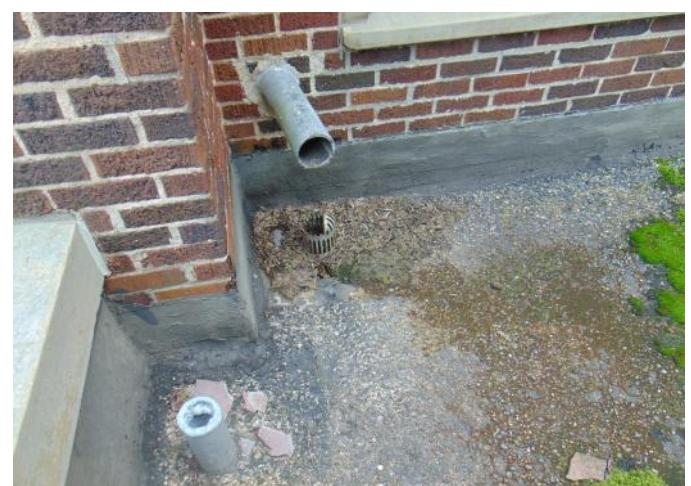
Photo 6: Area 2 -broken drain strainer

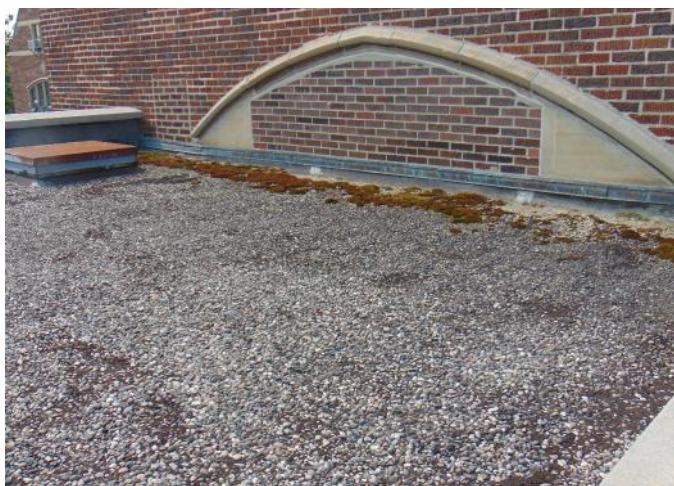
1. Moss has accumulated on the membrane against the south wall (Photo 7).
2. The surface of the roof and the base flashings are showing signs of age, surface wear (Photos 7 and 8).
3. The base flashings have deteriorated (Photo 9).

Photo 7: Area 3 - moss/surface wear

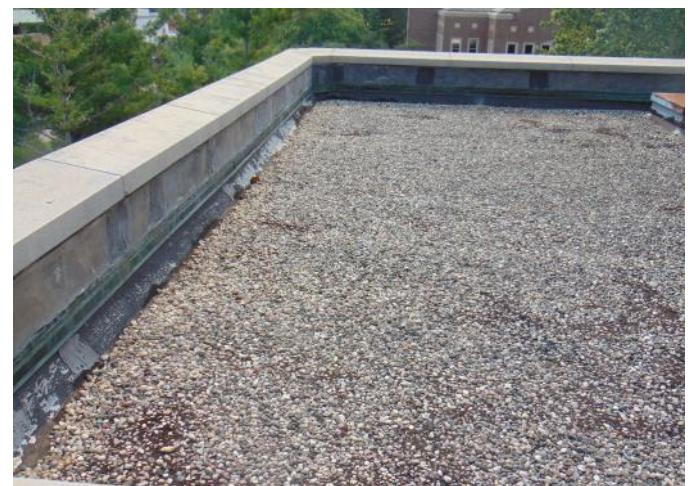
Photo 8: Area 3 - deteriorated base flashing

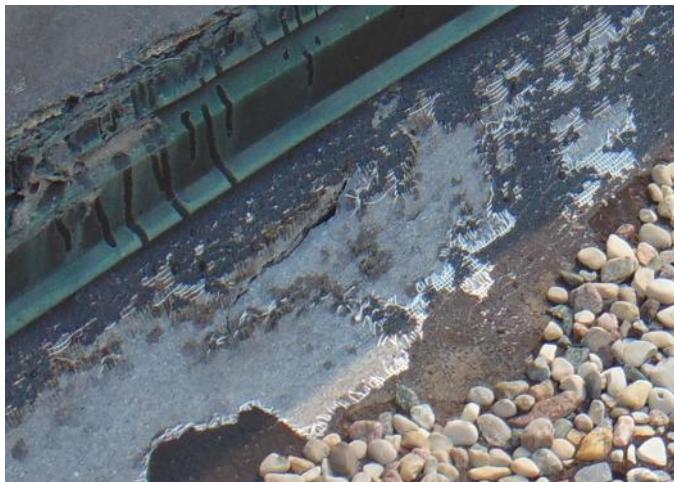
Photo 9: Area 3 - deteriorated base flashing

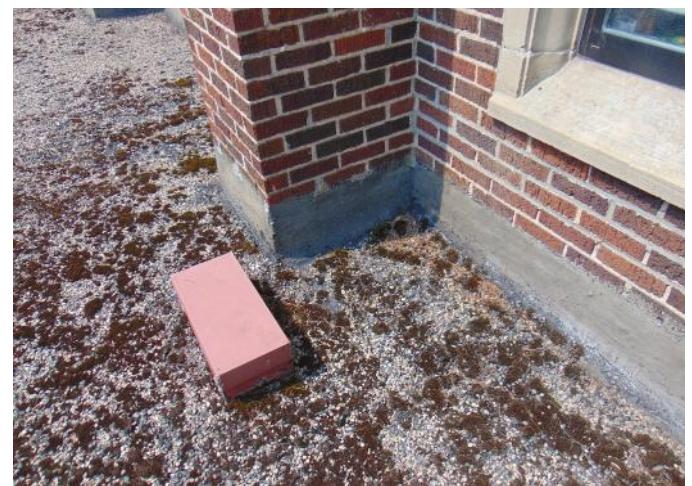
Photo 12 Area 4 -debris/vegetation - base flashing surface wear

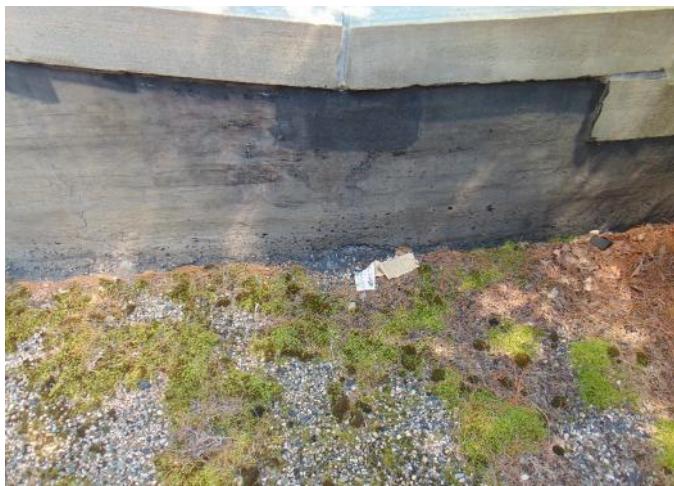
Photo 13: Area 4 - debris/vegetation - base flashing surface wear

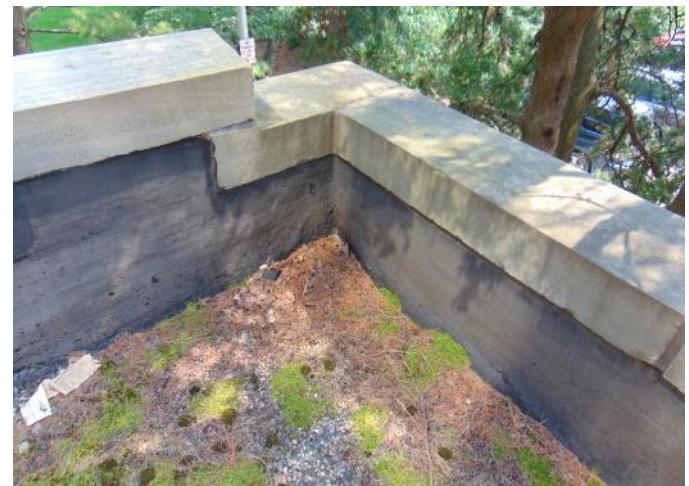
Photo 14: Area 4 - debris/vegetation - base flashing surface wear

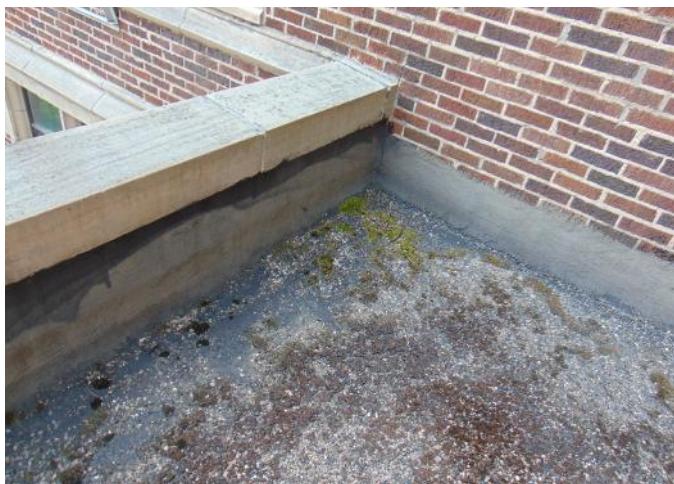
Photo 15: Area 4 - debris/vegetation - base flashing surface wear

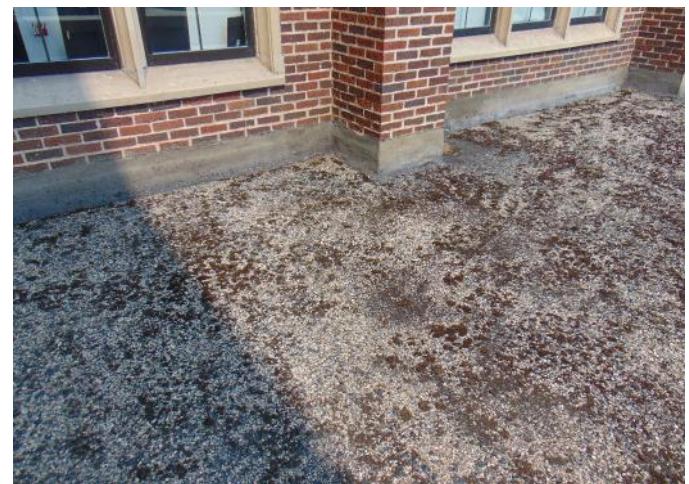
Photo 16: Area 4 - surface wear

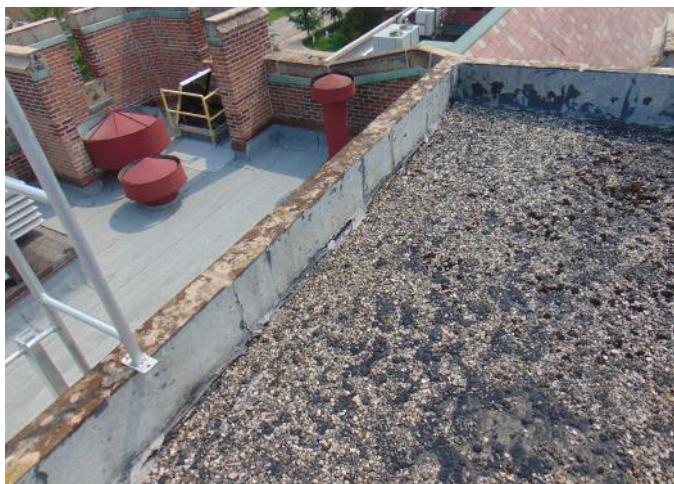
Photo 21: Area 7 - deteriorated surface and base flashing

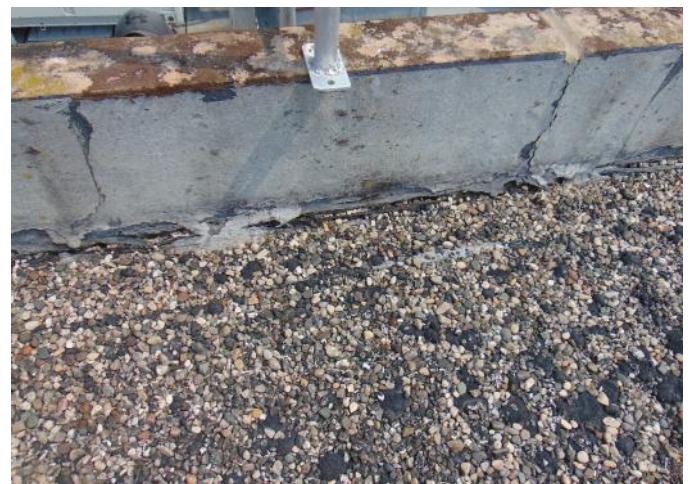
Photo 22: Area 7 - deteriorated surface and base flashing

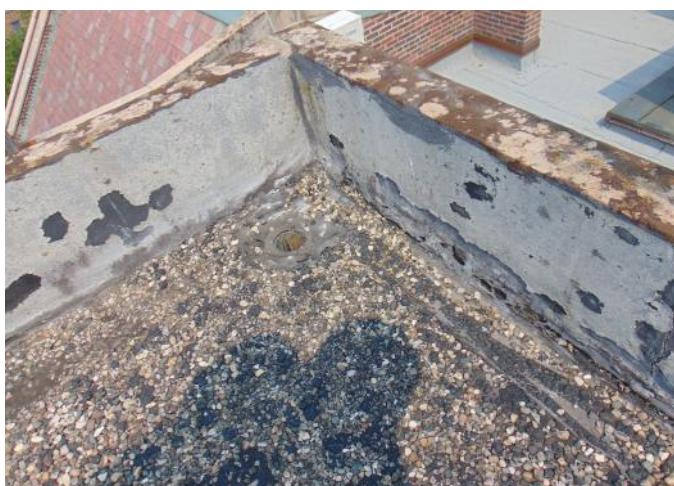
Photo 23: Area 7 - deteriorated surface and base flashing

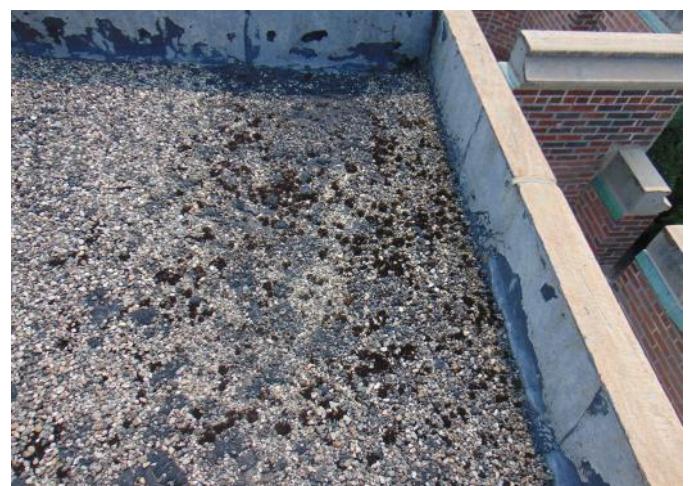
Photo 24: Area 7 - deteriorated surface and base flashing

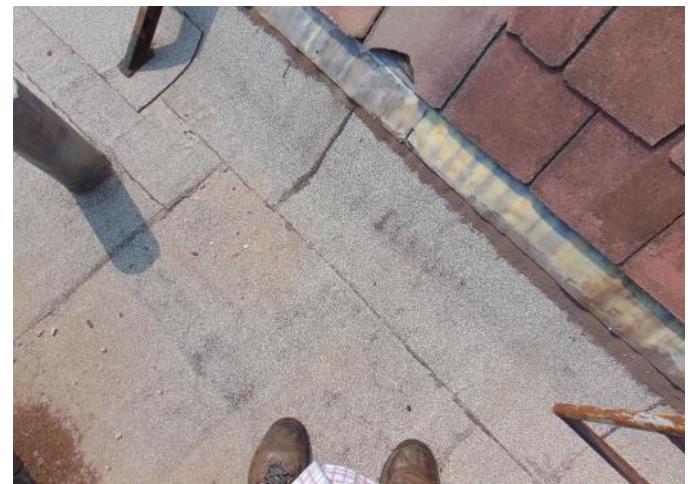
Photo 26: Area 8 - membrane in good condition

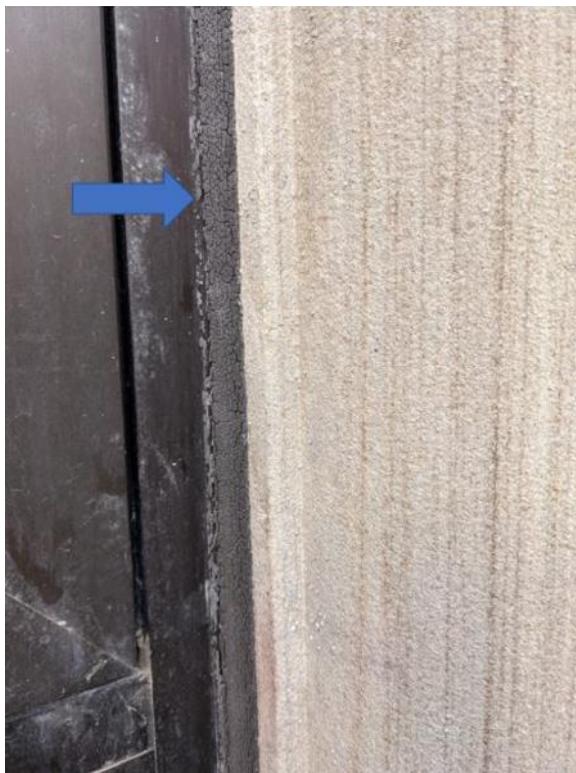
Photo 1: Typical defective caulking around the perimeter of windows

1. Caulking around perimeter of windows, louvers, doors, and at all previously caulked head joints and coping joints, belt courses and water tables.
 - a. Cut out all existing materials around the perimeter of windows, louvers and doors. Clean substrate to be recaulked by scraping, wire brushing, or grinding with an abrasive blade if needed. After substrate has been cleaned, install closed-cell backer-rod as needed, and recaulk window, louver and door perimeters 100% using Dow Corning® 791-756 sealants, installed as per the manufacturer's specifications.

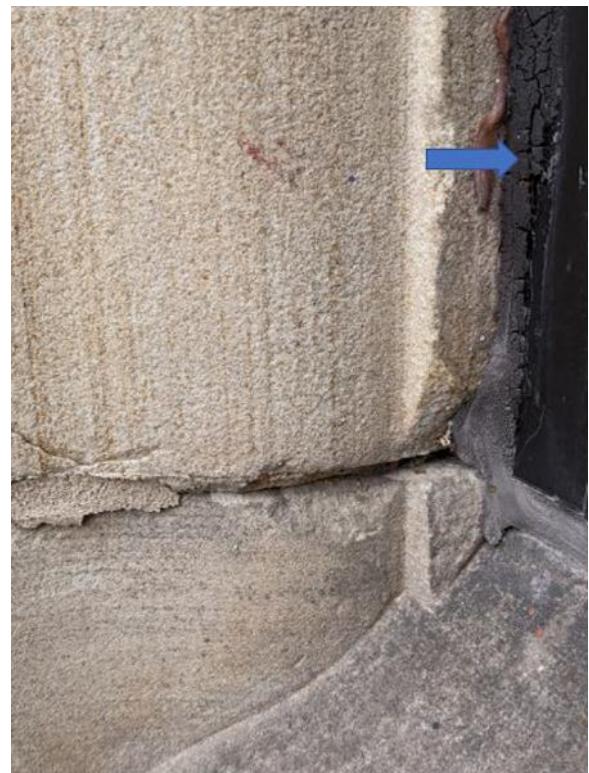
Photo 2: Typical defective caulking around the perimeter of windows

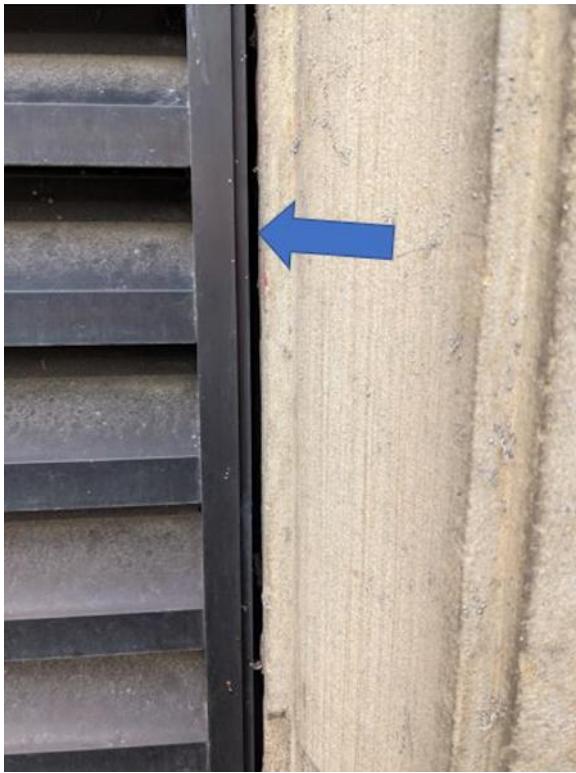
Photo 3: Missing caulking around louver

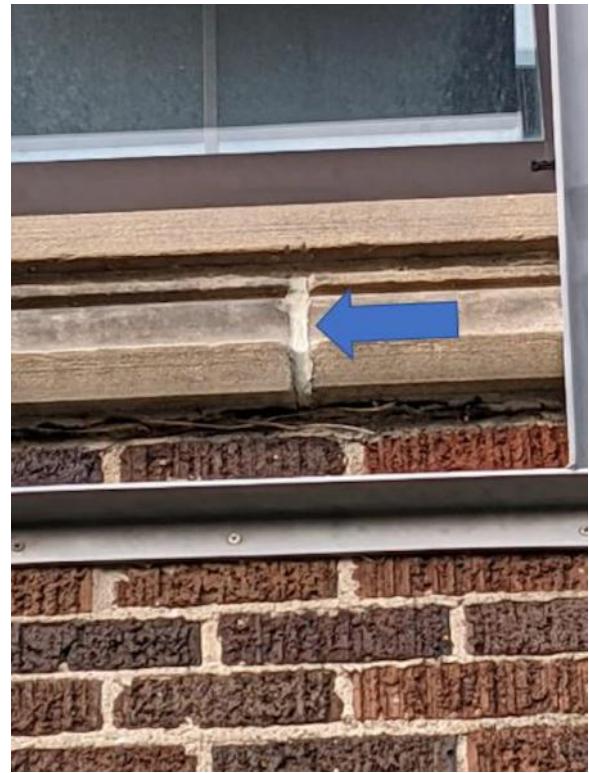
Photo 4: Typical head joint to be caulked

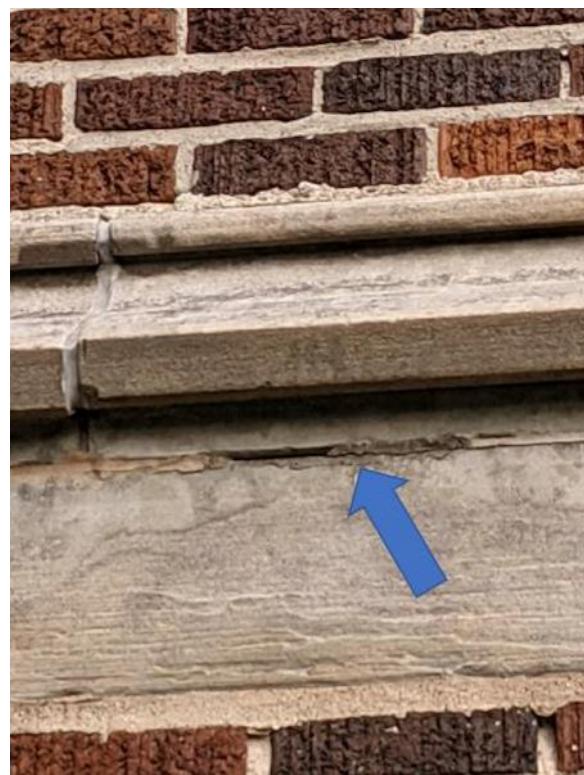
Photo 6: Typical deteriorated mortar joint

2. Tuckpointing - Repoint all defective mortar joints on the exterior masonry.
 - a. Defective joints are those in which the mortar is loose, eroded or powdered, broken, hollow, unsound or soft. Joints with fine hairline and fine shrinkage cracks that are otherwise sound, full and solid will not be considered as defective. Defective joints shall be cut to a depth of $\frac{3}{4}$ " or more using a machine grinder, pneumatic tools or hammer and chisel, and in such a manner so as to not damage the surface of the masonry. After mortar joints have been properly cut out, they shall be cleaned and washed out with water under sufficient pressure to remove all foreign matter, leaving the surfaces damp for new mortar. The prepared joints shall be firmly and neatly filled flush with non-shrinking mortar and tooled to match the existing joints. Color of new mortar shall match the existing mortar as near as possible. Precautions shall be taken against dropping or smearing pointing materials, leaving no pointing materials beyond the lines of the joints. After mortar has properly cured, face bricks shall be cleaned using water and Sure Klean 600 detergent or equal, brushing and scraping as necessary to remove all mortar from face bricks. Walls shall be thoroughly washed with clean water to remove all acid.
