**PRE-DEMOLITION LIMITED ASBESTOS AND HAZARDOUS MATERIAL SURVEY  
IM SPORTS - WEST BUILDING**

393 CHESTNUT ROAD  
EAST LANSING, MI 48824

Project #188BS25645 and 188BS26401

October 5, 2026

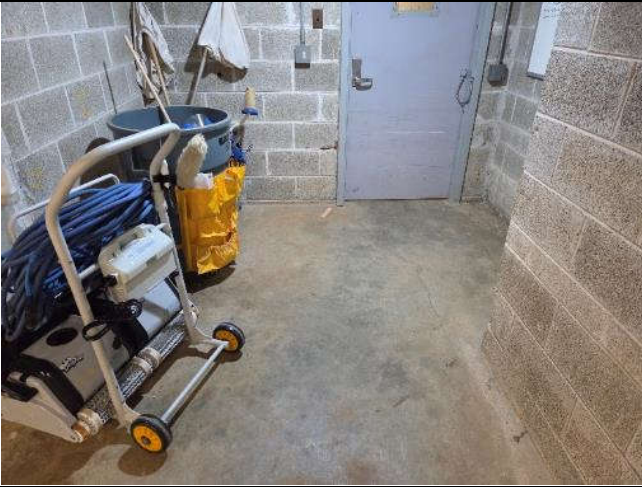
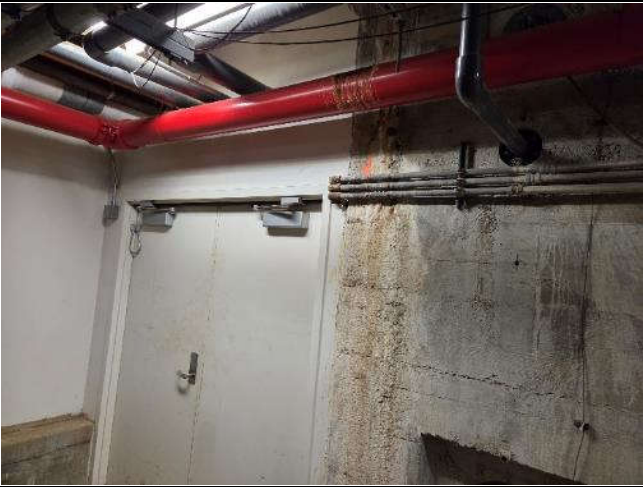
| <b>View Of:</b> | HA-1 Concrete Slab |
| <b>Asbestos %</b> | ND |

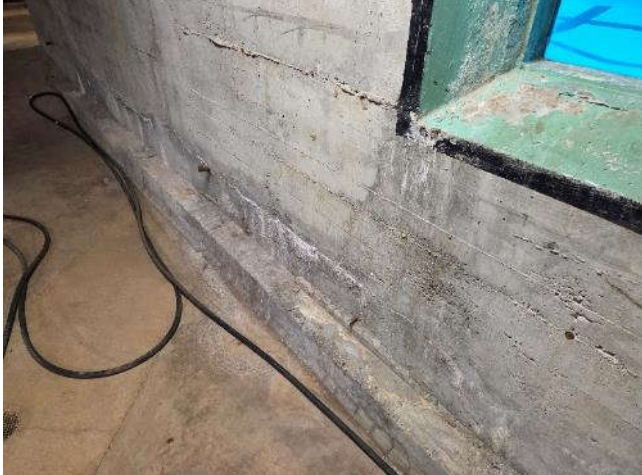
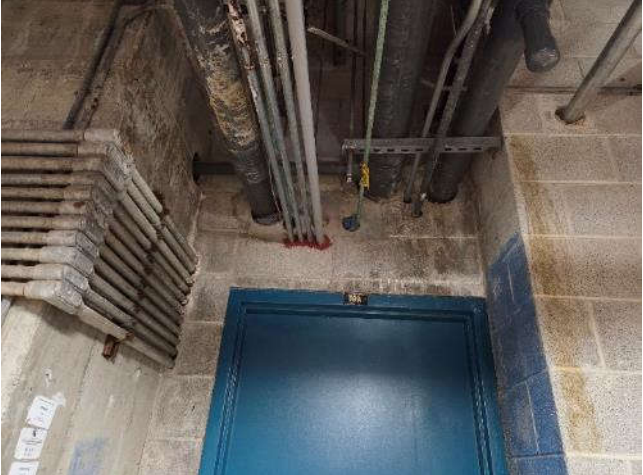
| <b>View Of:</b> | HA-2 – Concrete Poured Walls |
| <b>Asbestos %</b> | ND |

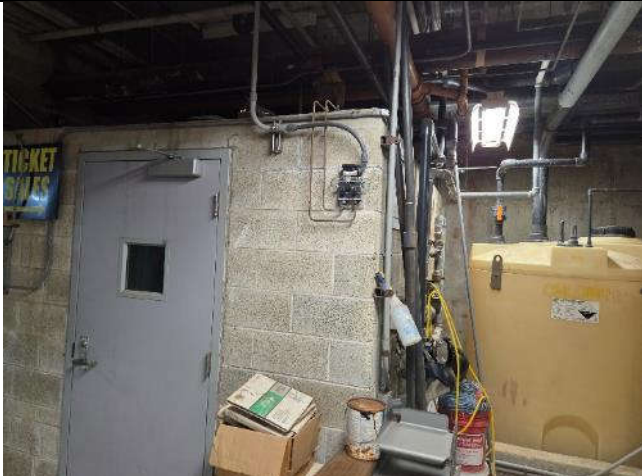
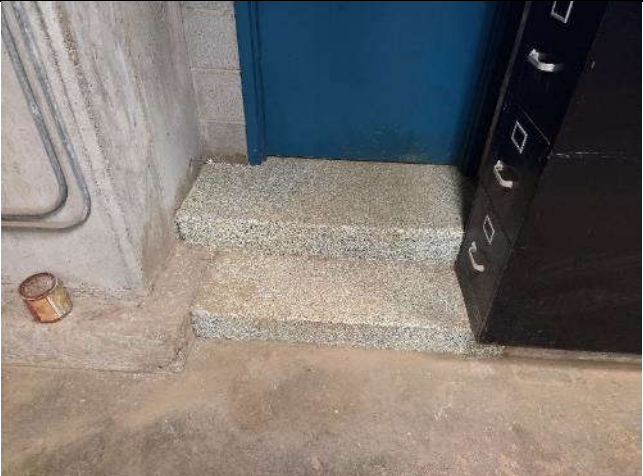
| <b>View Of:</b> | HA-3 Concrete Patch (base of wall) |
| <b>Asbestos %</b> | ND |

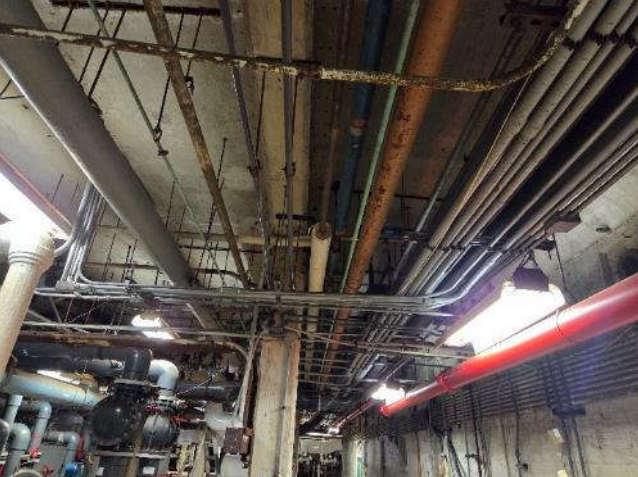
| <b>View Of:</b> | HA-7 TSI Magnesia | <b>View Of:</b> | HA-8 TSI Mag Fittings – Blue line |
| <b>Asbestos %</b> | 3.25% Chrysotile | <b>Asbestos %</b> | 40% Chrysotile |

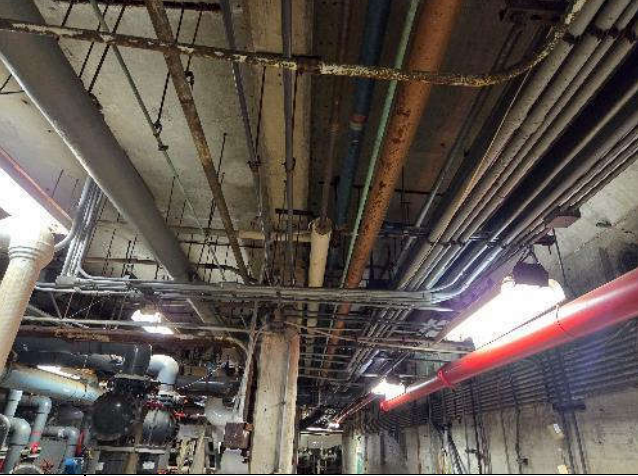
| <b>View Of:</b> | HA-9 TSI Air Cell (blue line) and Mag Fittings | <b>View Of:</b> | HA-10 TSI Air Cell (blue line) and Mag Fittings |
| <b>Asbestos %</b> | 50% Chrysotile | <b>Asbestos %</b> | ND |

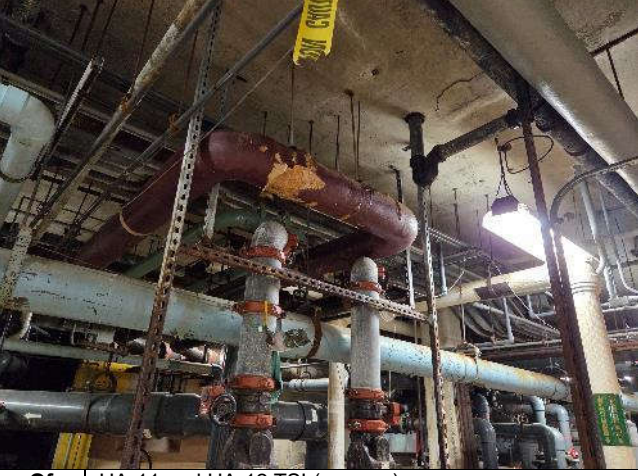
| <b>View Of:</b> | HA-11 and HA-12 TSI (maroon) | <b>View Of:</b> | HA-13 Duct Wrap Covered by White Plastic |
| <b>Asbestos %</b> | 45% Chrysotile | <b>Asbestos %</b> | ND |

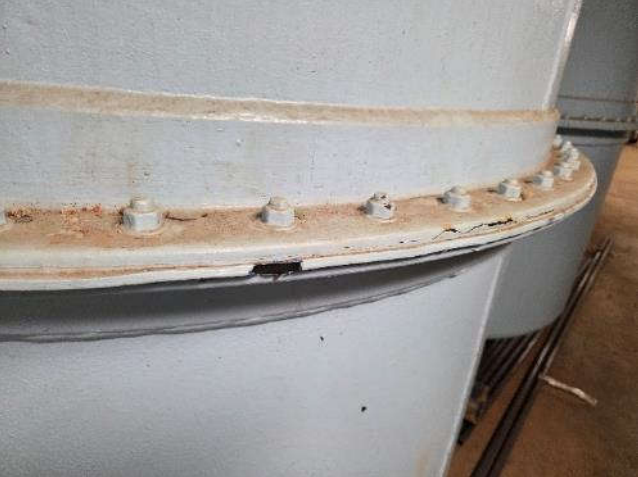
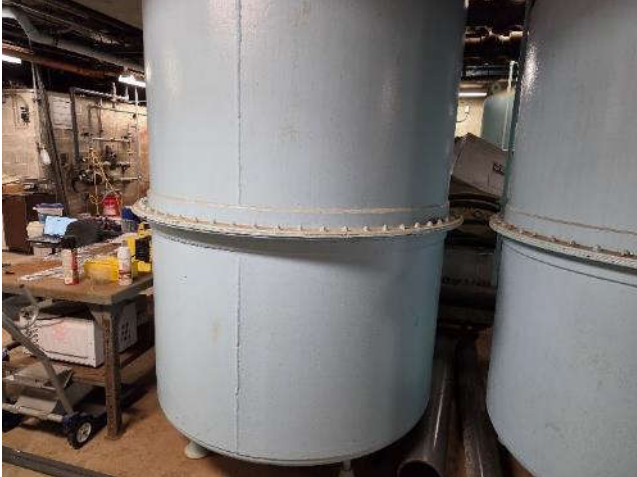
| <b>View Of:</b> | HA-14 Gasket (zoomed in photo) | <b>View Of:</b> | HA-14 Gasket |
| <b>Asbestos %</b> | ND | <b>Asbestos %</b> | ND |

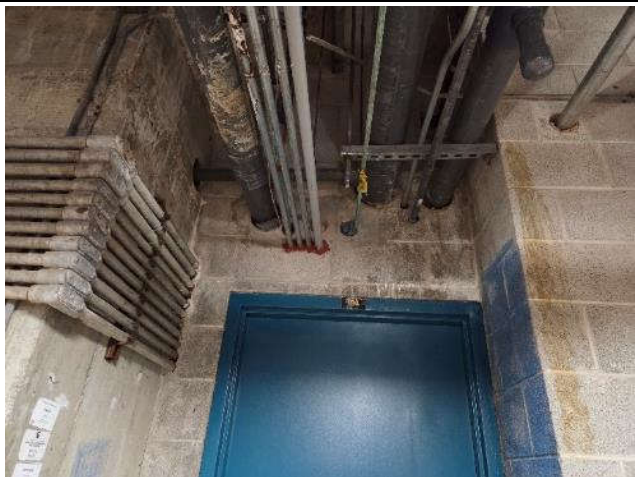
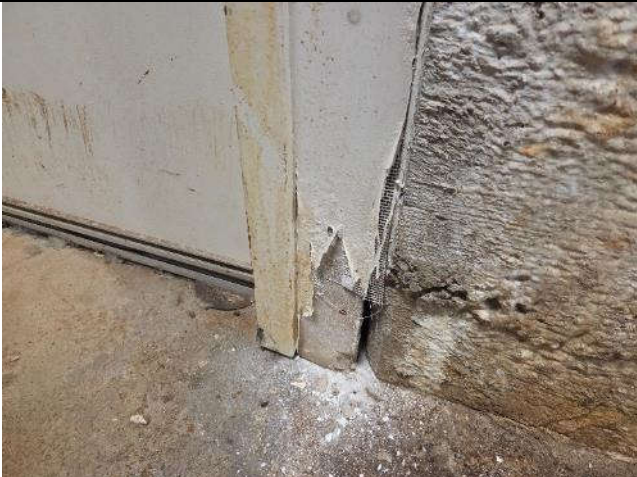
| <b>View Of:</b> | HA-15 – Fire Caulk – Wall penetrations | <b>View Of:</b> | HA-16 Drywall System (in basement) |
| <b>Asbestos %</b> | ND | <b>Asbestos %</b> | ND |

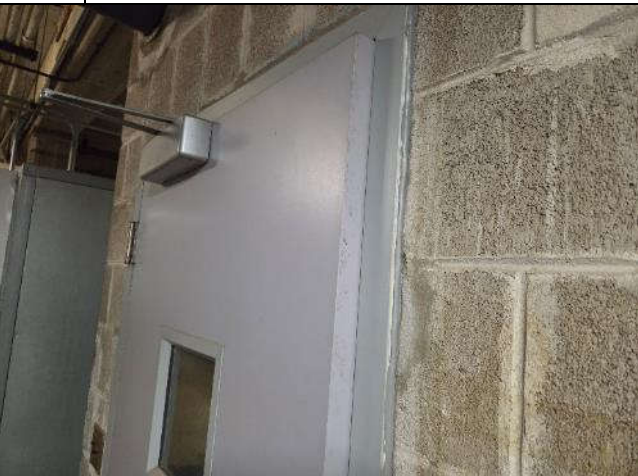
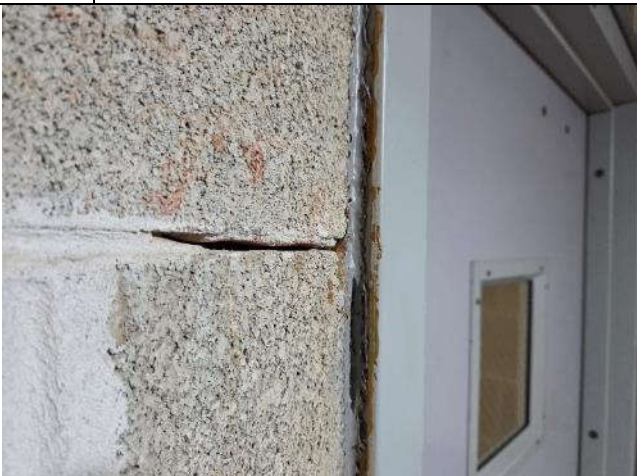
| <b>View Of:</b> | HA-17 – Interior Caulk (gray on metal frame) | <b>View Of:</b> | HA-17 – Interior caulk (gray) |
| <b>Asbestos %</b> | ND | <b>Asbestos %</b> | ND |

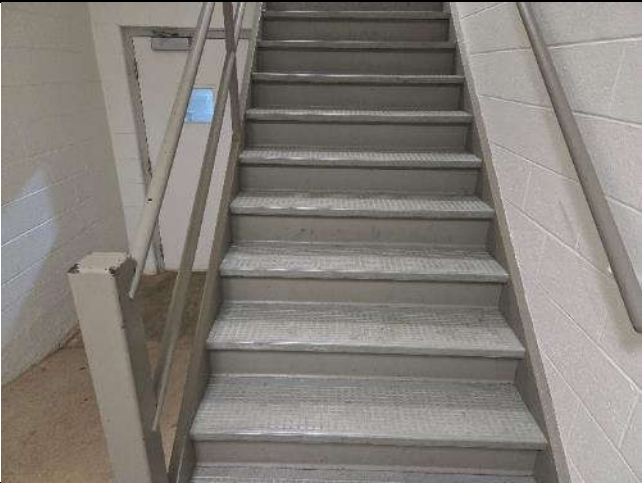
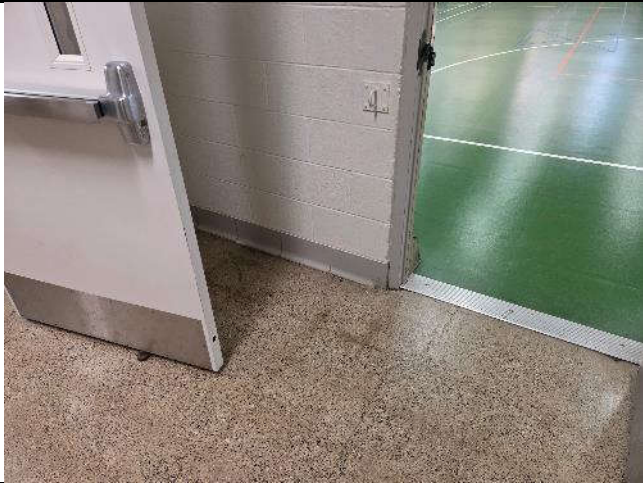
| <b>View Of:</b> | HA-18 Stair Tread | <b>View Of:</b> | HA-19 Cove Base (on block) |
| <b>Asbestos %</b> | ND | <b>Asbestos %</b> | ND |

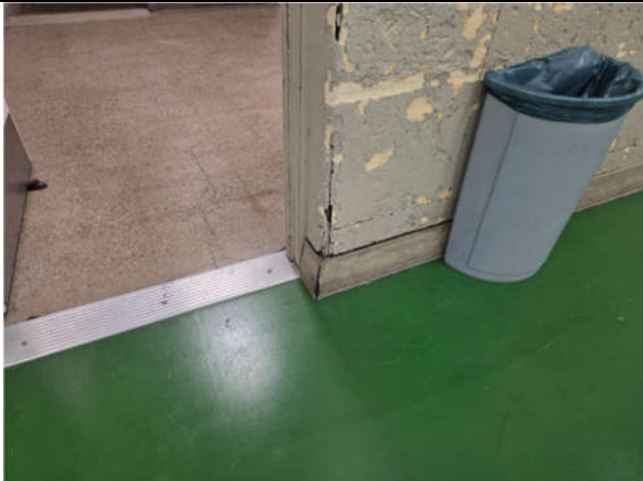
| <b>View Of:</b> | HA-20 – Textured Plaster | <b>View Of:</b> | HA-21 Cove Base and Green Turf |
| <b>Asbestos %</b> | 0.75% Chrysotile | <b>Asbestos %</b> | ND |

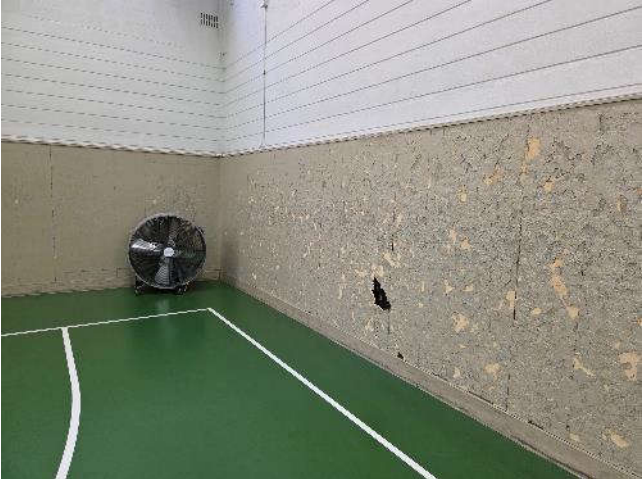
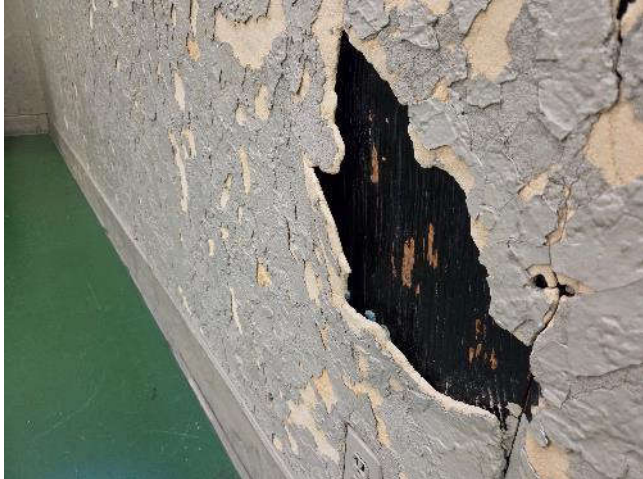
| <b>View Of:</b> | HA-22 Construction Adhesive (on padding) | <b>View Of:</b> | HA-23 Wall Mastic |
| <b>Asbestos %</b> | ND | <b>Asbestos %</b> | ND |

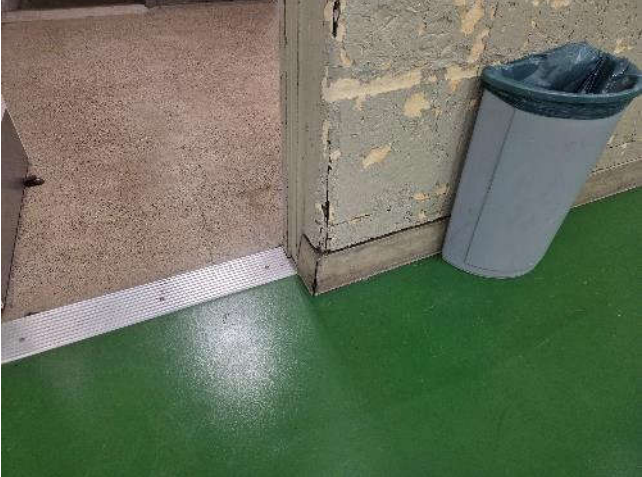
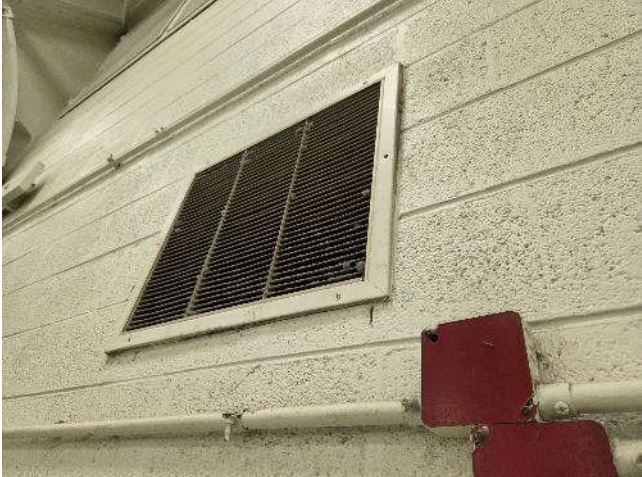
| <b>View Of:</b> HA-24 Cove Base and Green Turf | <b>View Of:</b> HA-25 Interior Caulk, gray (on vents) |
| <b>Asbestos %</b> ND | <b>Asbestos %</b> ND |

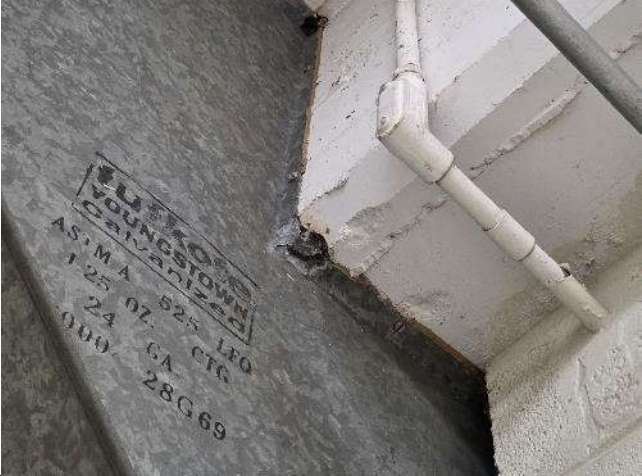
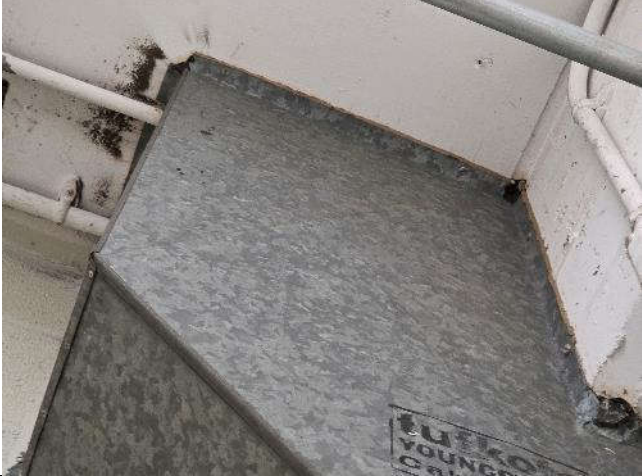
| <b>View Of:</b> HA-26 and HA-27 Duct Caulk | <b>View Of:</b> HA-26 and HA-27 Duct Caulk |
| <b>Asbestos %</b> 1.5% Chrysotile | <b>Asbestos %</b> 22% Chrysotile |

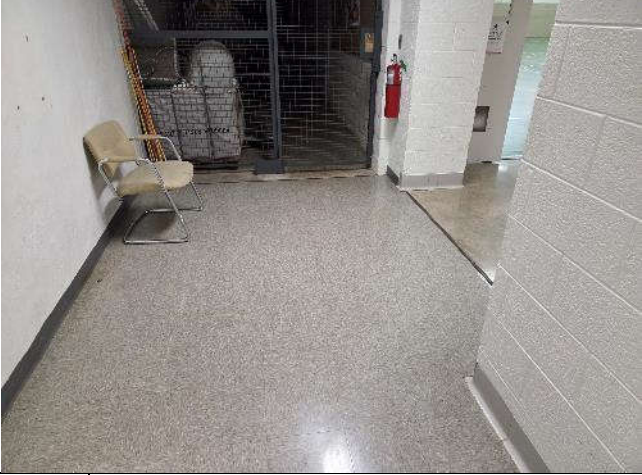
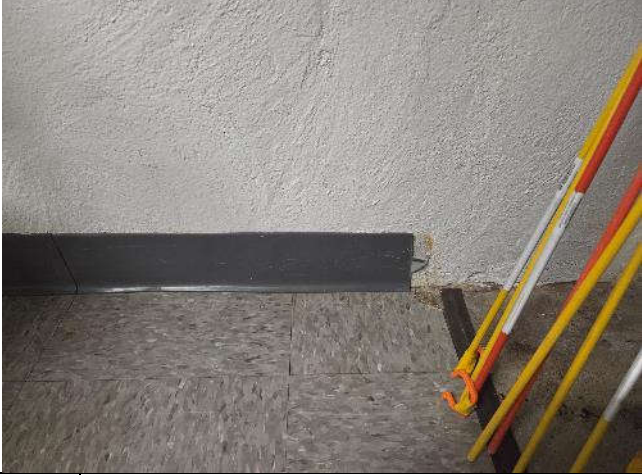
| <b>View Of:</b> HA-28 Floor Tile (gray mottled) | <b>View Of:</b> HA-29 4" Cove Base |
| <b>Asbestos %</b> ND | <b>Asbestos %</b> Assumed |

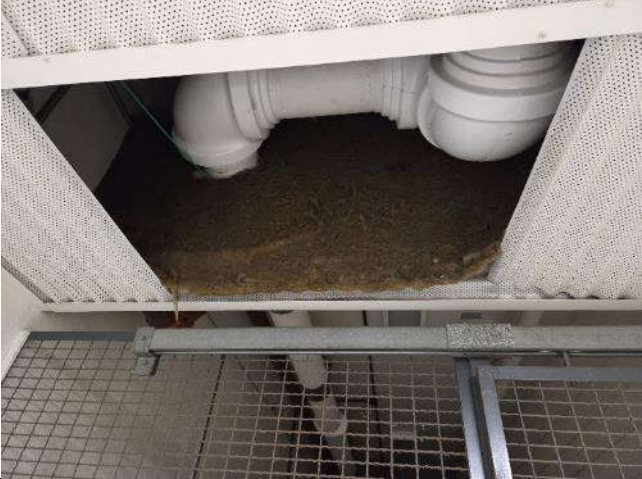
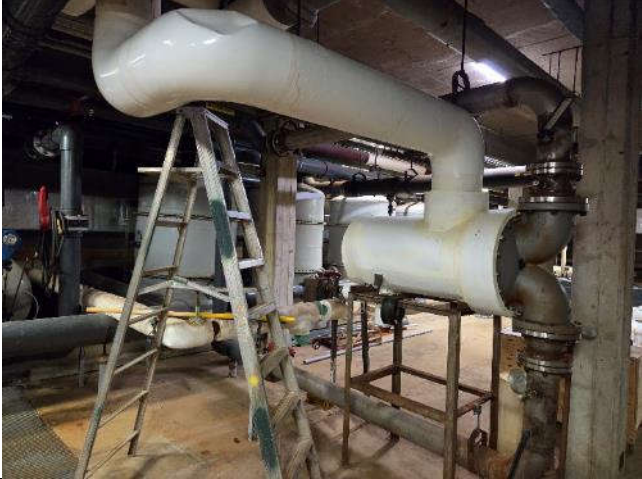
| <b>View Of:</b> | HA-30 Rolled-In Insulation (above corrugated metal) | <b>View Of:</b> | HA-31 Pipe Insulation (yellow fiberglass) |
| <b>Asbestos %</b> | ND | <b>Asbestos %</b> | ND |

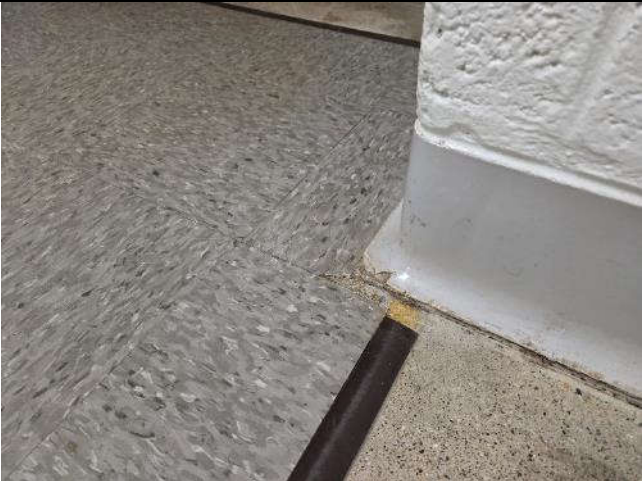
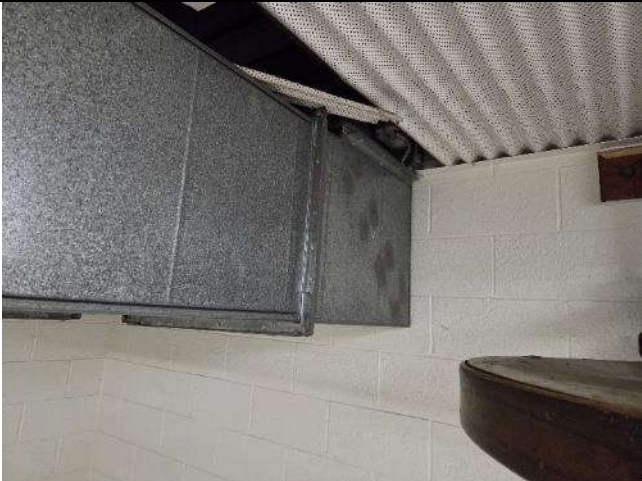
| <b>View Of:</b> | HA-32 Construction Adhesive (on transition strip) | <b>View Of:</b> | HA-33 Duct Caulk (gray) |
| <b>Asbestos %</b> | ND | <b>Asbestos %</b> | ND |

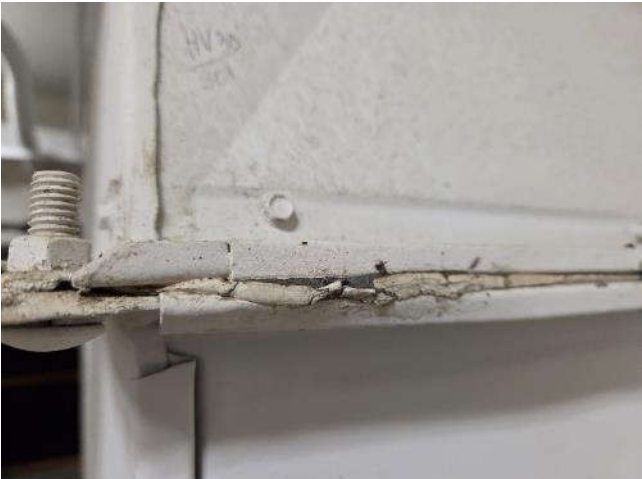
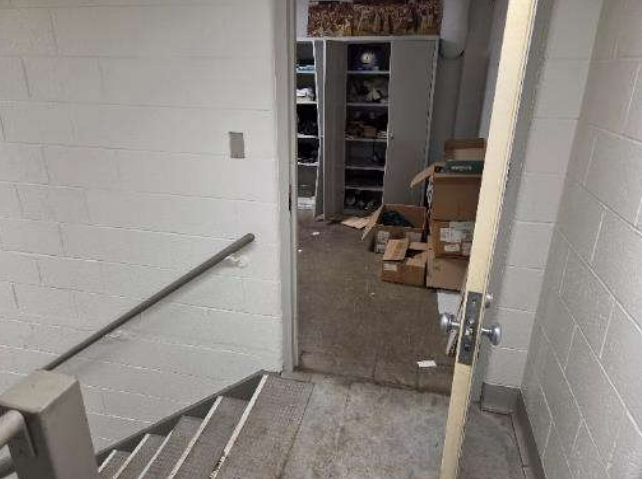
| <b>View Of:</b> | HA-34 Duct Caulk (between metal) | <b>View Of:</b> | HA-35 Vinyl Flooring (green and white marbling) |
| <b>Asbestos %</b> | ND | <b>Asbestos %</b> | 2% Chrysotile (flooring); ND (mastic) |

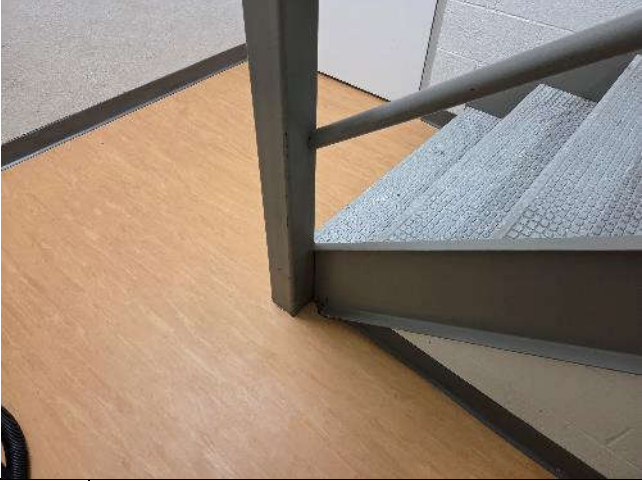
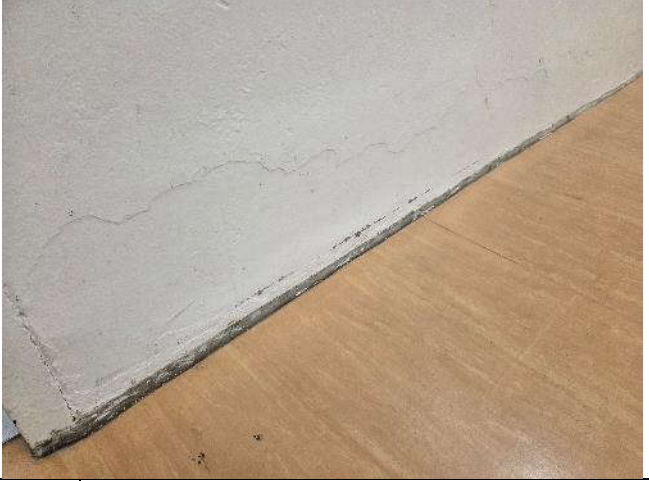
| <b>View Of:</b> | HA-36 Vinyl Flooring (wood grain) | <b>View Of:</b> | HA-37 Interior Caulk |
| <b>Asbestos %</b> | ND | <b>Asbestos %</b> | ND |

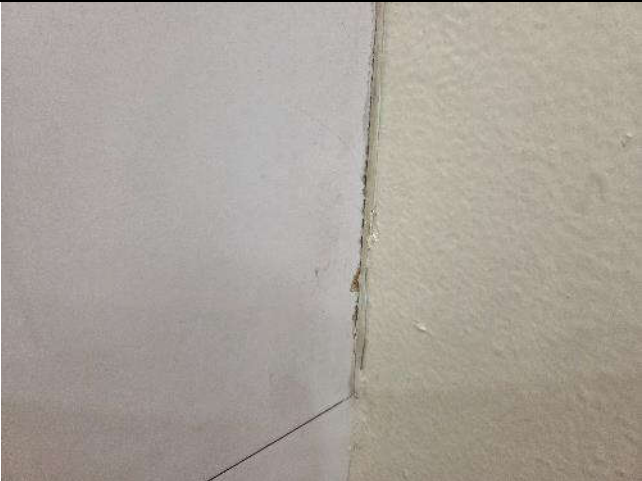
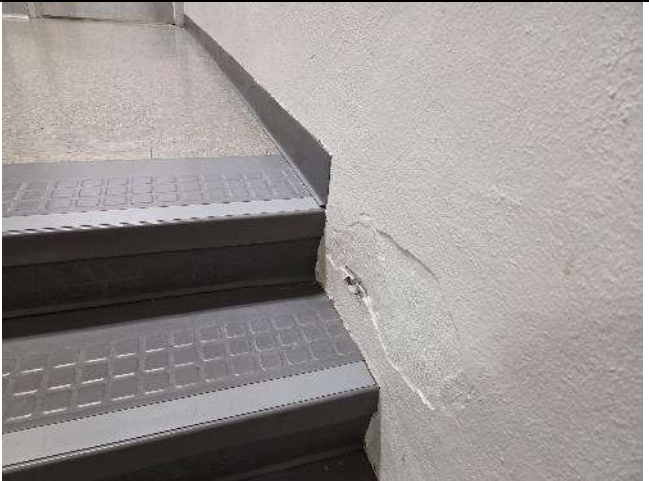
| <b>View Of:</b> | HA-38 Interior Caulk (on wall seam) | <b>View Of:</b> | HA-39 Mortar (over block wall) |
| <b>Asbestos %</b> | ND | <b>Asbestos %</b> | ND |

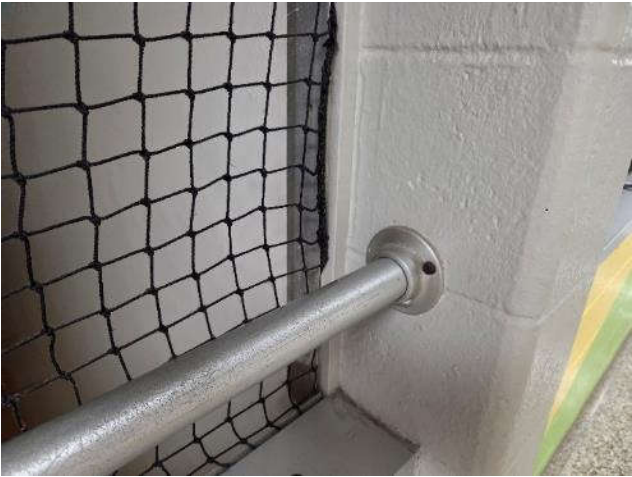
| <b>View Of:</b> | HA-120 Window Glaze (gray and brittle) | <b>View Of:</b> | HA-121 Caulk (white between block wall and aluminum rails for netting in racquetball courts) |
| <b>Asbestos %</b> | Trace | <b>Asbestos %</b> | ND |

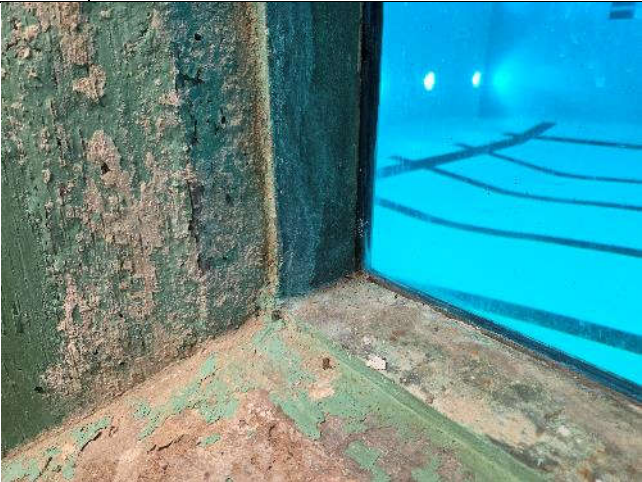
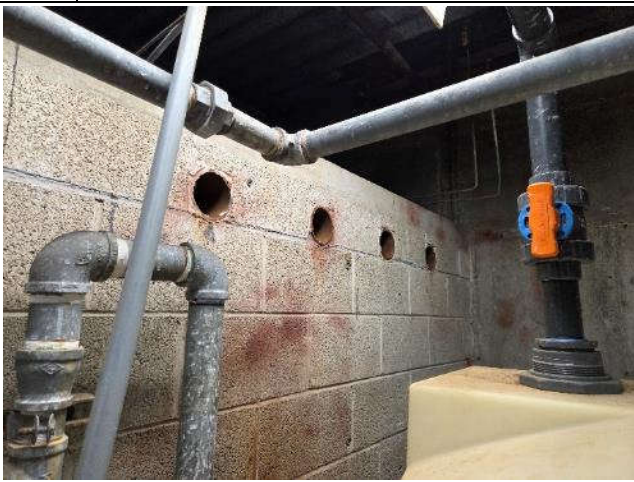
| <b>View Of:</b> | HA-130 Window Glaze (pool room) | <b>View Of:</b> | HA-131 Fire Caulk (white) |
| <b>Asbestos %</b> | ND | <b>Asbestos %</b> | ND |

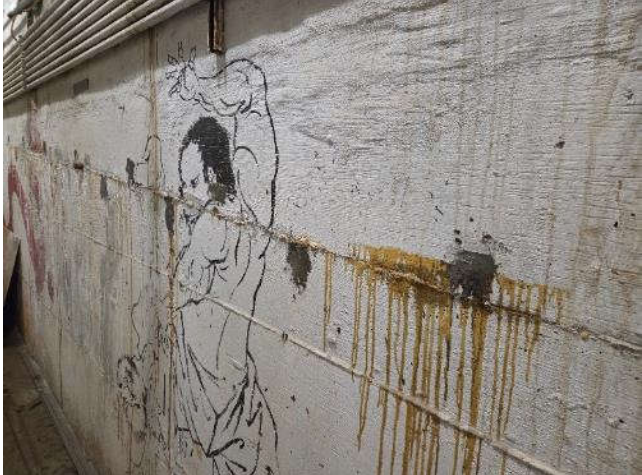
| <b>View Of:</b> | HA-132 Expansion Joint (interior walls between concrete block) | <b>View Of:</b> | HA-133 Penetration mud (dark gray) |
| <b>Asbestos %</b> | 0.25% Chrysotile | <b>Asbestos %</b> | ND |

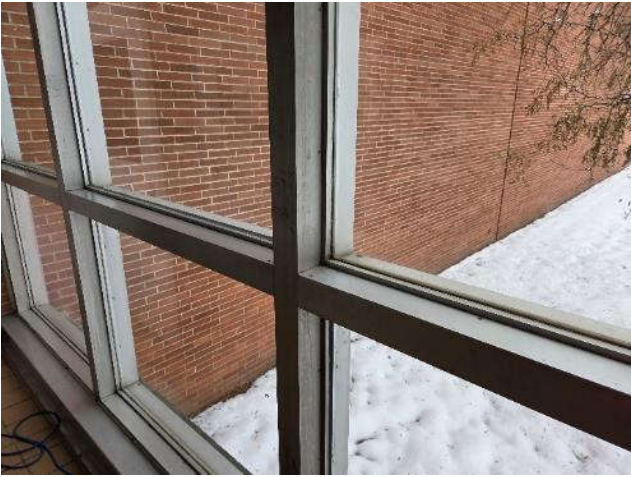
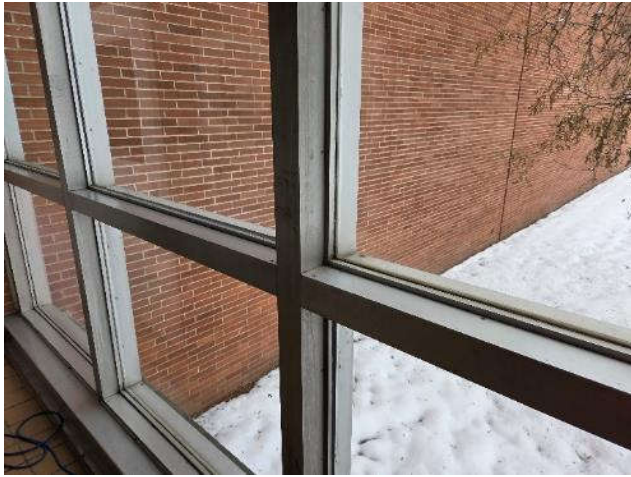
| <b>View Of:</b> | HA-138 Window Glaze (7'x7' panes) | <b>View Of:</b> | HA-139 Window Caulk (gray 7'x7' panes) |
| <b>Asbestos %</b> | 1.25% Chrysotile | <b>Asbestos %</b> | ND |
