MICHIGAN STATE
U N I V E R S I T Y

INFRASTRUCTURE PLANNING AND FACILITIES
PLANNING, DESIGN AND CONSTRUCTION

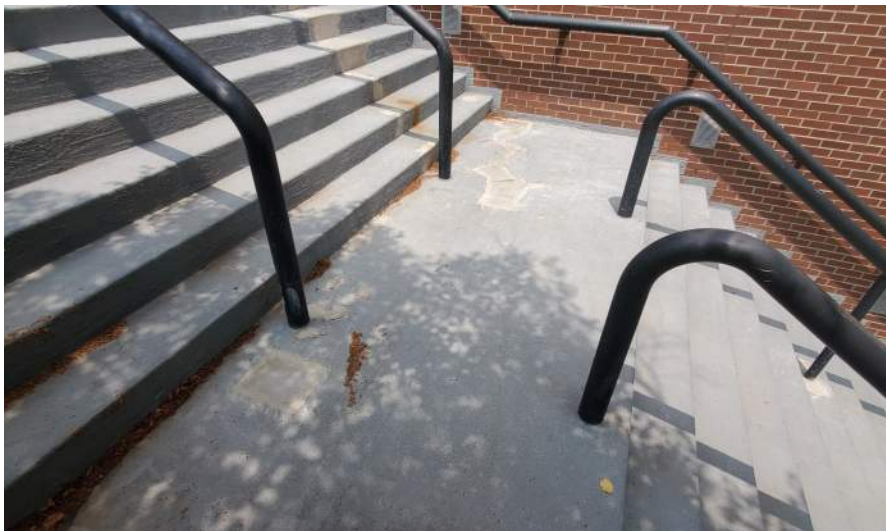
Cracked coating in the stair landing and repairs to the stairs.

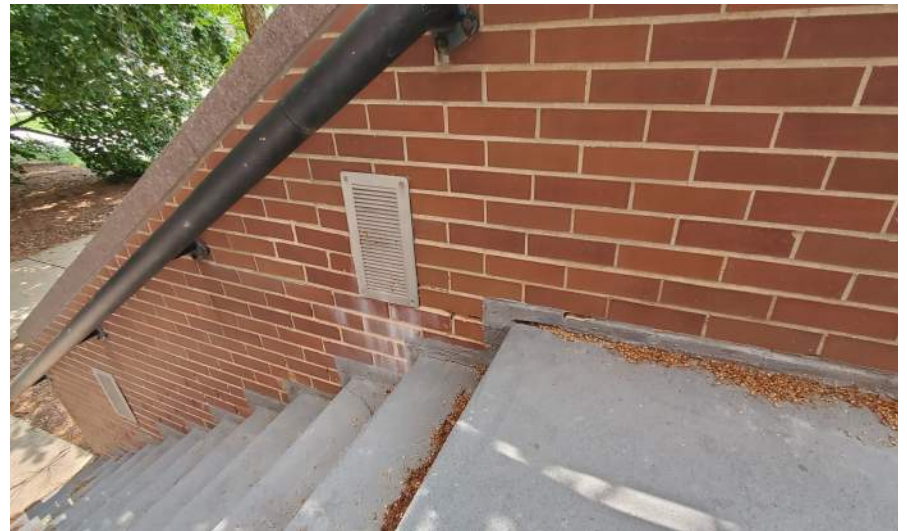
Deteriorated brick and mortar around lights.

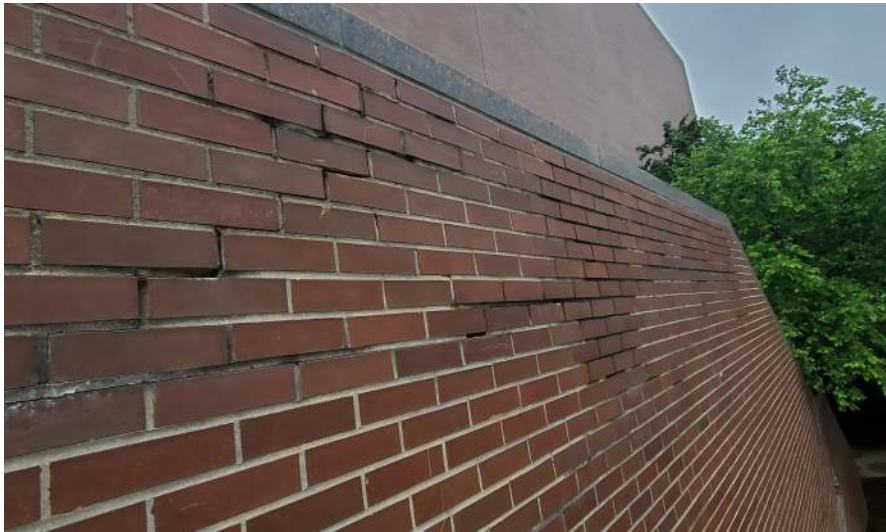
Deteriorated mortar at the top of the stair exterior wall.

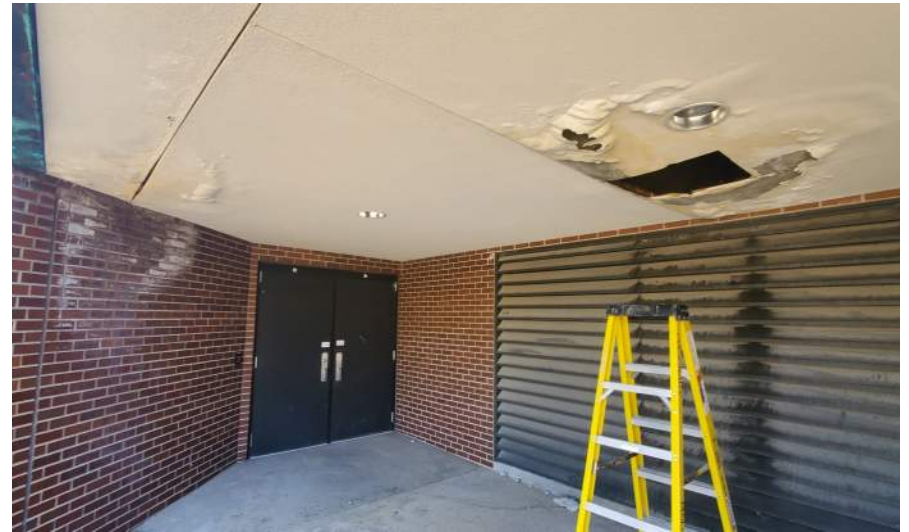
Damaged soffit under Plaza.

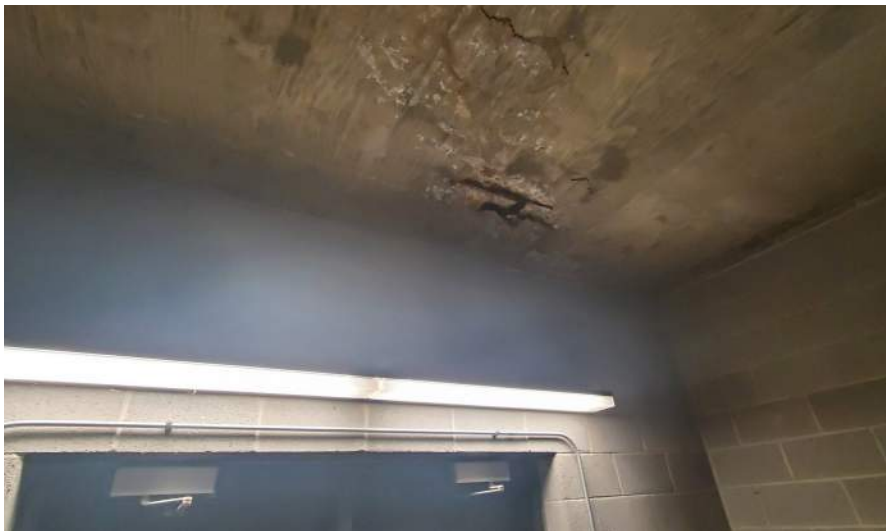
Damaged ceiling in the utility stairway under the Plaza.

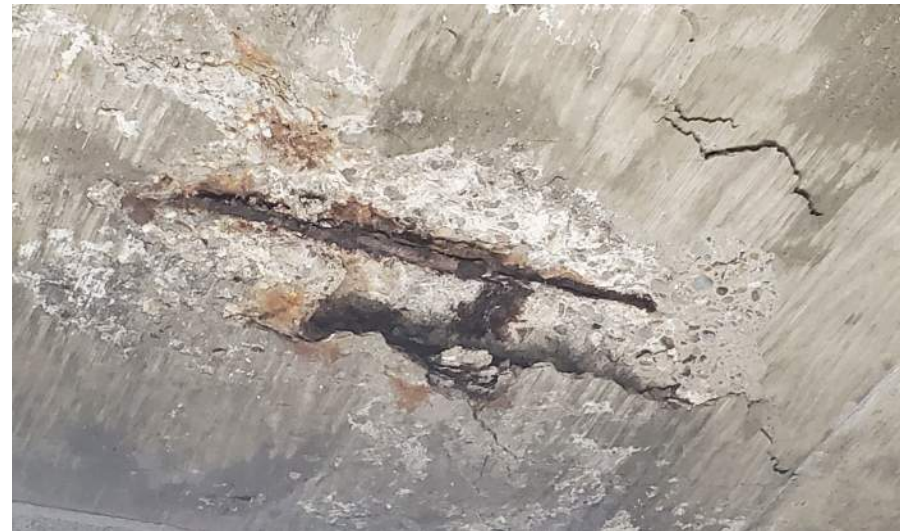
Corroded reinforcement in the utility stairway ceiling.

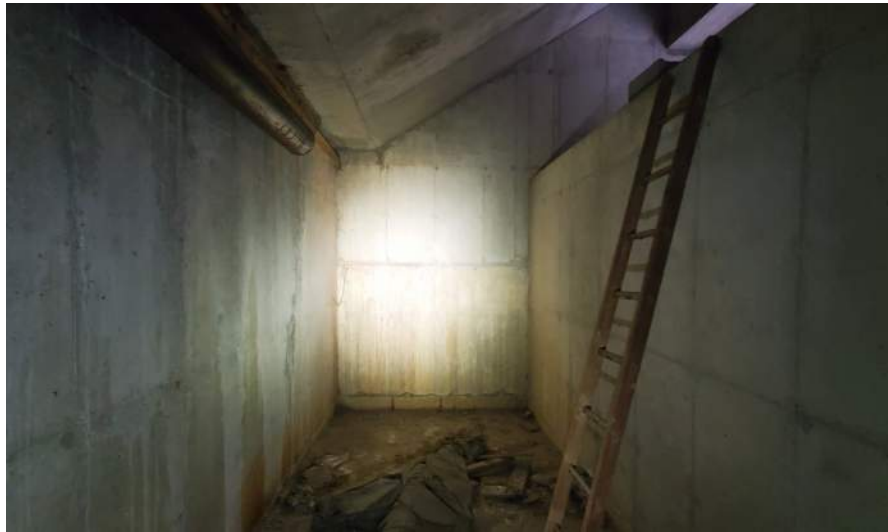
Plenum under the stairway overview.

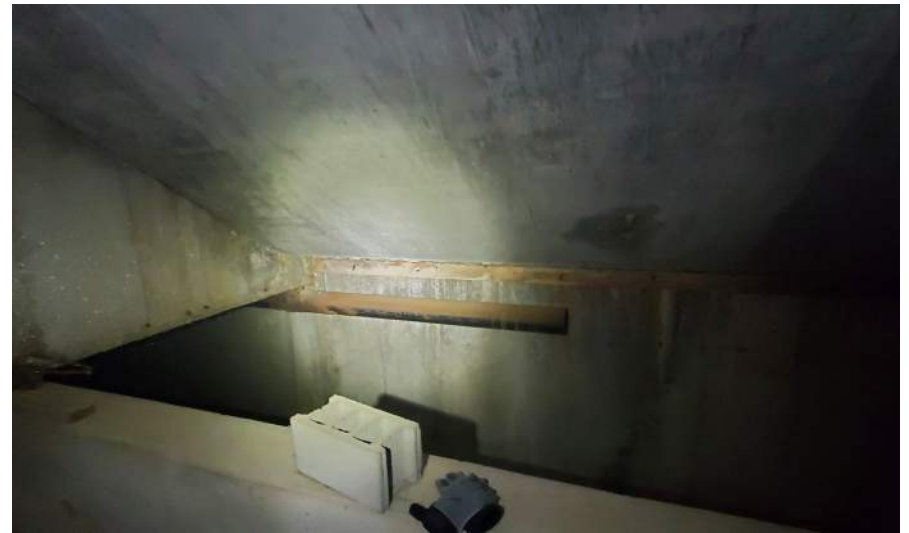
Water staining along the back plenum wall under stair landing,

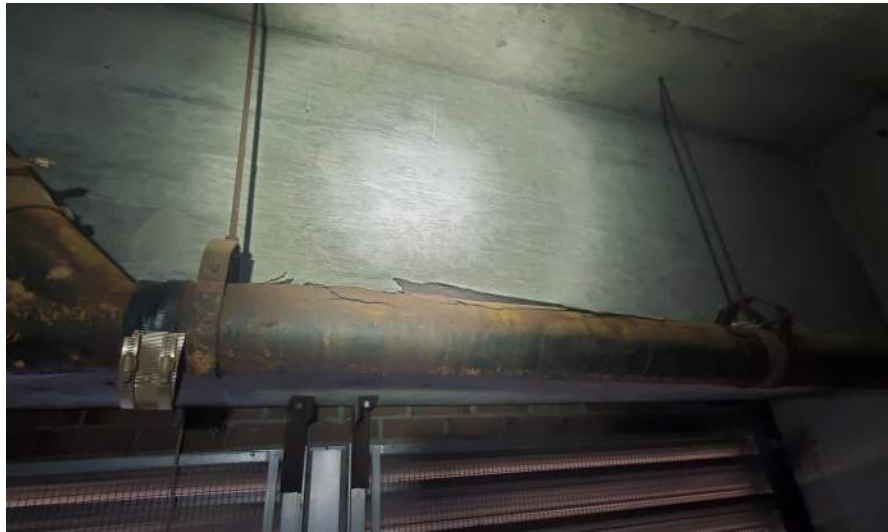
Corroded Plaza drain pipe in the plenum.

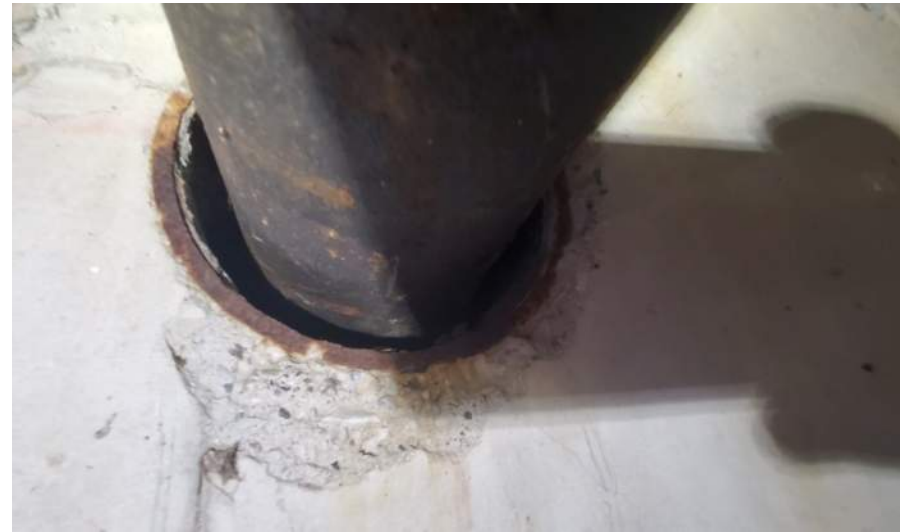
Plaza drain pipe drains into Wharton Center through plenum.

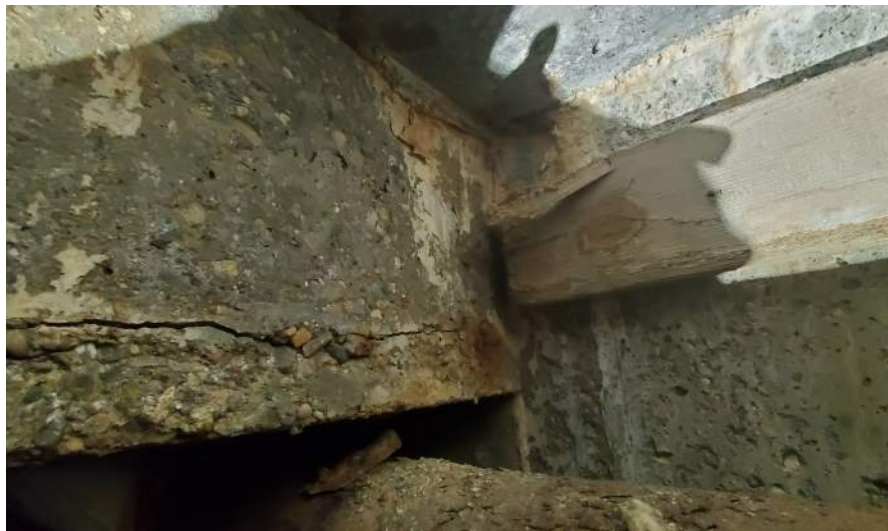
Damaged ceiling intersection of plenum where stairs meet the building.

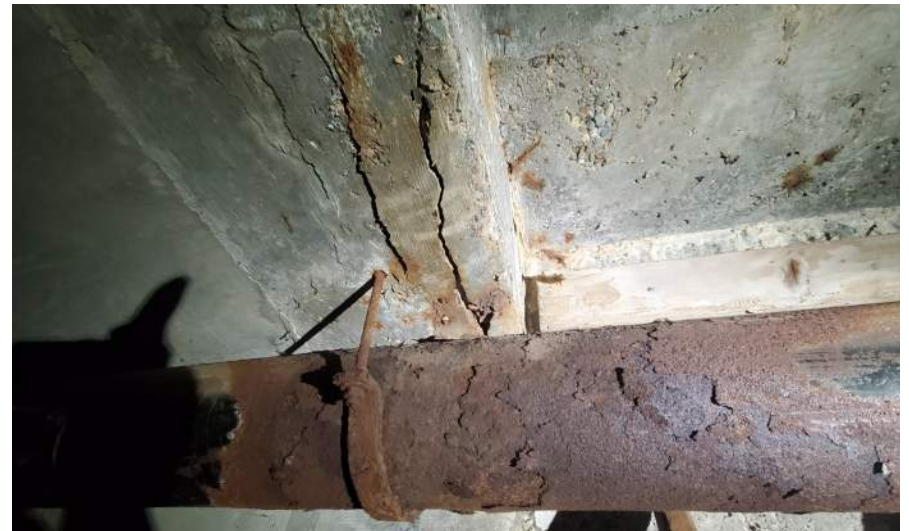
Damaged ceiling Intersection of plenum where stairs meet the building,

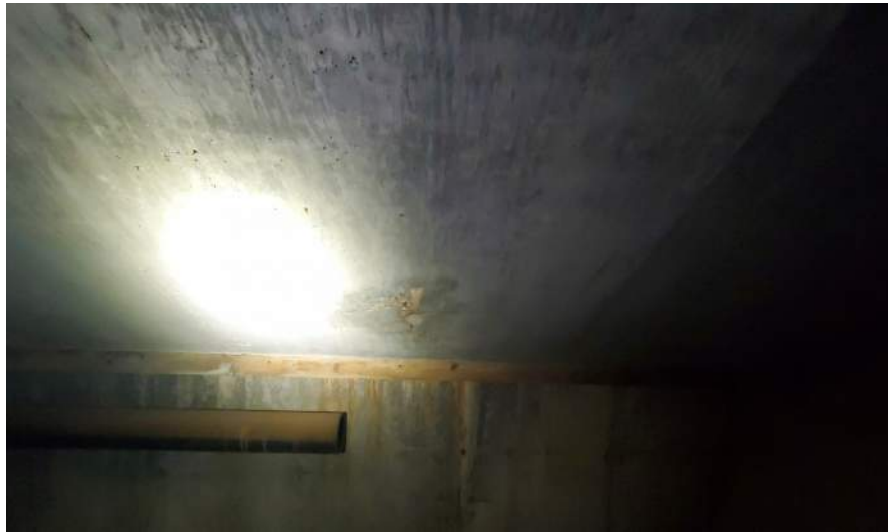
Small spot of reinforcement corrosion in the plenum ceiling.

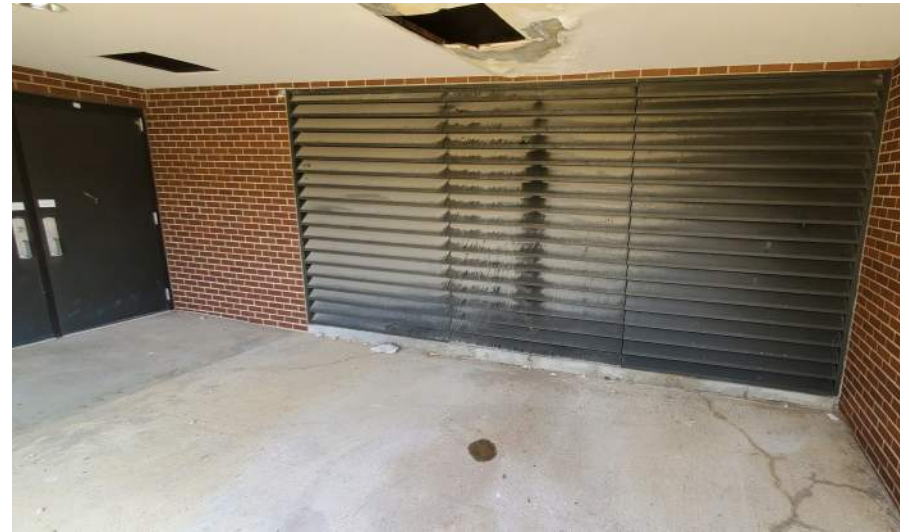
Drain leaking through soffit opening.

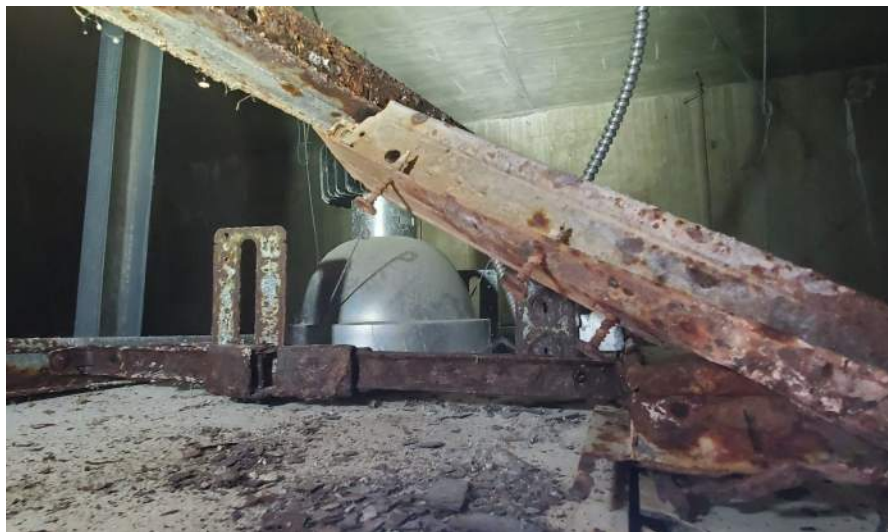
Soffit structure and light corroded from drain water.

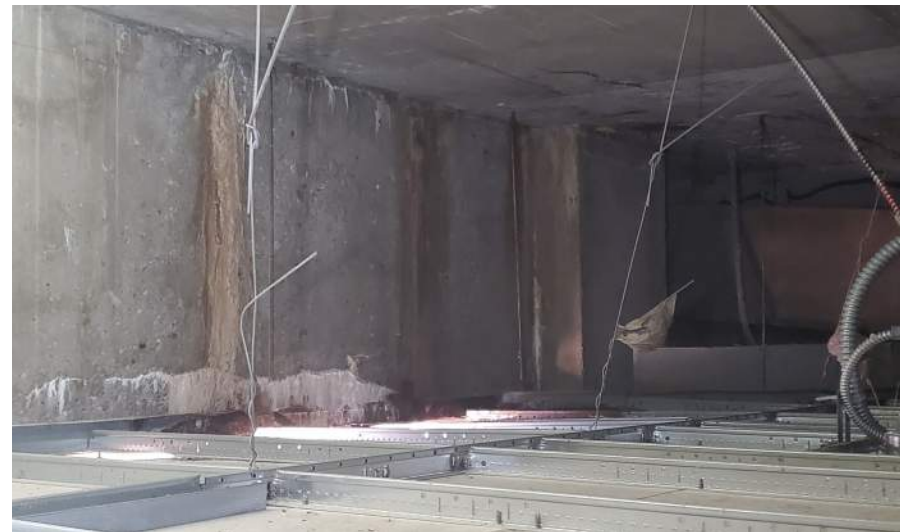
Water staining where the plaza intersects with the building.

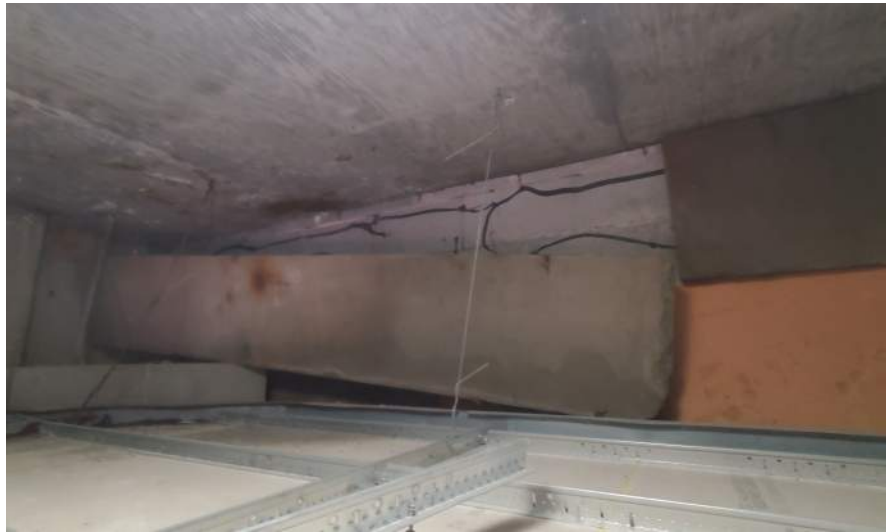
Building insulation has fallen in the soffit space.

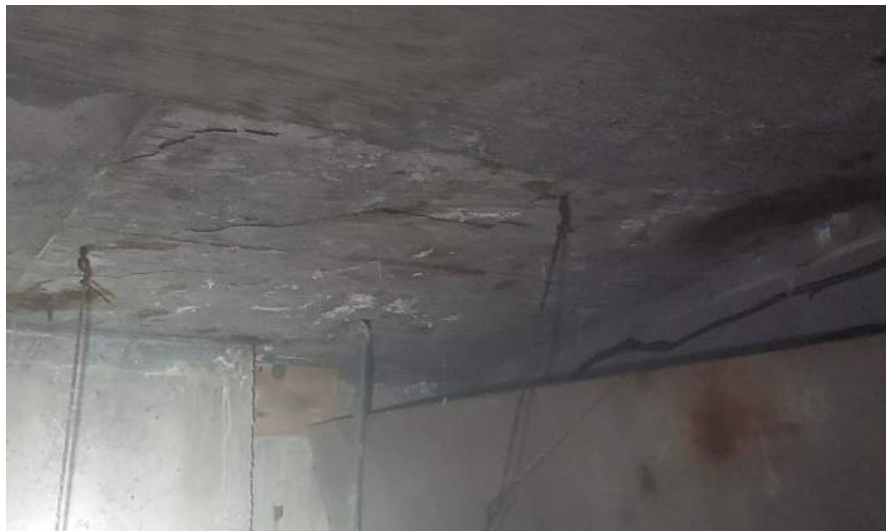
Corrosion in the ceiling structure above soffit space.

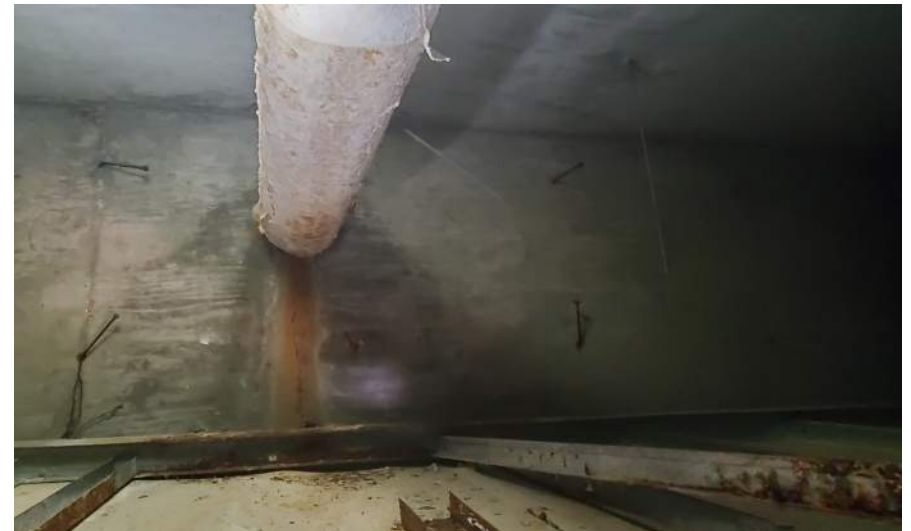
Plaza drain pipe is insulated in the soffit space, but not the plenum space.

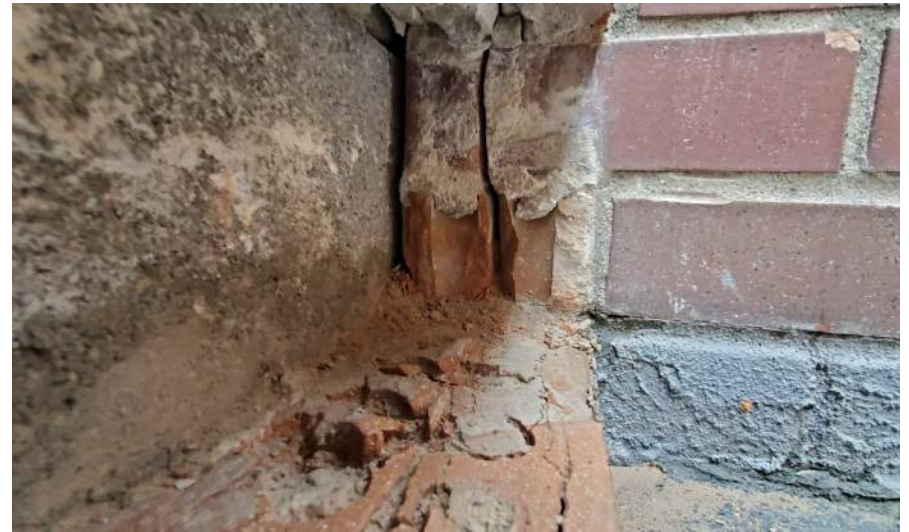
Brick in the parapet wall is cracked through the middle.

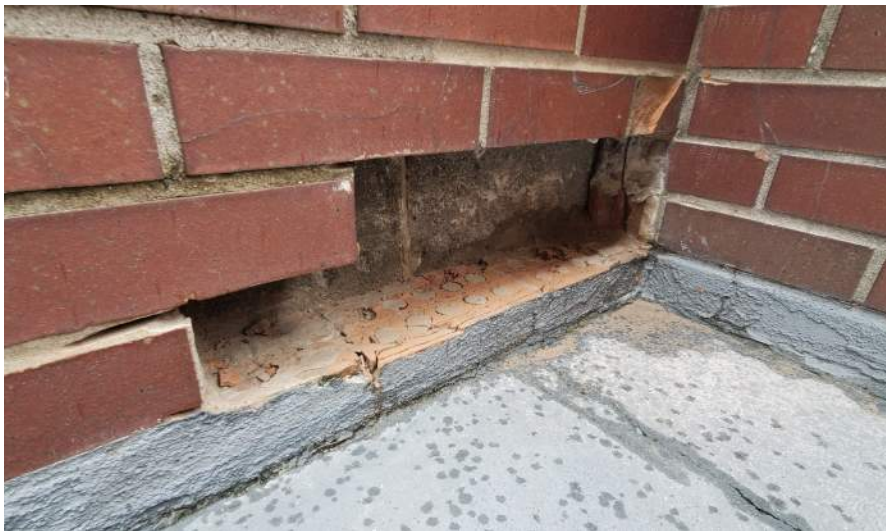
CMU back wall in sound state.

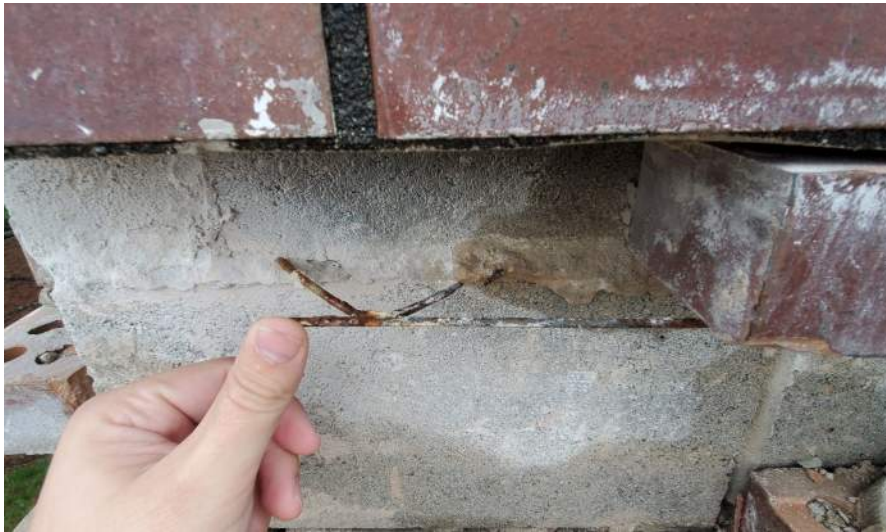
Brick ties are corroded and broken from back wall.

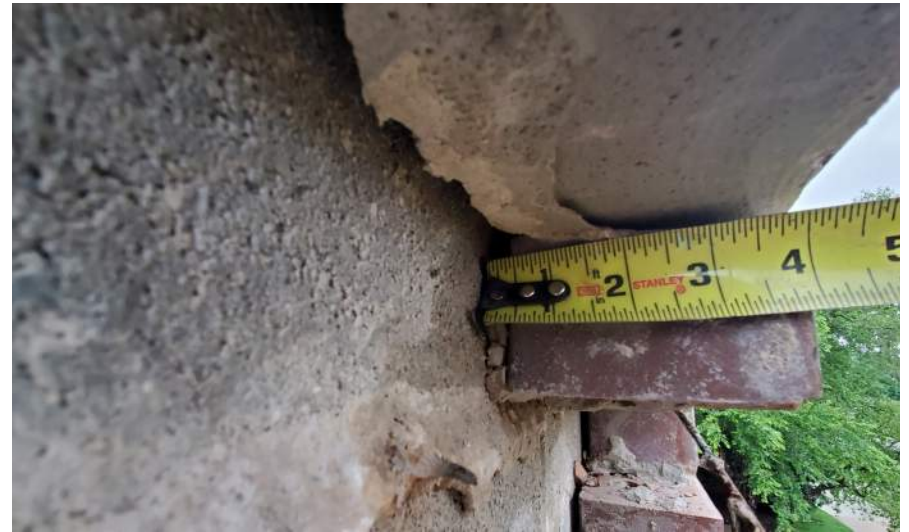
Less than a half inch gap between brick veneer and CMU back wall.

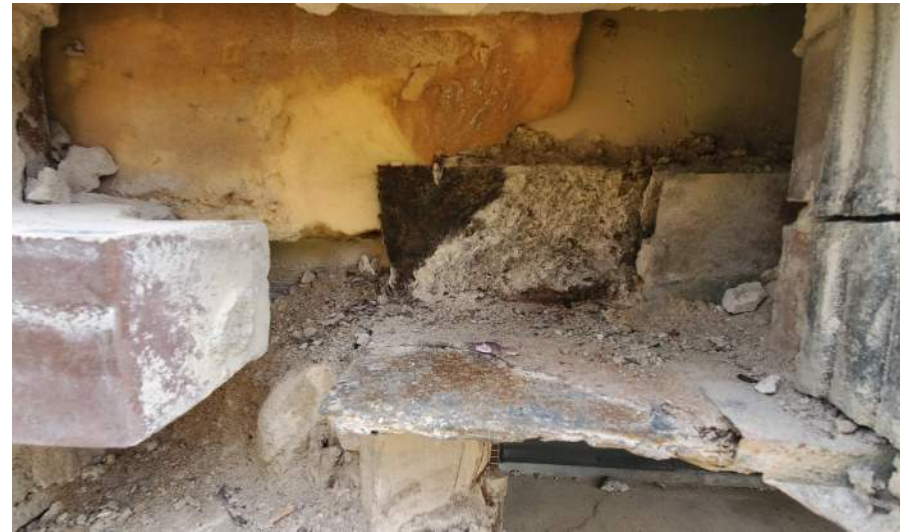
Lintel end vertical leg is heavily corroded.

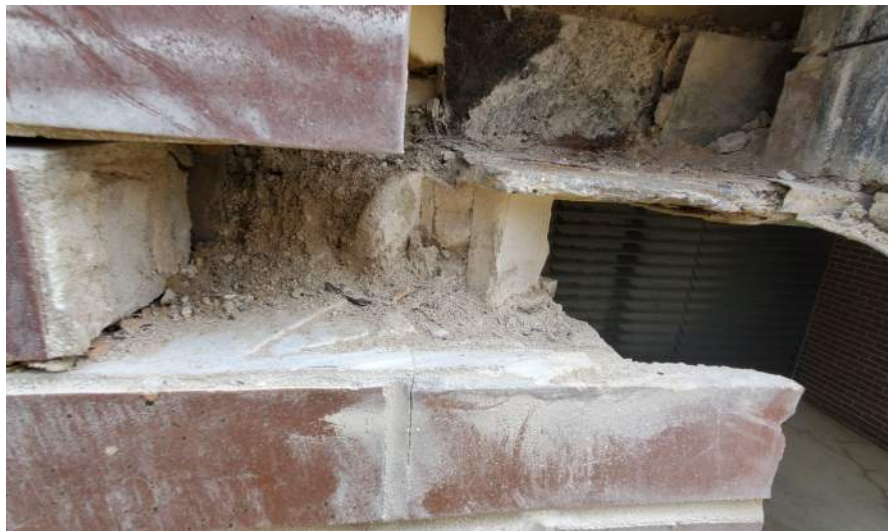
Lintel is about six inches short of sitting on structural CMU back wall.

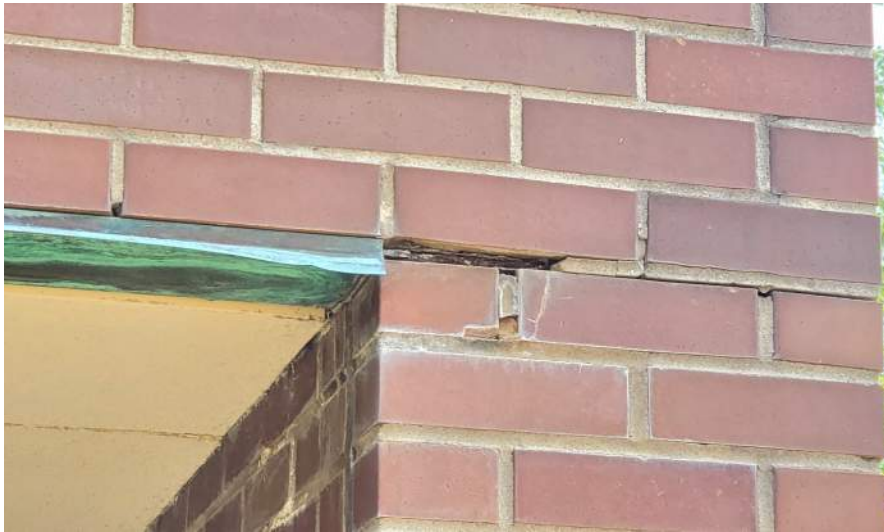
Lintel end opposite the masonry opening is corroded and damaging area.

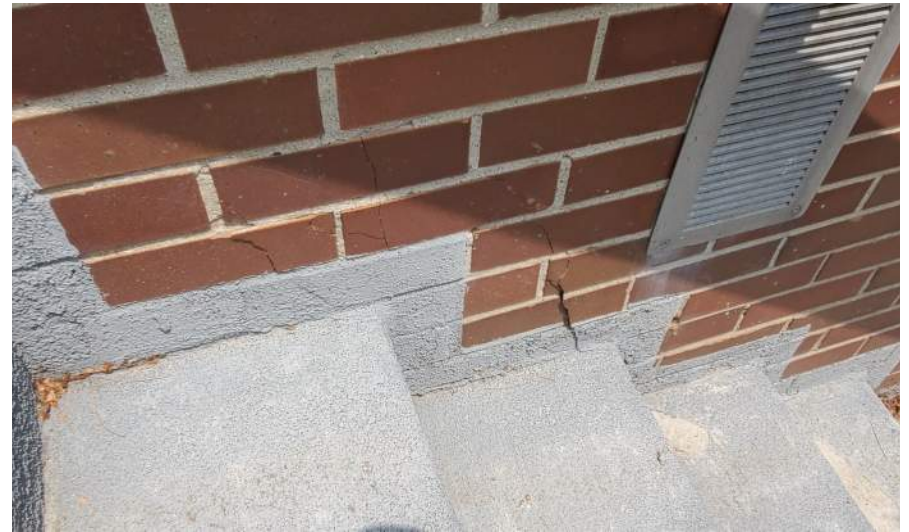
Small areas of damaged brick where the stairs meet Wharton Center.

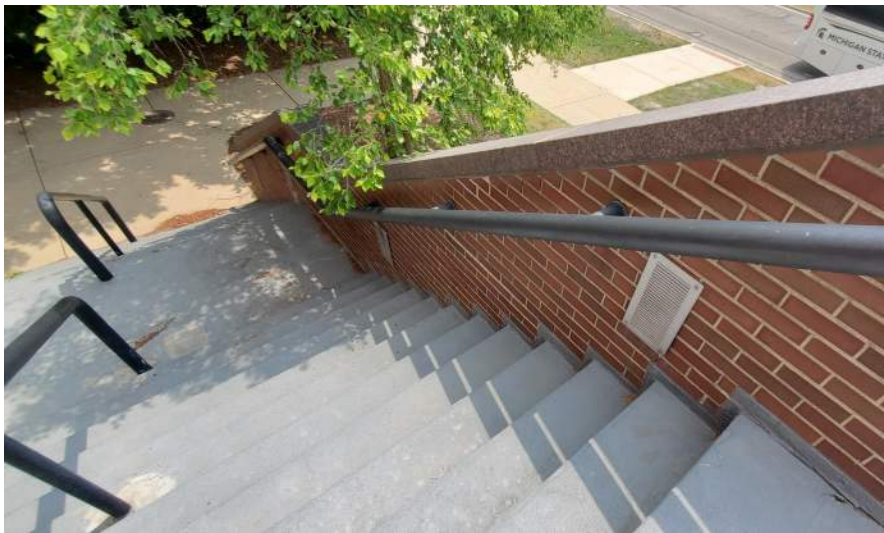
Railing used for stairway is very large and not able to fully grasp.

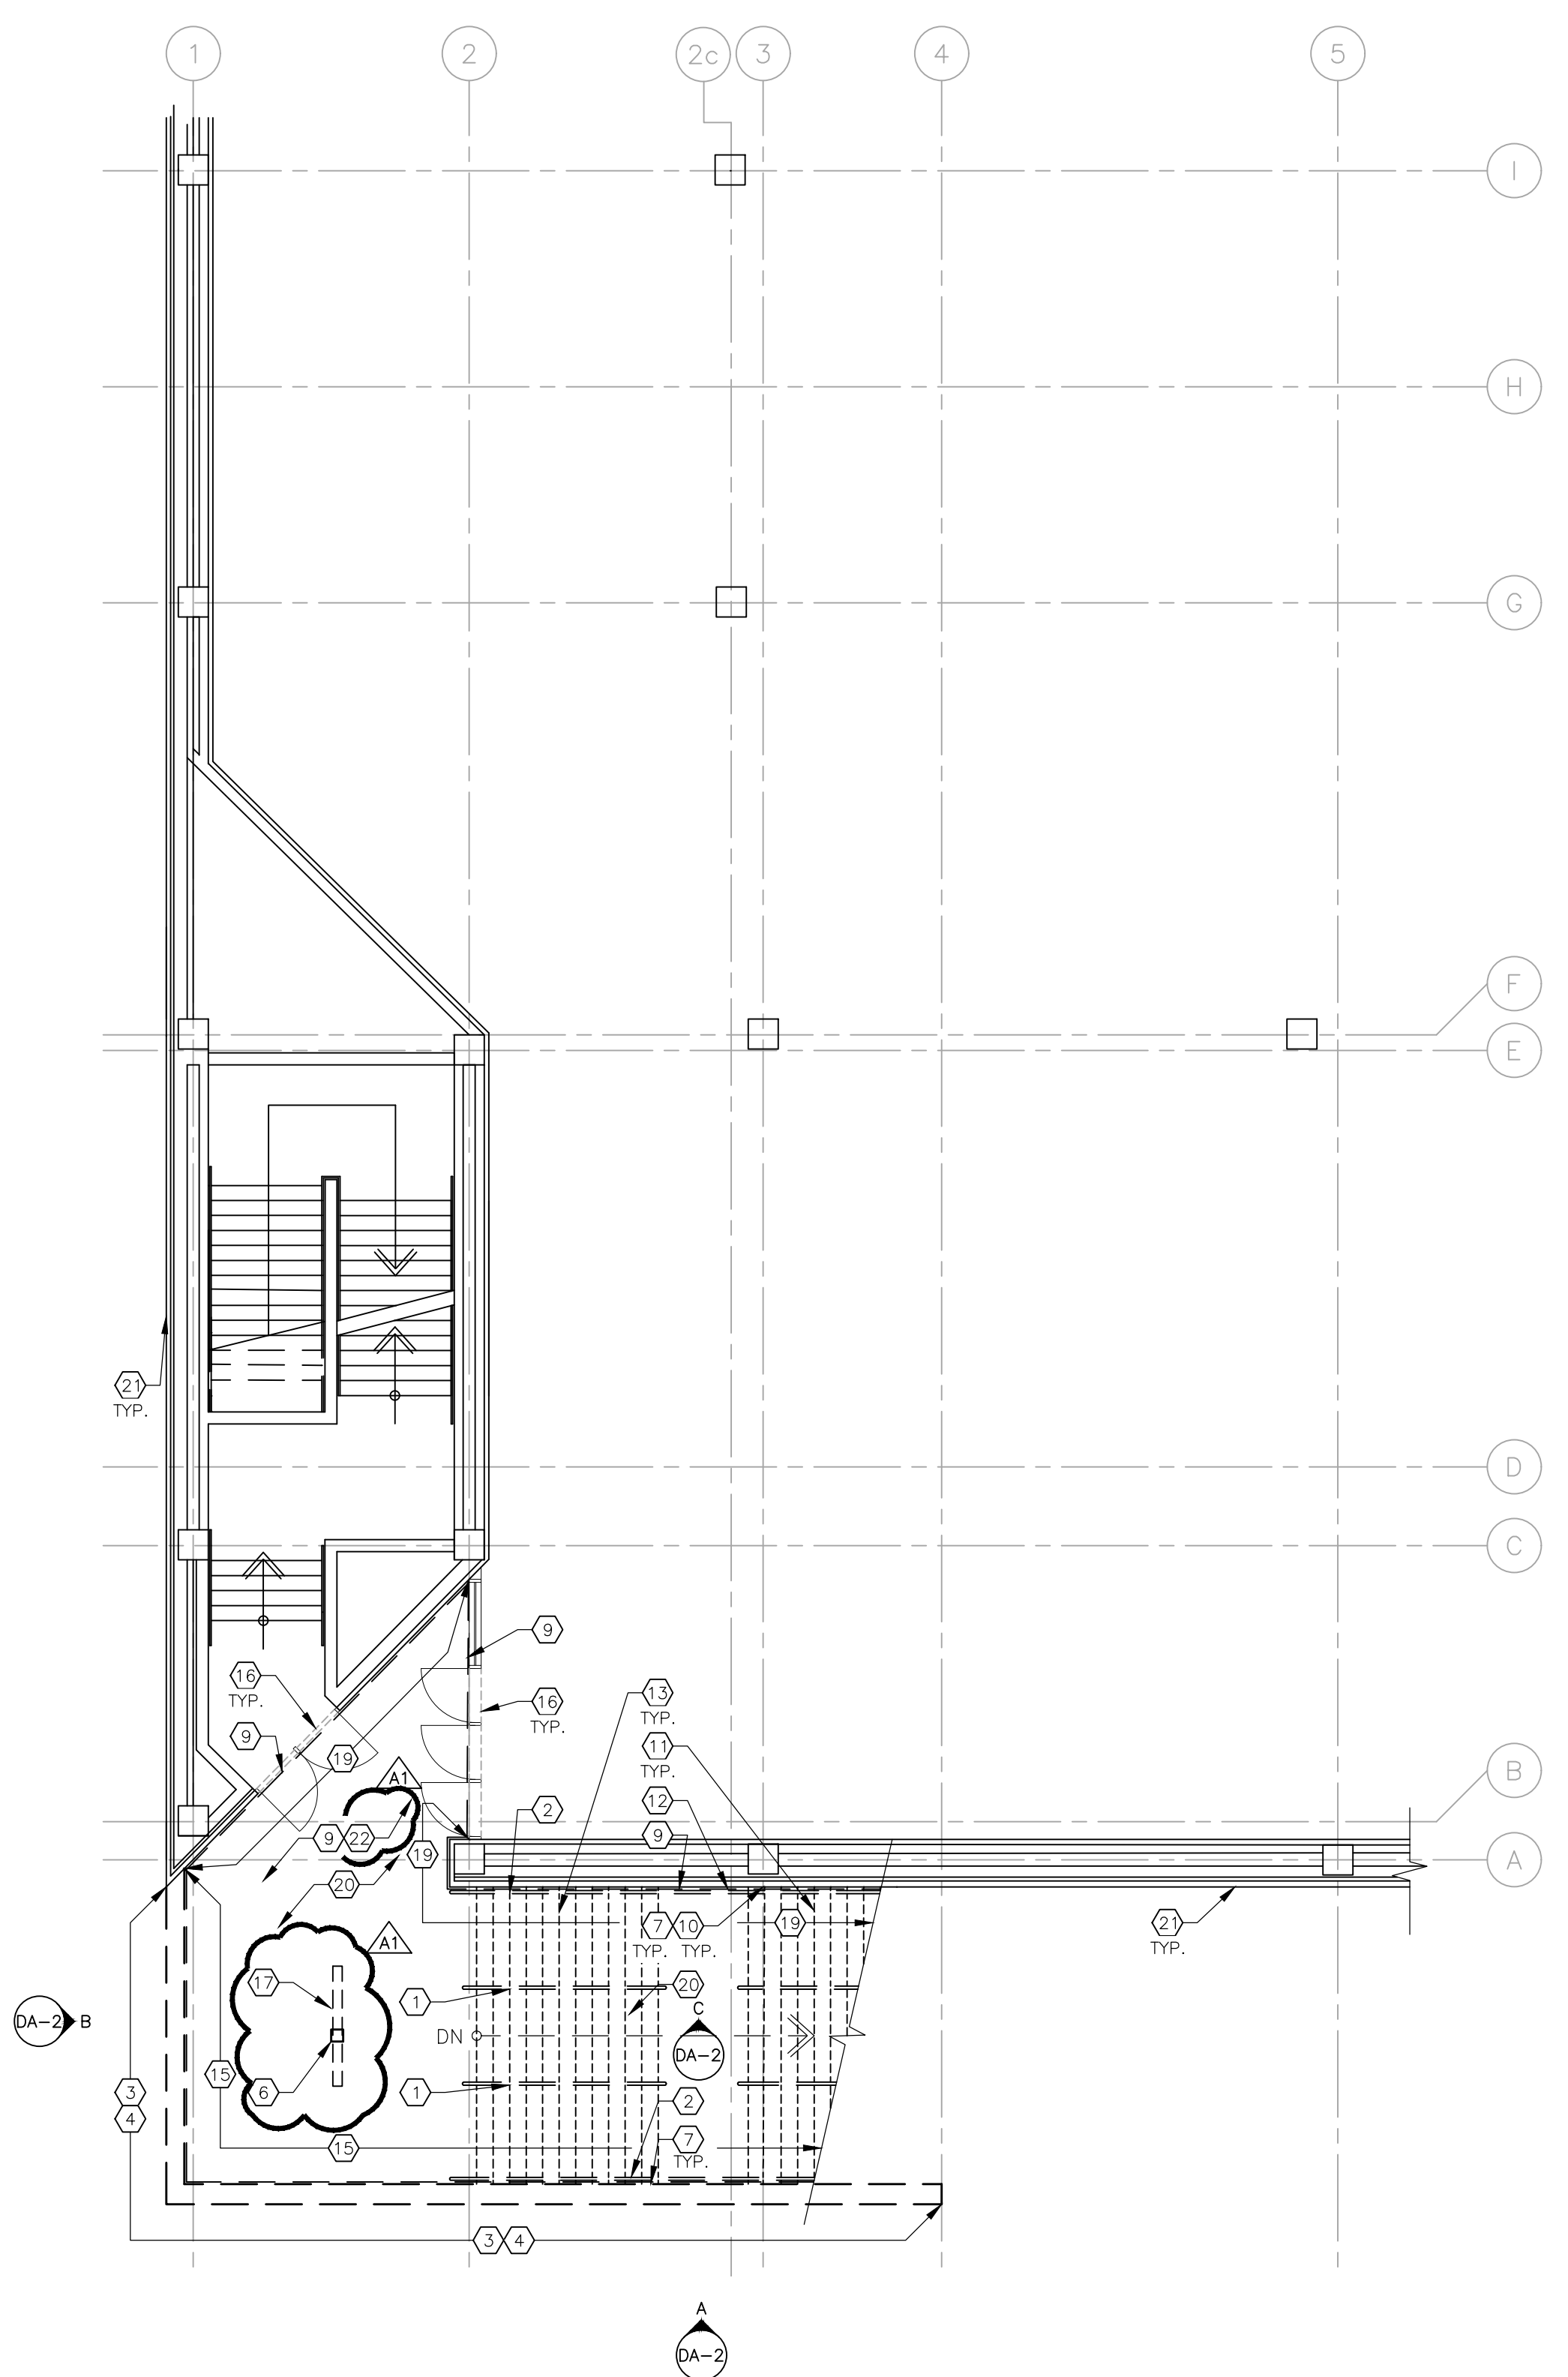
PARTIAL SECOND FLOOR DEMOLITION PLAN
SCALE: 1/8" = 1'-0"

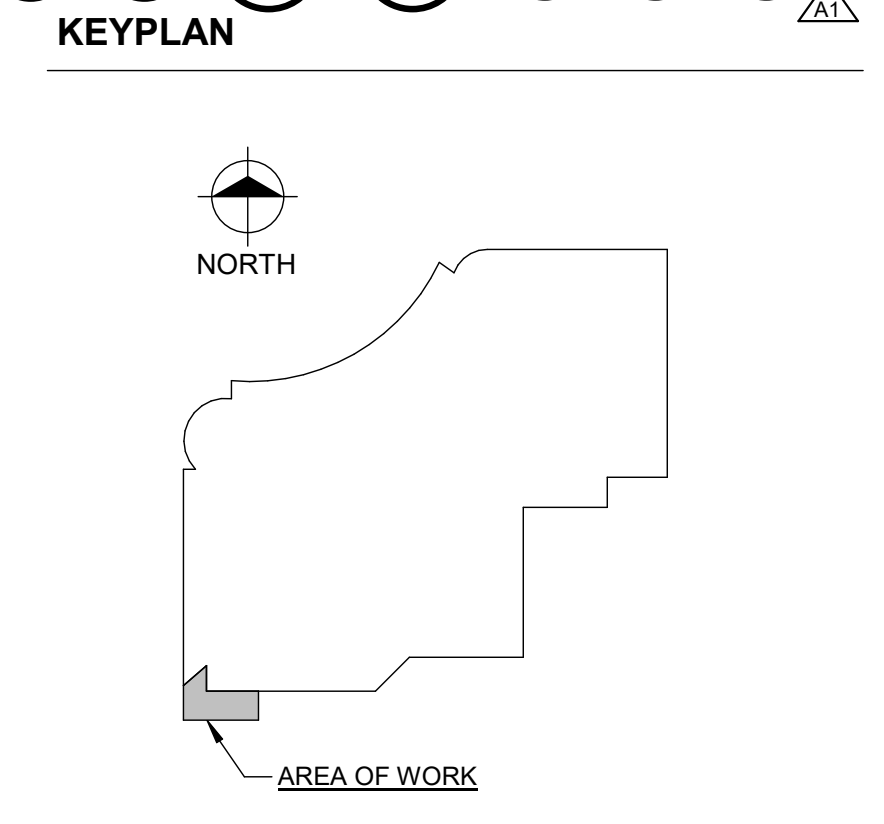
- KEY NOTES**
- INFILL EXISTING SLAB OPENING WITH CONCRETE.
 - CORE EXISTING SLAB FOR NEW FLOOR DRAIN PIPE. COORDINATE EXISTING REINFORCEMENT WITH PROPOSED CORES.
 - TOPPING SLAB. SEE ARCHITECTURAL FOR MORE INFORMATION.
 - NEW TRENCH DRAIN. INSTALL IN ACCORDANCE WITH MANUFACTURERS RECOMMENDATIONS. REFER TO ARCHITECTURAL FOR TOP OF TOPPING SLAB ELEVATION AT DRAIN. TOP OF FINISHED DRAIN SHOULD BE RECESSED 1/8" BELOW TOP OF TOPPING. SET THE DRAIN USING #4 BARS DRILLED AND EPOXY ANCHORED INTO SLAB WITH 3" EMBEDMENT. VERIFY TOP OF STRUCTURAL SLAB TO BE 871'-11 1/2" PRIOR TO DRAIN INSTALLATION. CHIP OUT A MAXIMUM OF 1/2" FROM STRUCTURAL SLAB. NOTIFY ENGINEER IF ELEVATION IS DIFFERENT OR IF FIELD CONDITIONS VARY AND DO NOT PROCEED WITH DRAIN INSTALLATION.

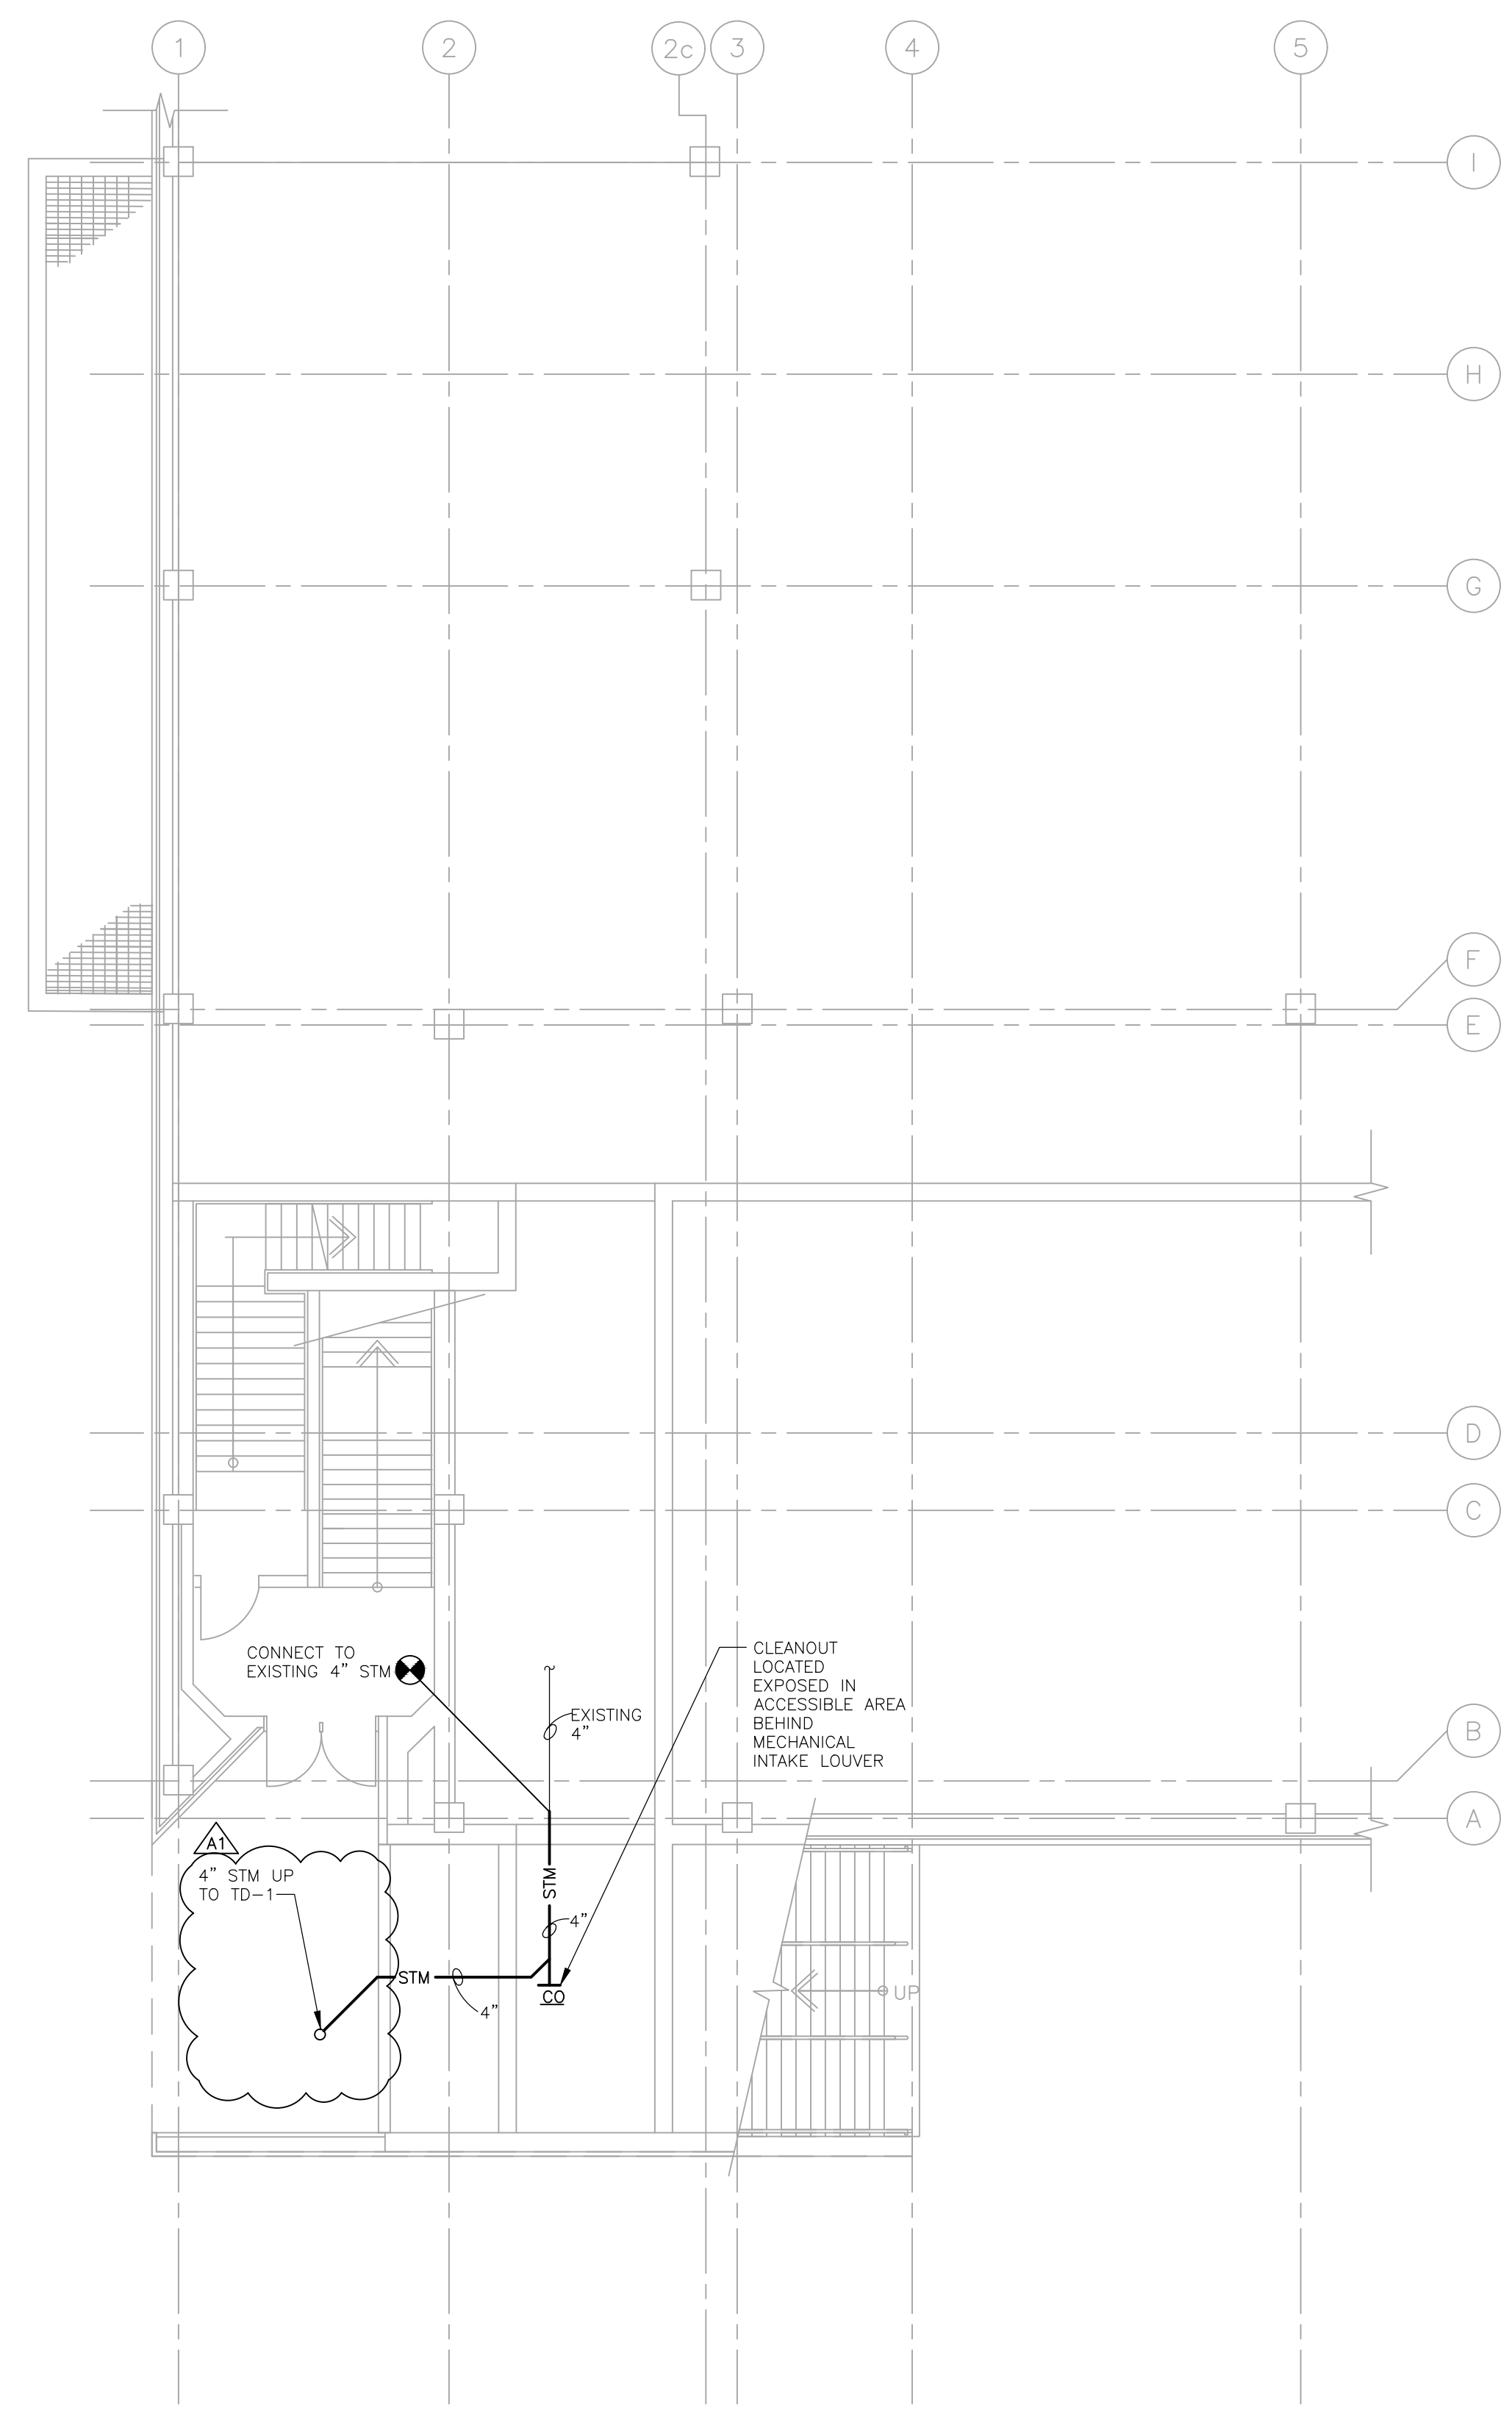
PARTIAL FIRST FLOOR PLUMBING PLAN
 SCALE: 1/8" = 1'-0"
