SPARTAN STADIUM

Spartan Stadium is the home of Michigan State University football. The stadium features a natural grass turf field, press box, team support spaces, fan amenities, and seating for 75,005 spectators. Future improvements to the stadium will include basic, fundamental updates throughout, as well as a complete renovation of the East Side in an effort to continually enhance the game day atmosphere for both players and fans.

COMPONENTS

EXISTING CONDITIONS

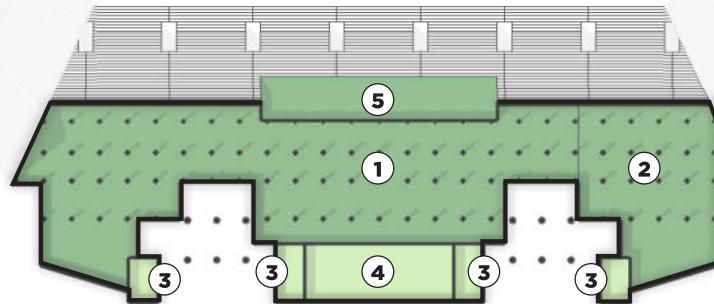
LEVEL 2 | CLUB LEVEL

- ① CLUB LOUNGE / SUPPORT - 1,800 CAP.
- ② ELITE CLUB - 500 CAP.
- ③ STAIRS / ELEVATOR
- ④ RAMP
- ⑤ OUTDOOR FIELD VIEW PATIO

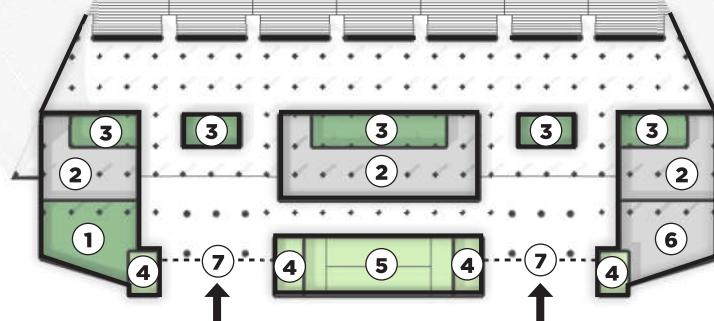
LEVEL 1 | CONCOURSE LEVEL

- ① TEAM STORE
- ② RESTROOMS
- ③ CONCESSIONS
- ④ STAIRS / ELEVATOR
- ⑤ RAMP
- ⑥ MECHANICAL
- ⑦ ENTRY GATES

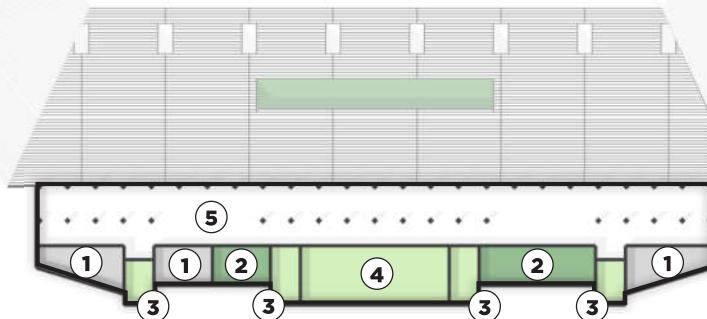
LEVEL 4 | LOWER BOWL, UPPER CONCOURSE

- ① RESTROOMS
- ② CONCESSIONS
- ③ STAIRS / ELEVATOR

- ④ RAMP
- ⑤ CONCOURSE

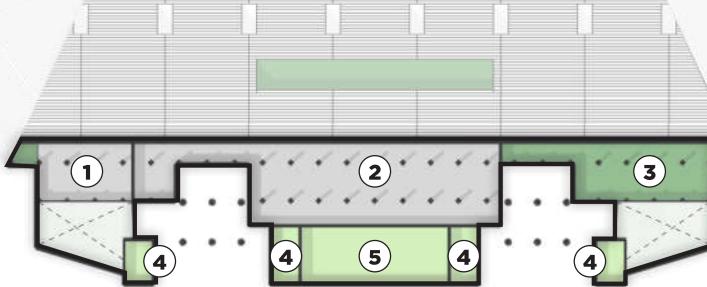
LEVEL 3 | BROADCAST LEVEL

- ① MEP
- ② BROADCAST STUDIO
- ③ VARSITY S CLUB - 200 CAP.

- ④ STAIRS / ELEVATOR
- ⑤ RAMP

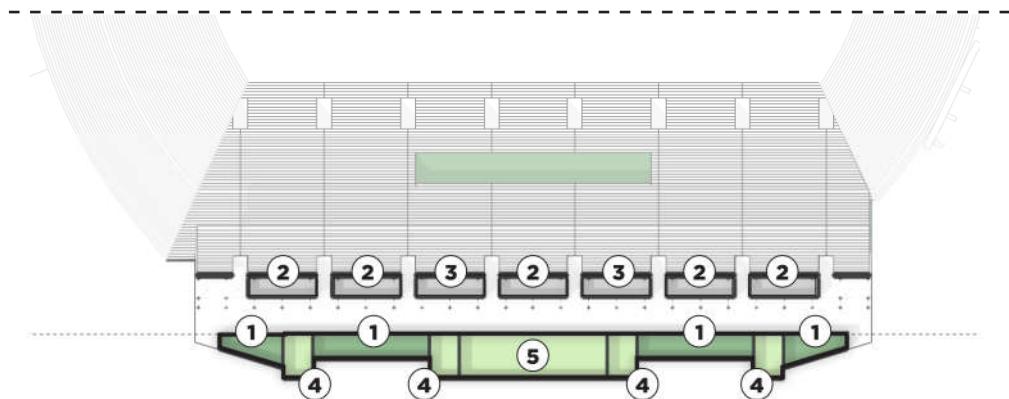
LEVEL 5 | UPPER DECK CONCOURSE

- ① CONCESSIONS
- ② RESTROOMS
- ③ MEP / STORAGE

- ④ STAIRS / ELEVATOR
- ⑤ RAMP

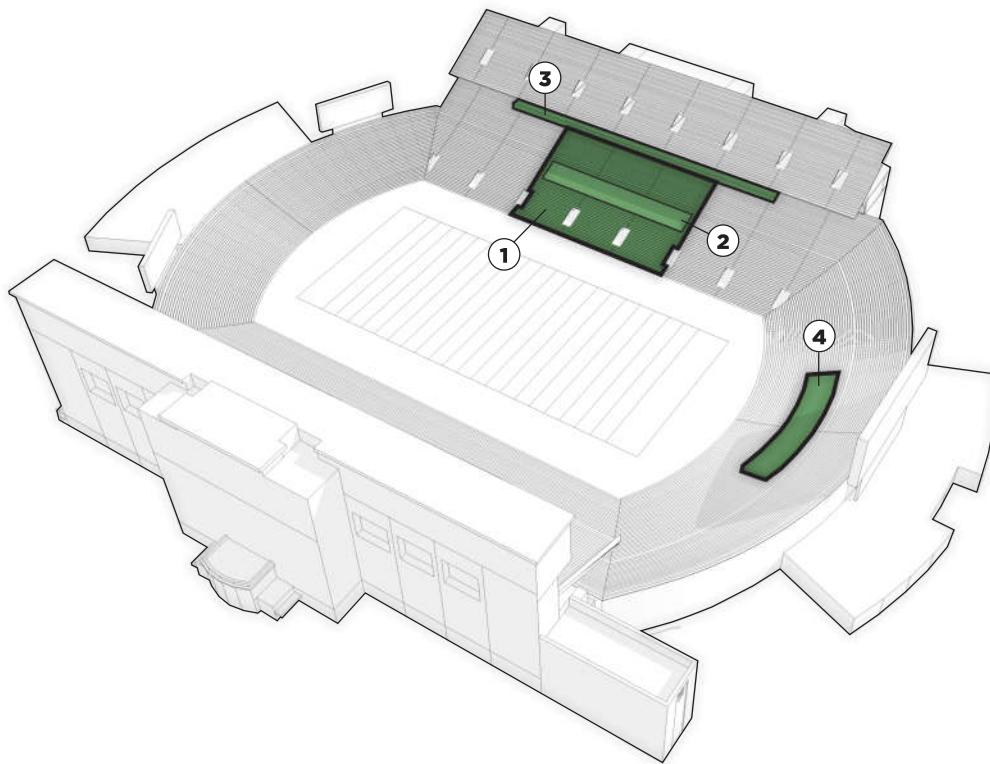
SEATING | IMPROVEMENTS

① PREMIUM SEATING

LOGE BOXES

CLUB SEATS

THEATER SEATS

LIVING ROOM SEATS

② CLUB PATIO

③ LOGE BOXES

(30, 4 PERSON)

④ STUDENT SEATING

SAFE STANDING

PATIO

SOCIAL LOUNGE

SELFIE PLATFORM

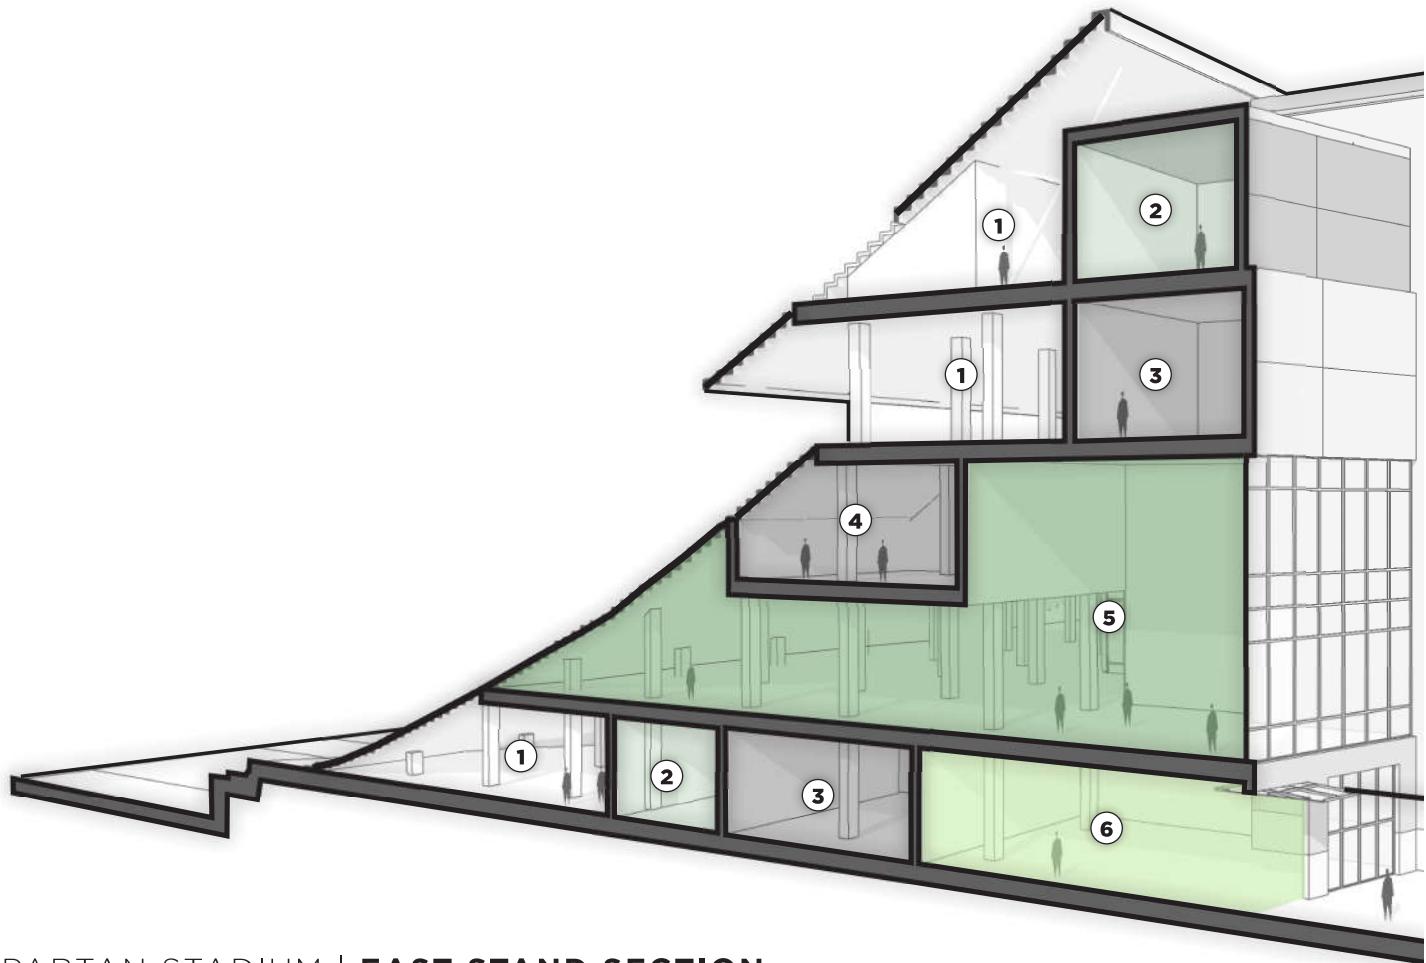
SPARTAN STADIUM | EAST STAND SECTION

①	CONCOURSE	⑤	CLUB LOUNGE / SUPPORT
②	CONCESSIONS	⑥	TEAM STORE
③	RESTROOMS	⑦	GAME DAY PLAZA
④	BROADCAST STUDIO
