Central Services - Demolition

CP24092

PRE-DEMOLITION HAZARDOUS MATERIALS SURVEY REPORT **CENTRAL SERVICES**

**Subject: Pre-Demolition Hazardous Materials Survey Report
Michigan State University
Central Services
570 Red Cedar Road
East Lansing, MI 48824**

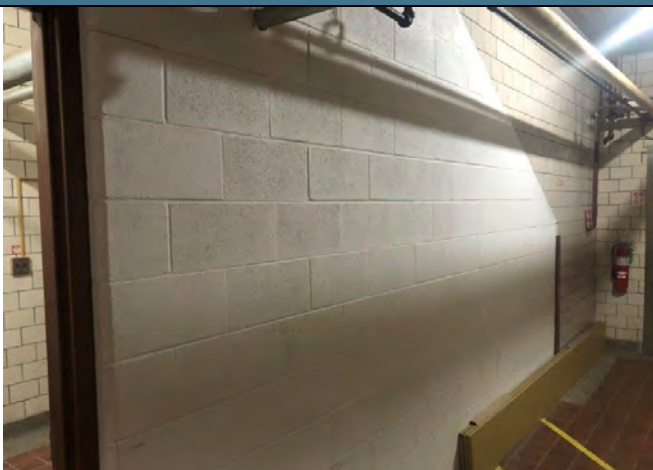
Photograph #5

Homogenous Material Description
HA-5: CMU block mortar
Asbestos Present (Yes/No/Assumed)
No
Total Quantity Present
40405 SF
Additional Notes

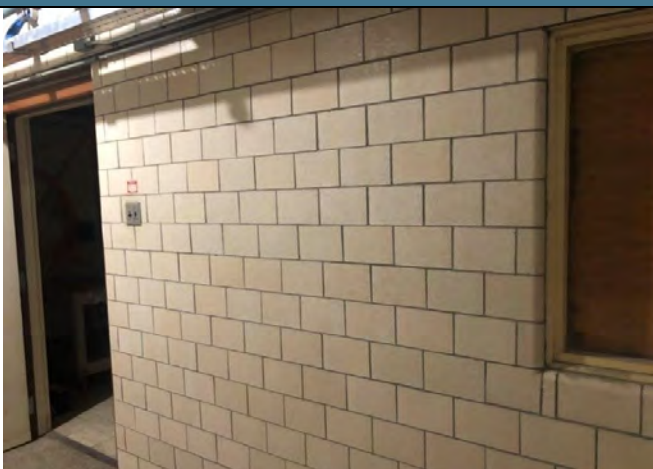
Photograph #6

Homogenous Material Description
HA-6: Grey glazed ceramic block mortar
Asbestos Present (Yes/No/Assumed)
No
Total Quantity Present
33190 SF
Additional Notes

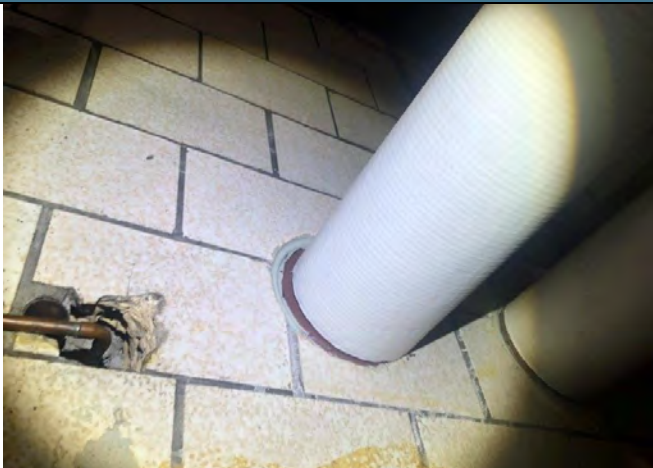
Photograph #10

Homogenous Material Description
HA-10: Grey penetration caulk
Asbestos Present (Yes/No/Assumed)
No
Total Quantity Present
57 LF
Additional Notes

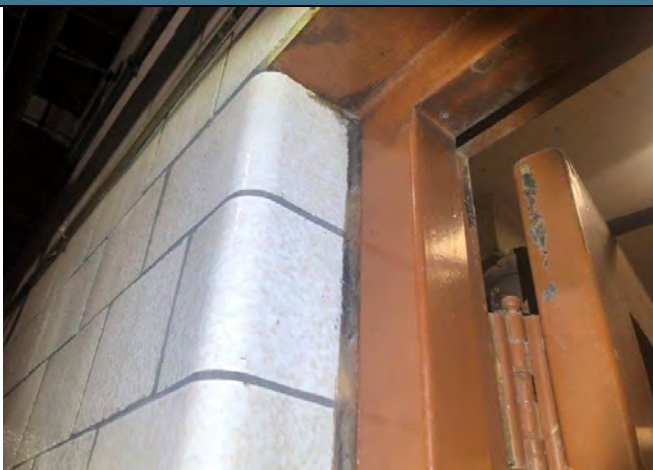
Photograph #11

Homogenous Material Description
HA-11: Dark brown caulk on door frames
Asbestos Present (Yes/No/Assumed)
Yes, 2% Chrysotile
Total Quantity Present
880 LF
Additional Notes

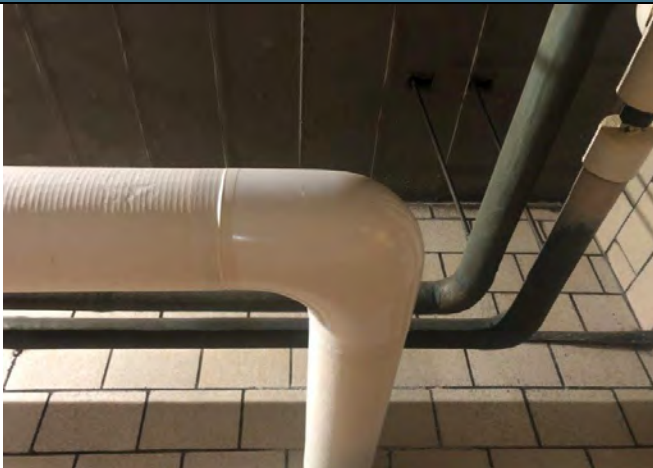
Photograph #13

Homogenous Material Description
HA-13: Plastic covered fiberglass pipe fitting
Asbestos Present (Yes/No/Assumed)
No
Total Quantity Present
1456 Fittings
Additional Notes

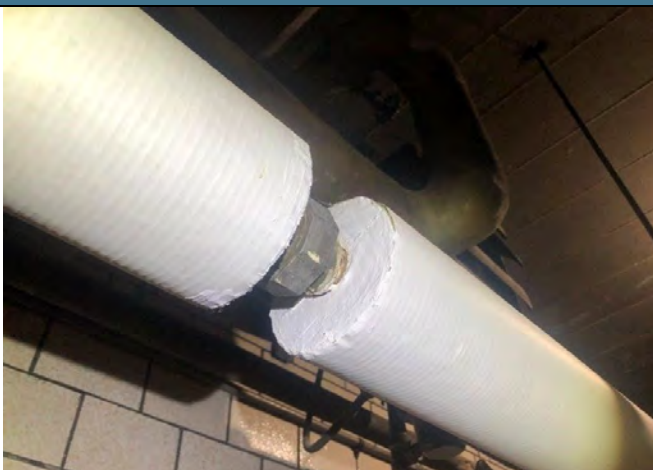
Photograph #14

Homogenous Material Description
HA-14: White caulk on HA-12
Asbestos Present (Yes/No/Assumed)
No
Total Quantity Present
145 SF
Additional Notes

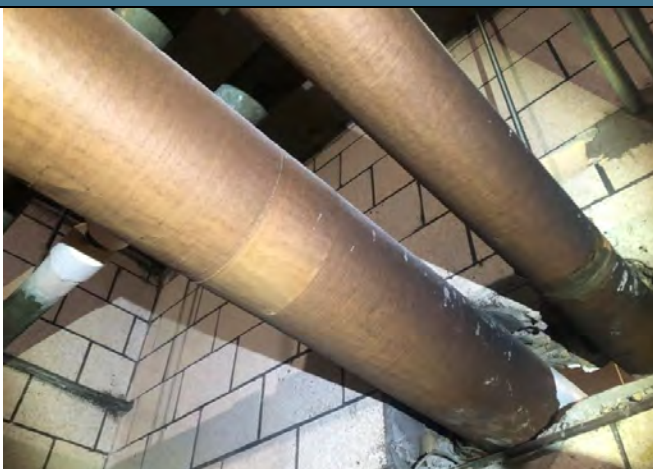
Photograph #15

Homogenous Material Description
HA-15: Brown paper wrapped pipe insulation
Asbestos Present (Yes/No/Assumed)
No
Total Quantity Present
1830 LF
Additional Notes

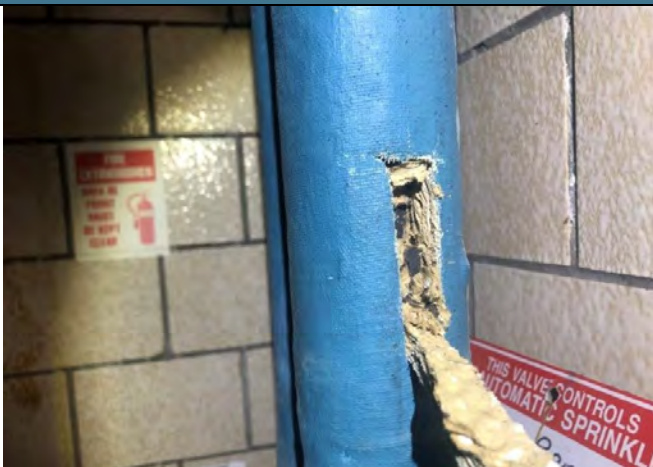
Photograph #18

Homogenous Material Description
HA-18: Wool felt pipe insulation
Asbestos Present (Yes/No/Assumed)
Yes, 35% Chrysotile
Total Quantity Present
875 LF
Additional Notes

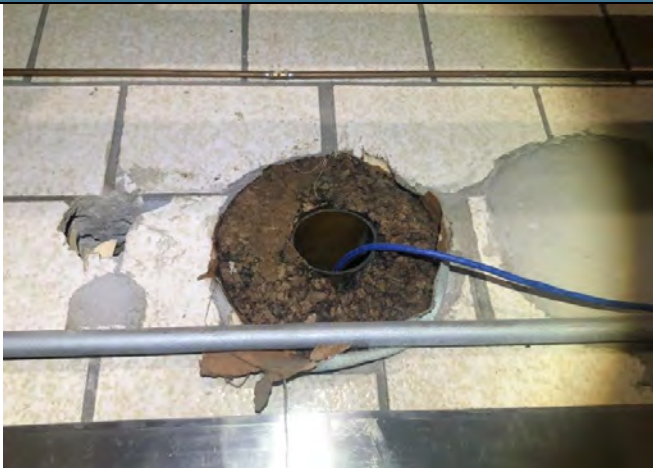
Photograph #22

Homogenous Material Description
HA-22: Cork pipe insulation
Asbestos Present (Yes/No/Assumed)
Cork No, Mag Layer Assumed
Total Quantity Present
11 LF
Additional Notes
Per MSU, mag layer may be hidden under cork

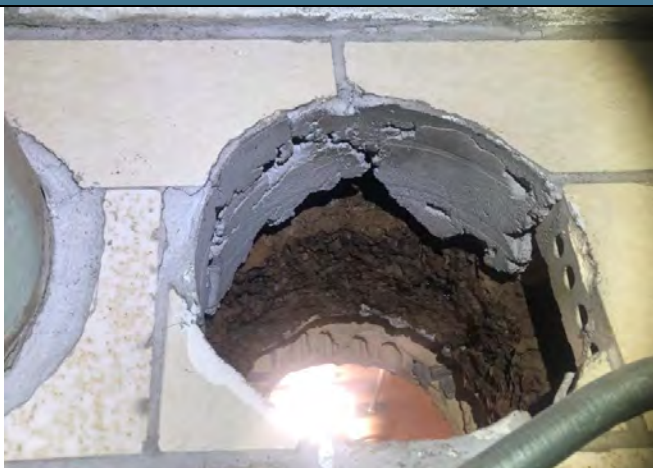
Photograph #23

Homogenous Material Description
HA-23: Cork insulation – wall insulation
Asbestos Present (Yes/No/Assumed)
No
Total Quantity Present
15645 SF
Additional Notes

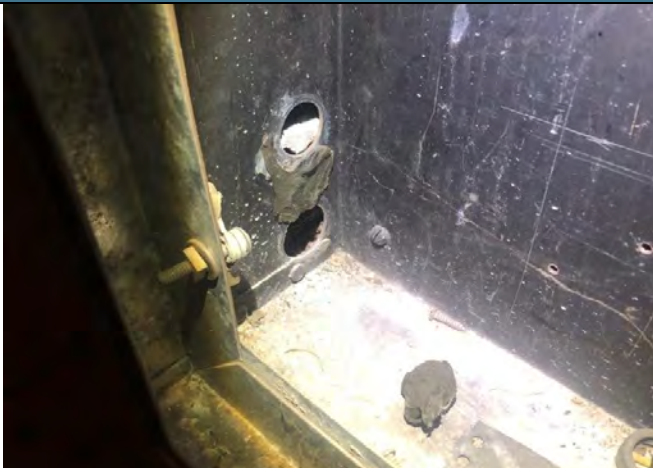
Photograph #25

Homogenous Material Description
HA-25: Green caulk in electrical box
Asbestos Present (Yes/No/Assumed)
Yes, 10% Chrysotile
Total Quantity Present
10 LF
Additional Notes

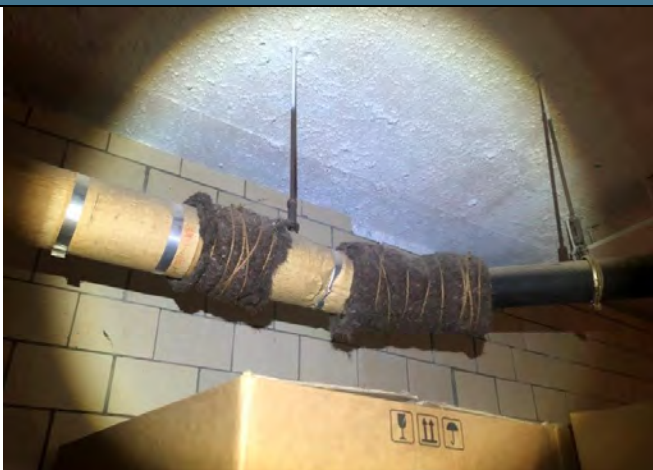
Photograph #26

Homogenous Material Description
HA-26: Pipe insulation – horse hair
Asbestos Present (Yes/No/Assumed)
No
Total Quantity Present
5 LF
Additional Notes

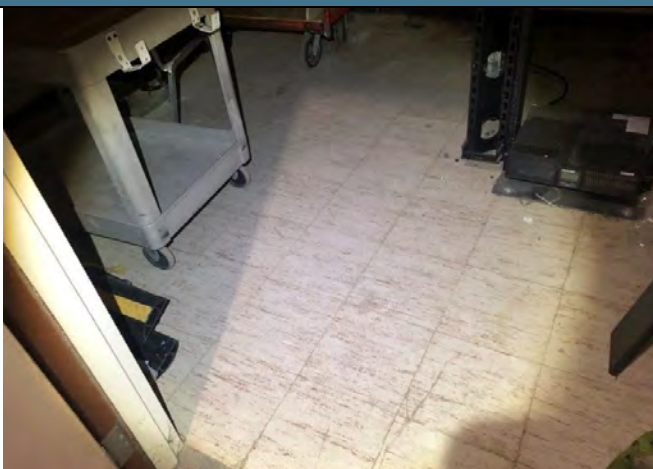
Photograph #27

Homogenous Material Description
HA-27: 12" beige floor tile, red streaks, mastic
Asbestos Present (Yes/No/Assumed)
No
Total Quantity Present
100 SF
Additional Notes

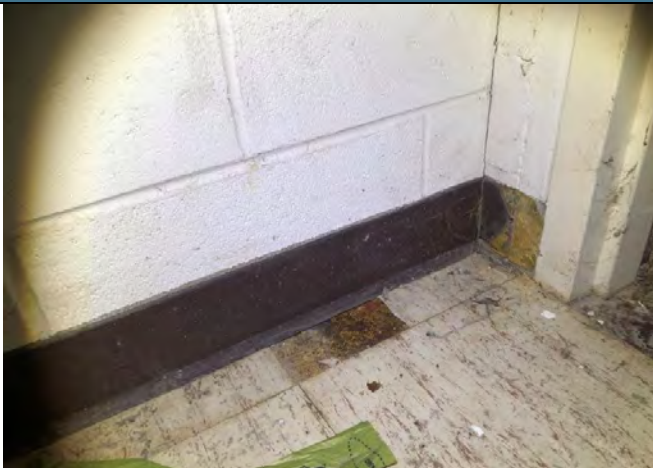
Photograph #28

Homogenous Material Description
HA-28: 4" brown cove base, adhesive
Asbestos Present (Yes/No/Assumed)
No
Total Quantity Present
40 LF
Additional Notes

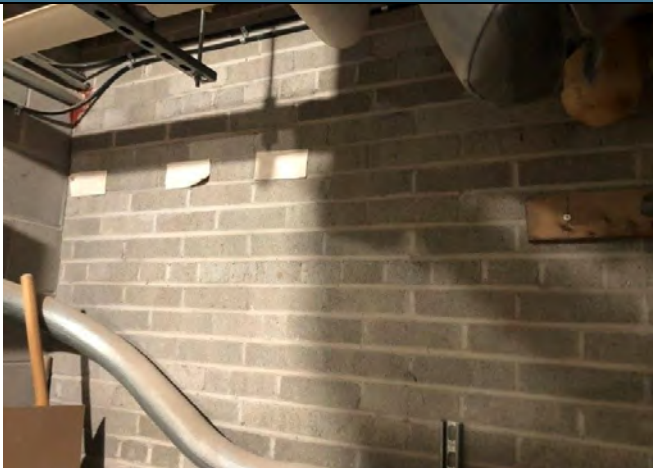
Photograph #31

Homogenous Material Description
HA-31: Brick mortar – 2”x6” concrete bricks
Asbestos Present (Yes/No/Assumed)
No
Total Quantity Present
200 SF
Additional Notes

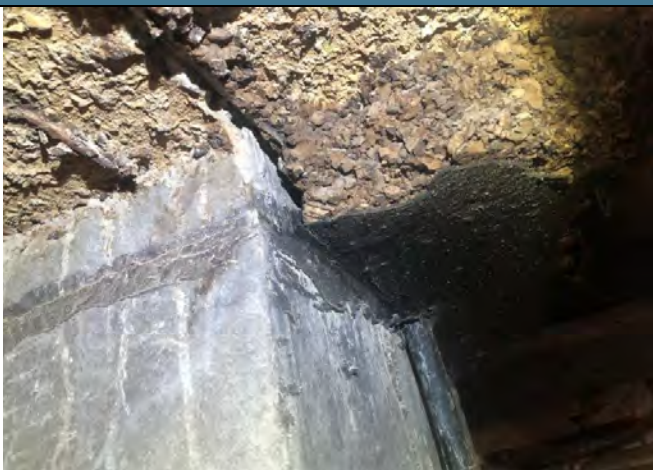
Photograph #32

Homogenous Material Description
HA-32: Interior caulk (tar), black, perimeter of cork insulation (associated with HA-24)
Asbestos Present (Yes/No/Assumed)
Yes, 3% Chrysotile
Total Quantity Present
160 LF
Additional Notes
Associated with HA-24

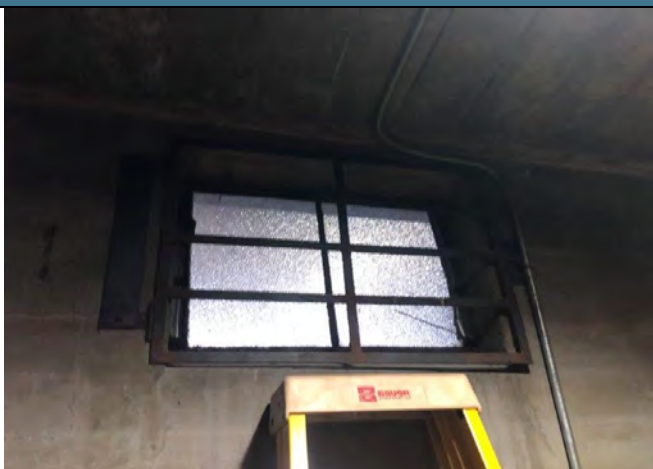
Photograph #33

Homogenous Material Description
HA-33: Window glaze - grey
Asbestos Present (Yes/No/Assumed)
No
Total Quantity Present
1 Window
Additional Notes

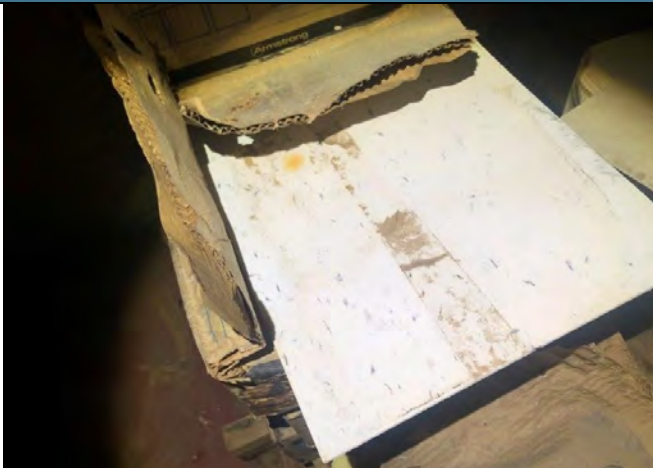
Photograph #37

Homogenous Material Description
HA-37: 12" white with black streaks floor tile
Asbestos Present (Yes/No/Assumed)
No
Total Quantity Present
6 Boxes
Additional Notes

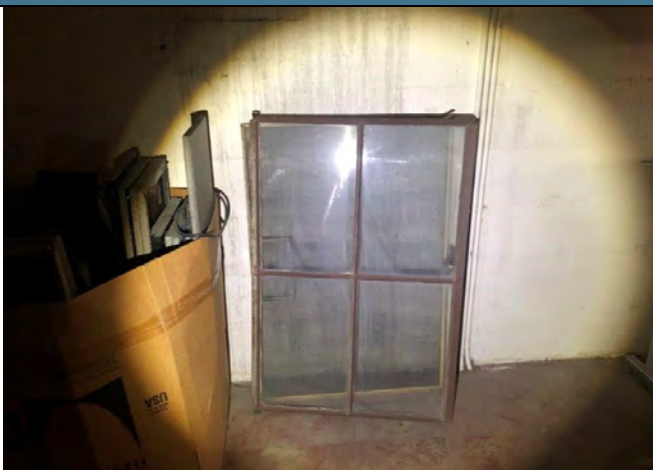
Photograph #38

Homogenous Material Description
HA-38: Window glaze, stack
Asbestos Present (Yes/No/Assumed)
Yes, 3% Chrysotile
Total Quantity Present
1 Window
Additional Notes

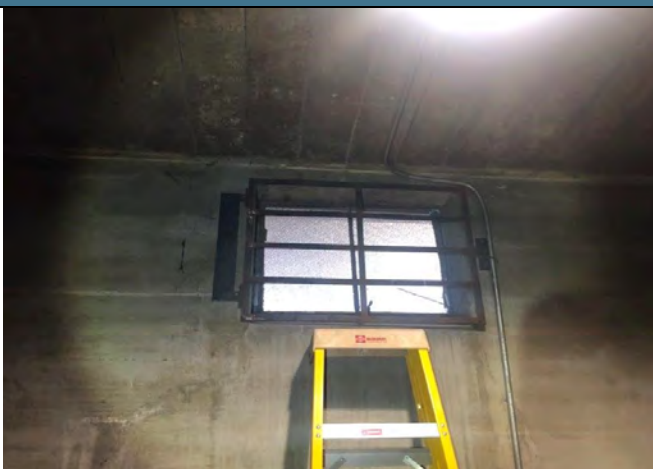
Photograph #39

Homogenous Material Description
HA-39: Soft grey window glaze
Asbestos Present (Yes/No/Assumed)
No
Total Quantity Present
1 Window
Additional Notes

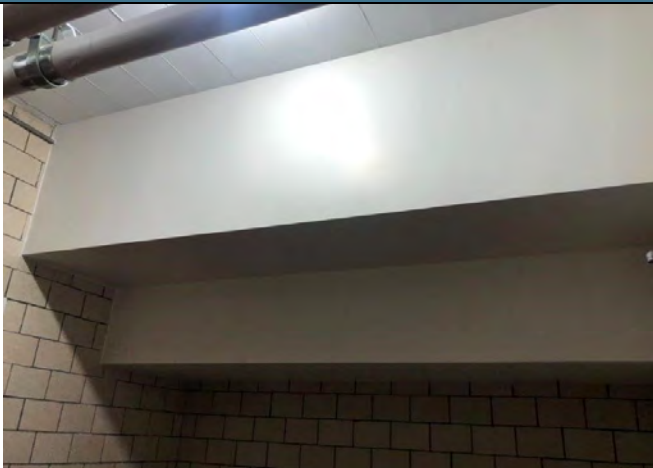
Photograph #40

Homogenous Material Description
HA-40: Wallboard system
Asbestos Present (Yes/No/Assumed)
No
Total Quantity Present
2535 SF
Additional Notes

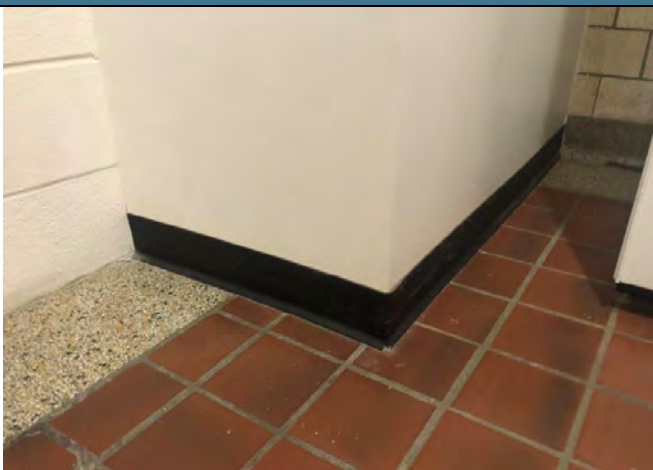
Photograph #41

Homogenous Material Description
HA-41: 4" black cove base, adhesive
Asbestos Present (Yes/No/Assumed)
No
Total Quantity Present
1315 LF
Additional Notes

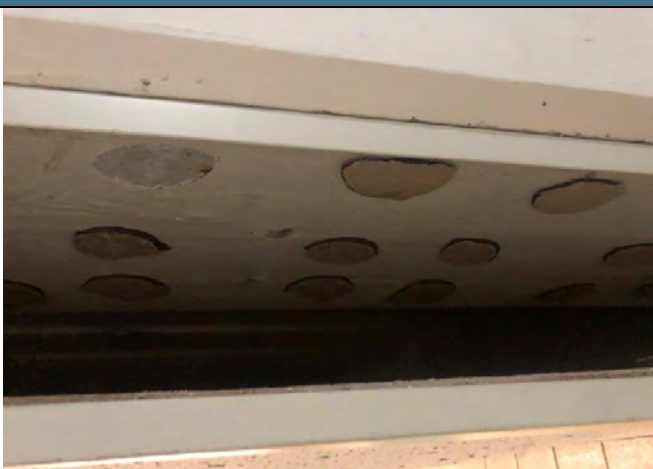
Photograph #42

Homogenous Material Description
HA-42: Glue pod, brown
Asbestos Present (Yes/No/Assumed)
No
Total Quantity Present
285 SF
Additional Notes

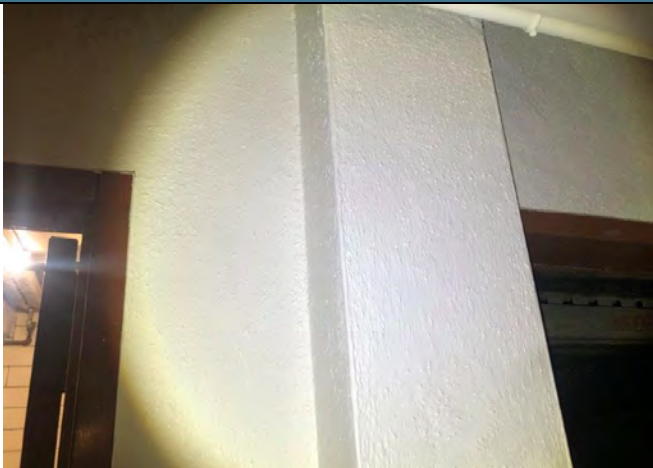
Photograph #43

Homogenous Material Description
HA-43: Textured plaster - walls
Asbestos Present (Yes/No/Assumed)
No
Total Quantity Present
4470 SF
Additional Notes

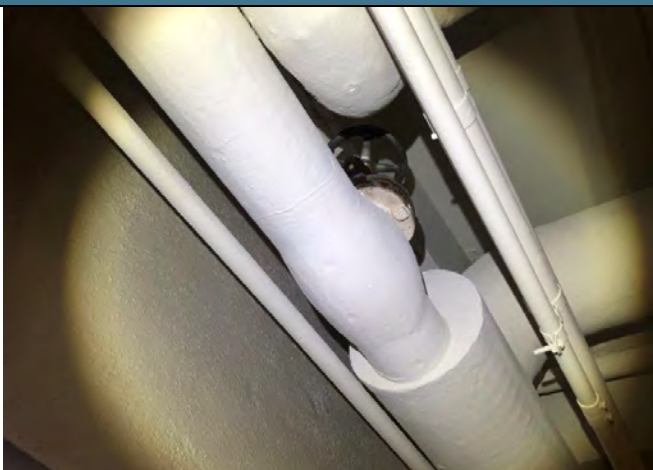
Photograph #44

Homogenous Material Description
HA-44: Magnesia pipe insulation
Asbestos Present (Yes/No/Assumed)
Yes, 30% Chrysotile
Total Quantity Present
985 LF
Additional Notes

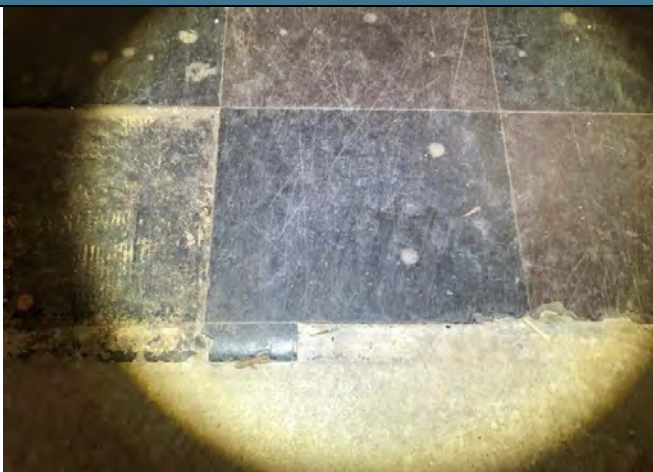
Photograph #50

Homogenous Material Description
HA-50: 9" black floor tile, black mastic
Asbestos Present (Yes/No/Assumed)
Yes, FT: 2% Chrysotile Mastic: ND
Total Quantity Present
210 SF
Additional Notes

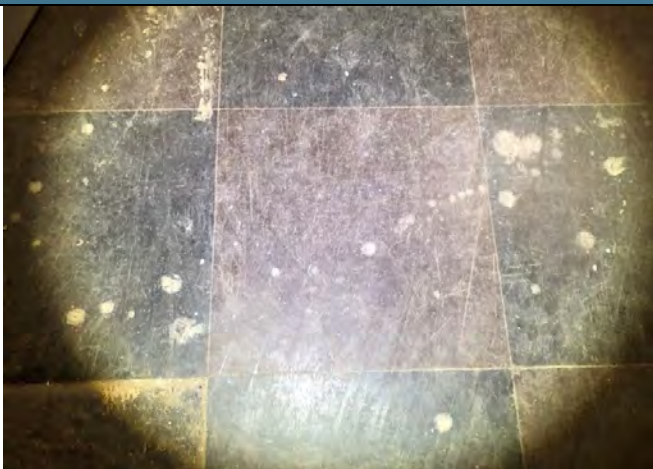
Photograph #51

Homogenous Material Description
HA-51: 9" dark brown tile, black mastic
Asbestos Present (Yes/No/Assumed)
Yes, FT: 2% Chrysotile Mastic: ND
Total Quantity Present
210 SF
Additional Notes

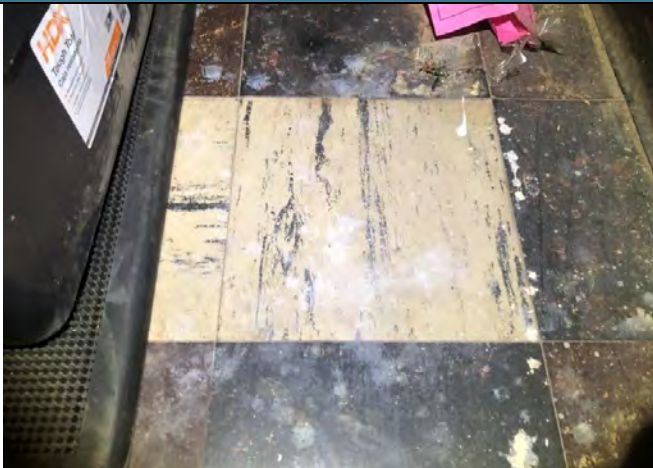
Photograph #52

Homogenous Material Description
HA-52: 9" grey floor tile, black mastic
Asbestos Present (Yes/No/Assumed)
Yes, FT: 7% Chrysotile Mastic: ND
Total Quantity Present
210 SF
Additional Notes

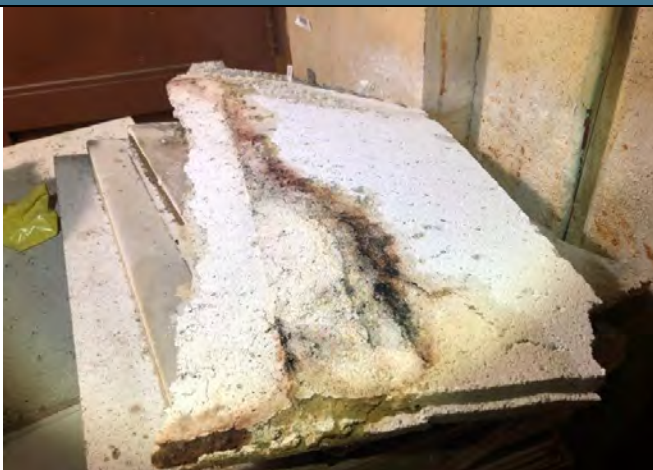
Photograph #53

Homogenous Material Description
HA-53: rough texture ceiling panel
Asbestos Present (Yes/No/Assumed)
No
Total Quantity Present
45 SF
Additional Notes

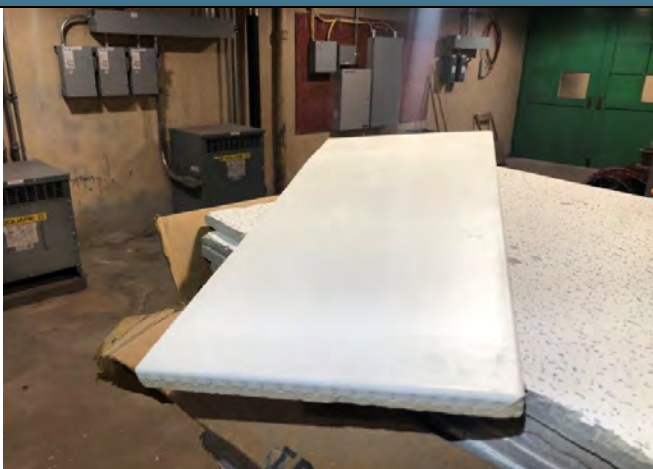
Photograph #54

Homogenous Material Description
HA-54: Metal covered ceiling panel
Asbestos Present (Yes/No/Assumed)
No
Total Quantity Present
10 SF
Additional Notes

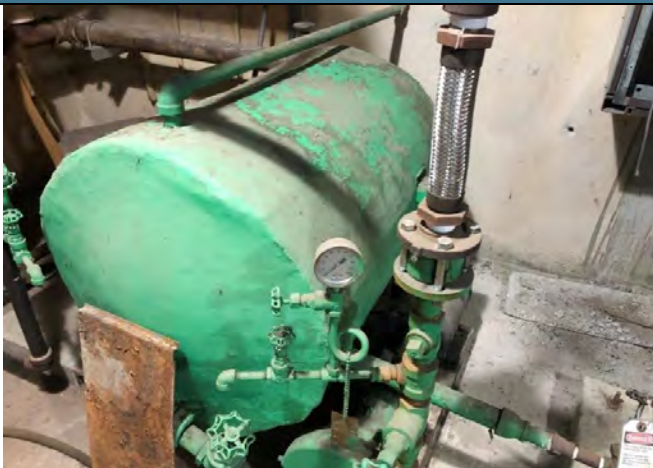
Photograph #59

Homogenous Material Description
HA-59: Tank insulation
Asbestos Present (Yes/No/Assumed)
Yes, 30% Chrysotile
Total Quantity Present
1 Tank (45 SF)
Additional Notes

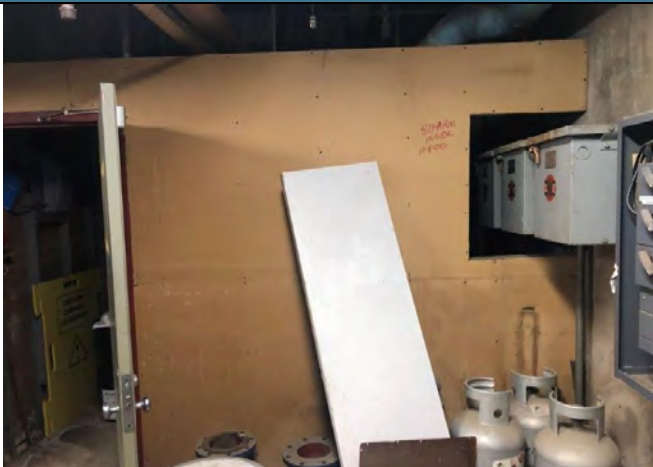
Photograph #60

Homogenous Material Description
HA-60: Wallboard walls
Asbestos Present (Yes/No/Assumed)
No
Total Quantity Present
135 SF
Additional Notes

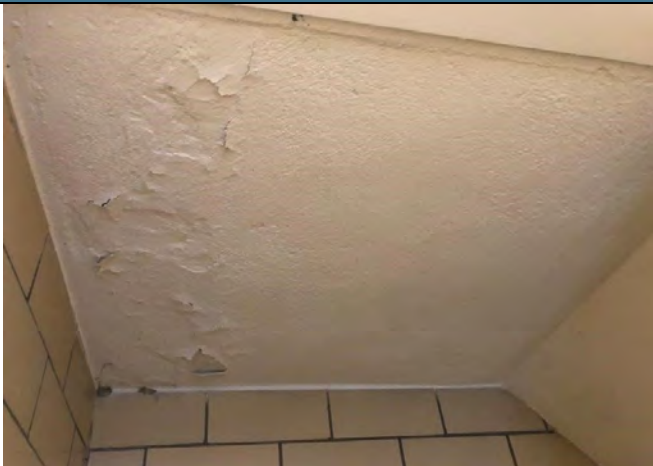
Photograph #61

Homogenous Material Description
HA-61: Textured plaster – rough ceiling
Asbestos Present (Yes/No/Assumed)
Yes, 3% Chrysotile
Total Quantity Present
180 SF
Additional Notes

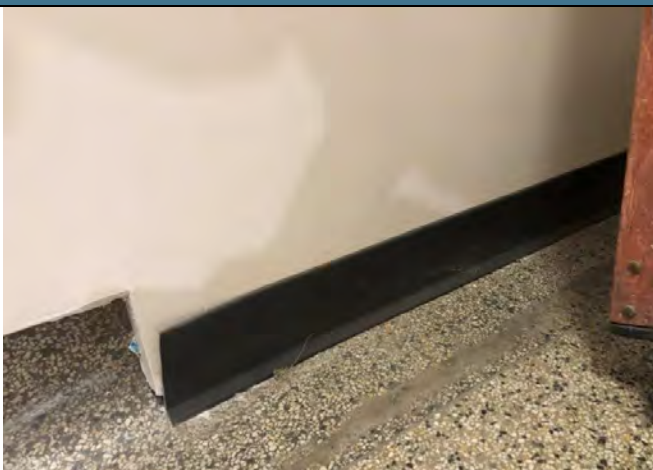
Photograph #62

Homogenous Material Description
HA-62: 4" grey cove base, adhesive
Asbestos Present (Yes/No/Assumed)
No
Total Quantity Present
20 LF
Additional Notes

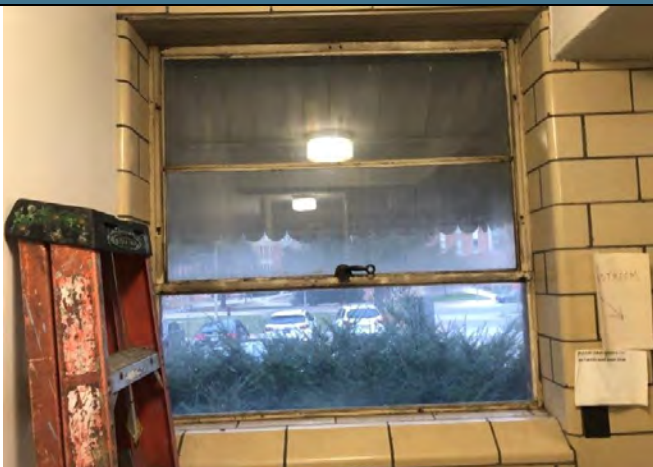
Photograph #63

Homogenous Material Description
HA-63: Grey caulk, window frame perimeter
Asbestos Present (Yes/No/Assumed)
Point Count: 2.25% Chrysotile
Total Quantity Present
570 LF
Additional Notes

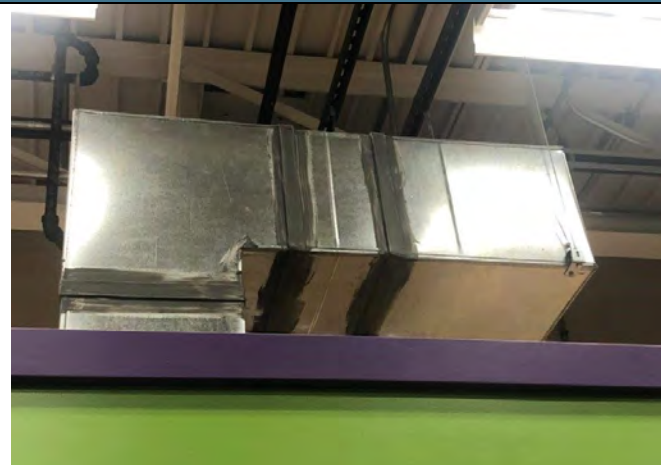
Photograph #75

Homogenous Material Description
HA-75: Grey duct caulk
Asbestos Present (Yes/No/Assumed)
No
Total Quantity Present
18 SF
Additional Notes

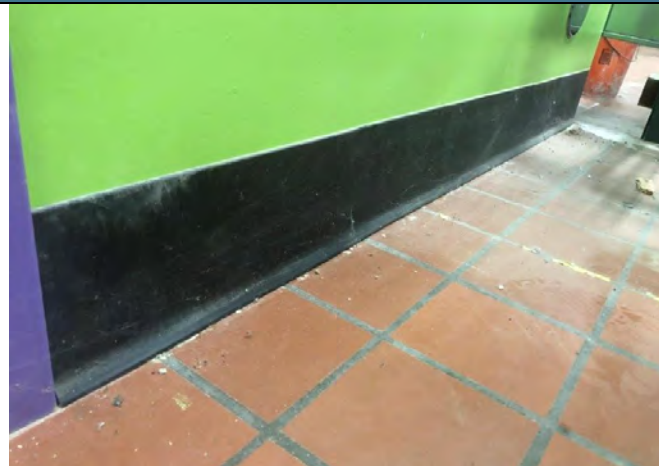
Photograph #76

Homogenous Material Description
HA-76: 6" black cove base, adhesive
Asbestos Present (Yes/No/Assumed)
No
Total Quantity Present
40 LF
Additional Notes

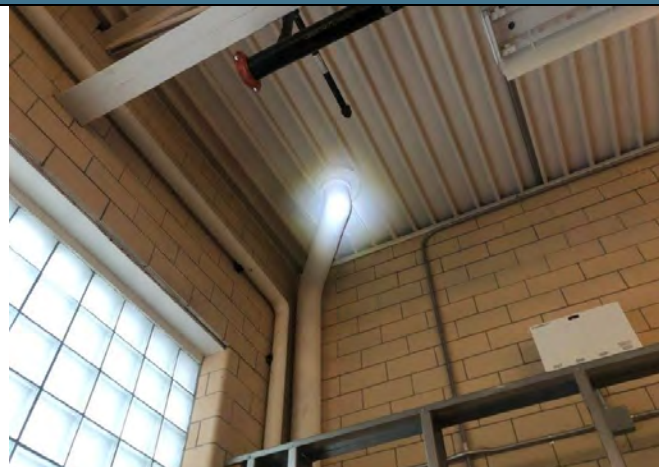
Photograph #78

Homogenous Material Description
HA-78: Roof drain fitting
Asbestos Present (Yes/No/Assumed)
Assumed
Total Quantity Present
1 Fitting
Additional Notes

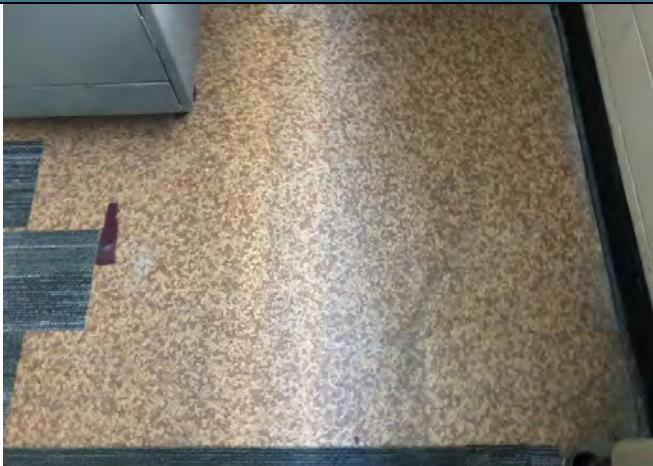
Photograph #79

Homogenous Material Description
HA-79: Floor sheeting, brown vinyl
Asbestos Present (Yes/No/Assumed)
Yes, 15% Chrysotile
Total Quantity Present
265 SF
Additional Notes

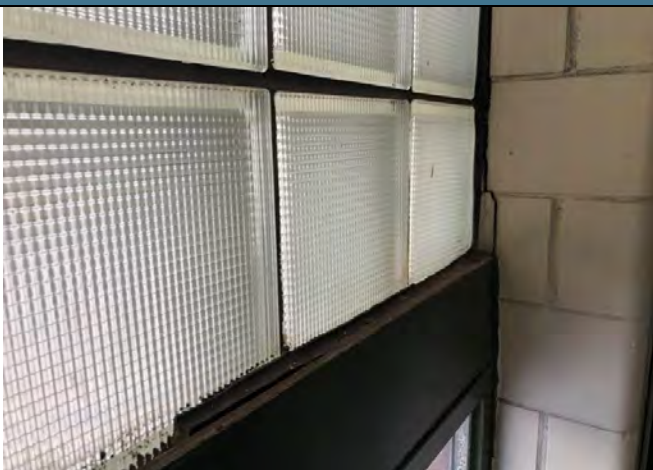
Photograph #80

Homogenous Material Description
HA-80: Brown caulk, perimeter of glass block
Asbestos Present (Yes/No/Assumed)
Point Count: 1.75% Chrysotile
Total Quantity Present
390 LF
Additional Notes

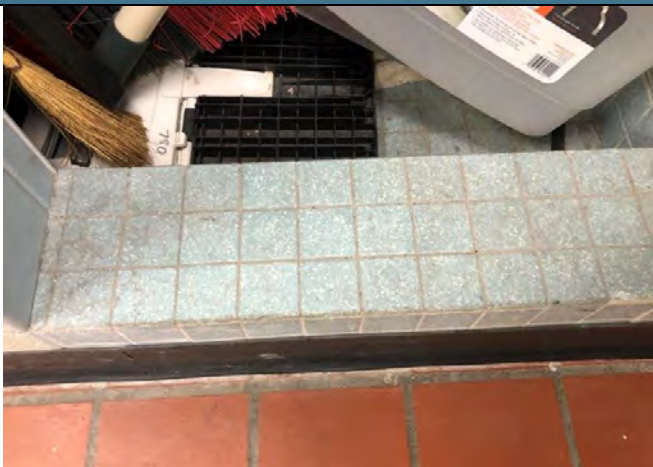
Photograph #81

Homogenous Material Description
HA-81: 2" blue ceramic floor tile, grout, mortar
Asbestos Present (Yes/No/Assumed)
No
Total Quantity Present
25 SF
Additional Notes

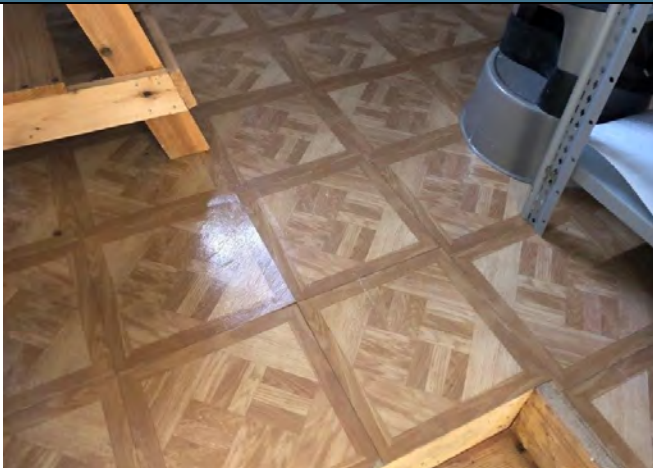
Photograph #88

Homogenous Material Description
HA-88: 12" wood pattern stick-on floor tile
Asbestos Present (Yes/No/Assumed)
No
Total Quantity Present
100 SF
Additional Notes

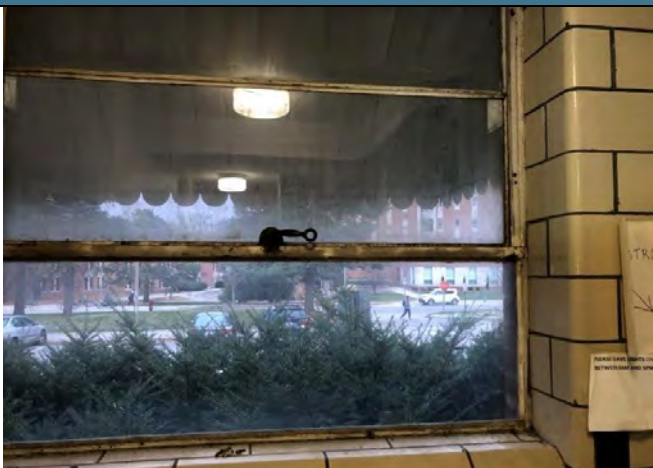
Photograph #89

Homogenous Material Description
HA-89: Beige window glaze, window interior
Asbestos Present (Yes/No/Assumed)
No
Total Quantity Present
6 Windows
Additional Notes

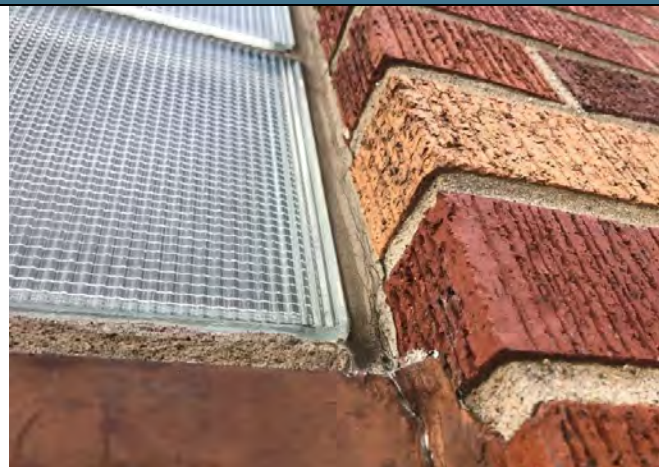
Photograph #96

Homogenous Material Description
HA-96: Grey caulk, perimeter of glass block
Asbestos Present (Yes/No/Assumed)
No
Total Quantity Present
465 LF
Additional Notes

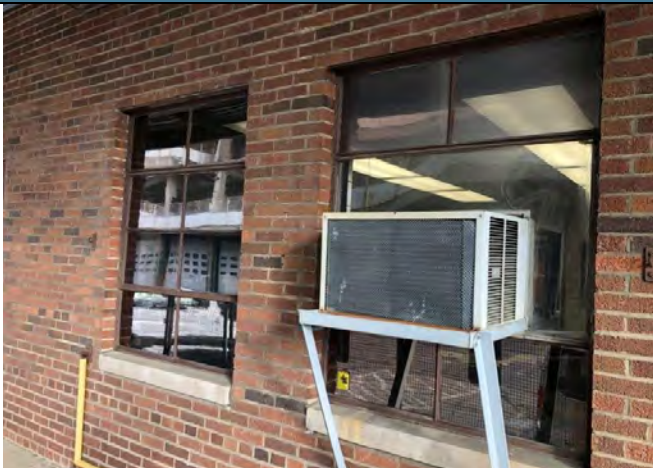
Photograph #97

Homogenous Material Description
HA-97: Window glaze, multi-pane steel windows
Asbestos Present (Yes/No/Assumed)
Point Count: 0.25% Chrysotile
Total Quantity Present
1060 LF
Additional Notes

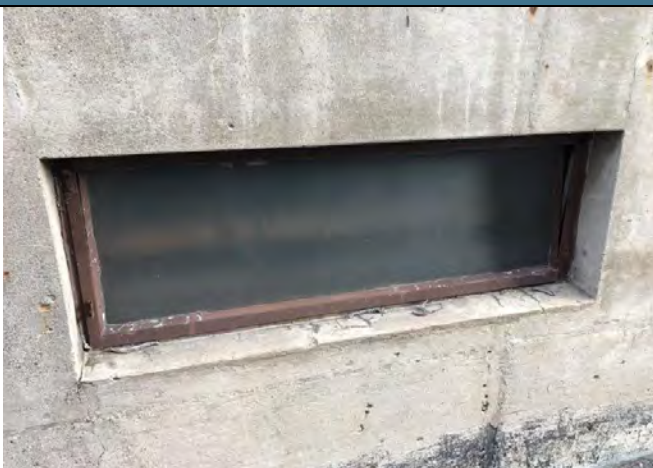
Photograph #98

Homogenous Material Description
HA-98: Window glaze – basement windows
Asbestos Present (Yes/No/Assumed)
Point Count: 0.25% Chrysotile
Total Quantity Present
375 LF
Additional Notes

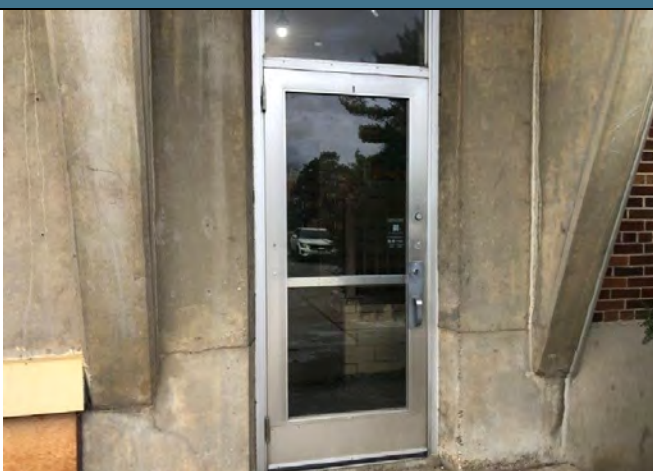
Photograph #99

Homogenous Material Description
HA-99: Metal door window glaze, grey
Asbestos Present (Yes/No/Assumed)
No
Total Quantity Present
15 LF
Additional Notes

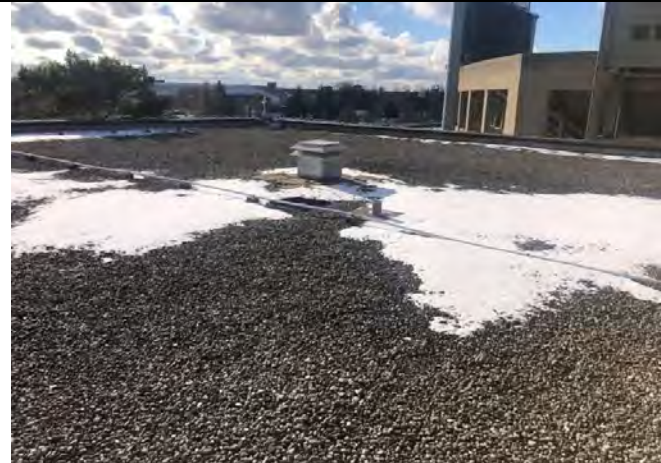
Photograph #105

Homogenous Material Description
HA-105: Flat rubber membrane roofing materials
Asbestos Present (Yes/No/Assumed)
No
Total Quantity Present
24300 SF
Additional Notes

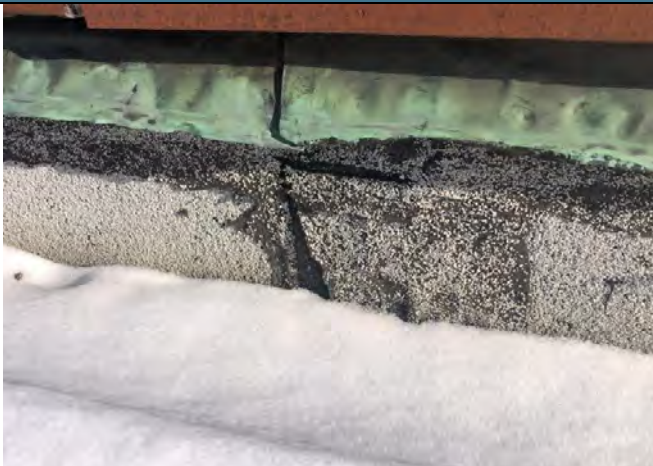
Photograph #109

Homogenous Material Description
HA-109: Black caulk, on parapet wall
Asbestos Present (Yes/No/Assumed)
No
Total Quantity Present
780 SF
Additional Notes

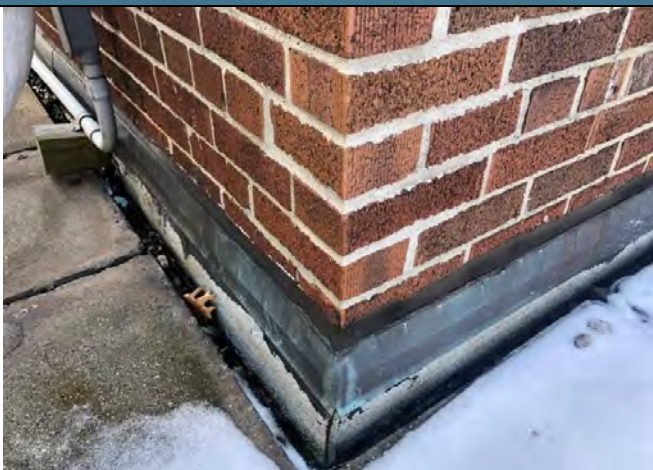
Photograph #110

Homogenous Material Description
HA-110: Black caulk on penthouse flashing
Asbestos Present (Yes/No/Assumed)
No
Total Quantity Present
60 LF
Additional Notes

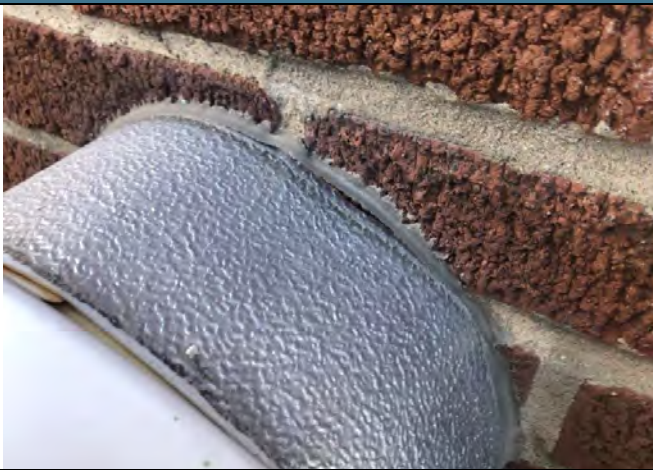
Photograph #113

Homogenous Material Description
HA-113: grey caulk on metal pipe
Asbestos Present (Yes/No/Assumed)
No
Total Quantity Present
25 LF
Additional Notes

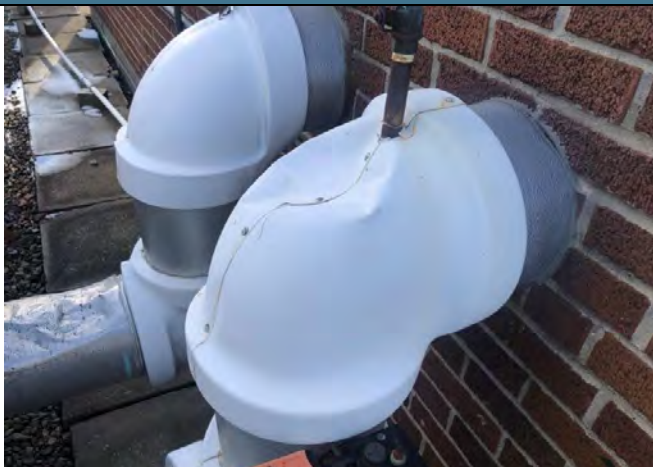
Photograph #114

Homogenous Material Description
HA-114: white caulk on plastic pipe fittings
Asbestos Present (Yes/No/Assumed)
No
Total Quantity Present
15 LF
Additional Notes

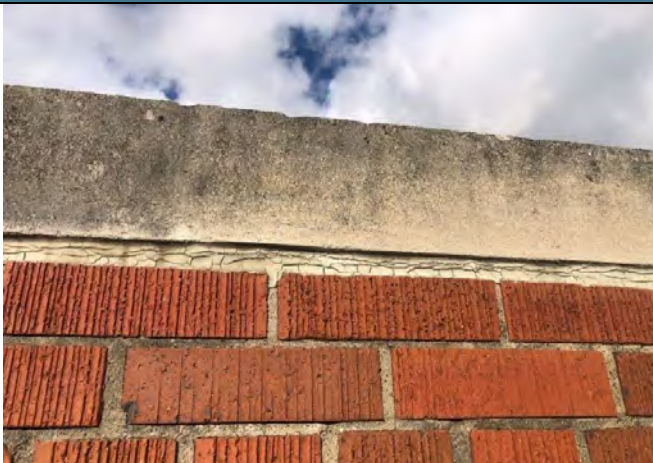
Photograph #117

Homogenous Material Description
HA-117: Dark grey caulk, under capstone
Asbestos Present (Yes/No/Assumed)
Yes, 10% Chrysotile
Total Quantity Present
400 SF
Additional Notes

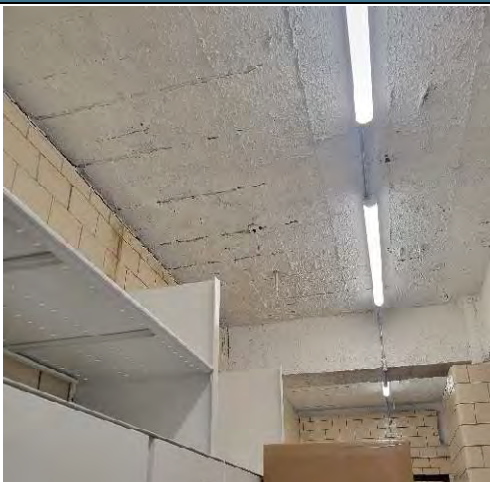
Photograph #123

Homogenous Material Description
HA-123: Cork insulation, remnants (cork & cork adhesive on concrete).
Asbestos Present (Yes/No/Assumed)
No
Total Quantity Present
14106 SF
Additional Notes
Black paper layer (ACM layer) & several inches of cork (HA-24) were previously removed in abatement project.

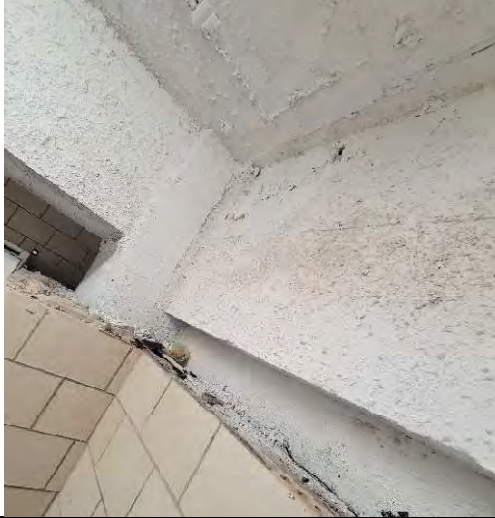
Photograph #124

Homogenous Material Description
	HA-124: Black asphaltic layer, remnant pieces, at top of interior perimeter walls in select areas
	Asbestos Present (Yes/No/Assumed)
	Yes, 4% Chrysotile
	Total Quantity Present
	120 SF
	Additional Notes
	Associated with HA-123 (and HA-24 which was previously abated).
