ADDENDUM  
PAGE 1 OF 1

# **PRE-DEMOLITION HAZARDOUS MATERIALS SURVEY REPORT**

## **CENTRAL SERVICES**

570 Red Cedar Road  
East Lansing, MI 48823

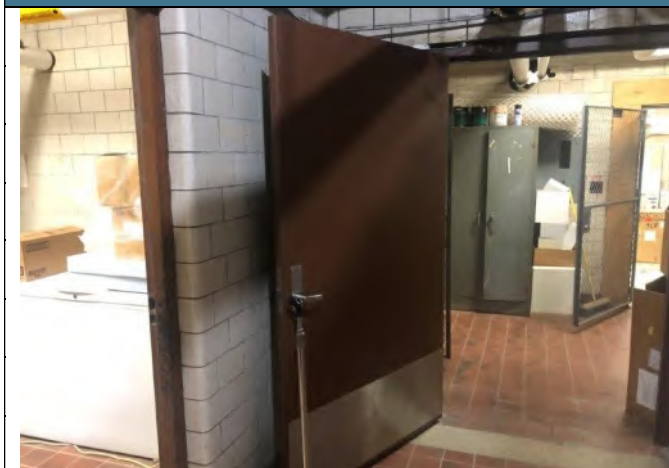
### Photograph #1

HA-1: Metal fire door & frame

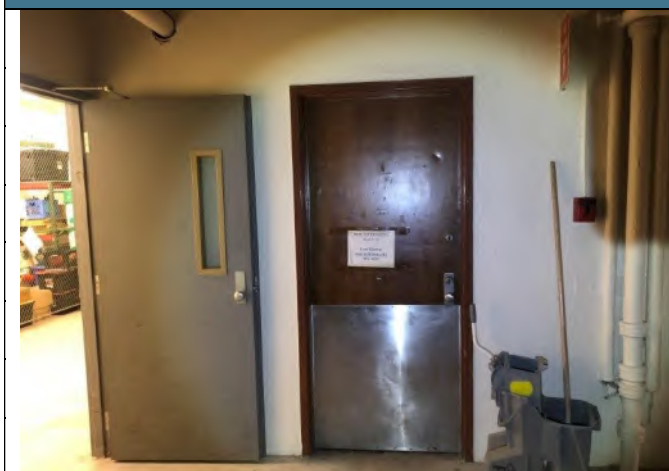
### Photograph #2

HA-2: Wood fire door & frame

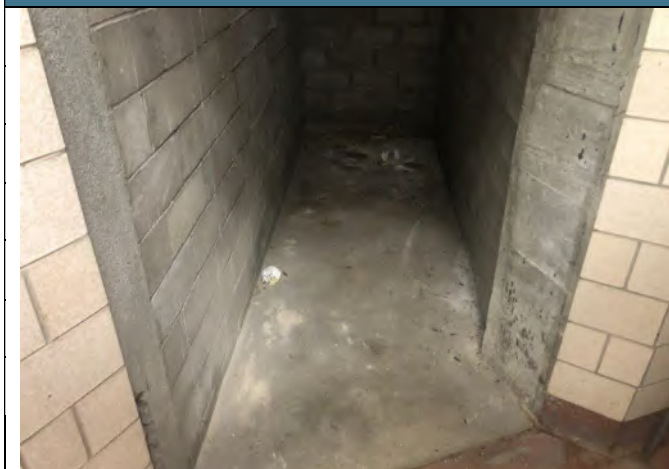
### Photograph #3

HA-3: Concrete foundation / deck

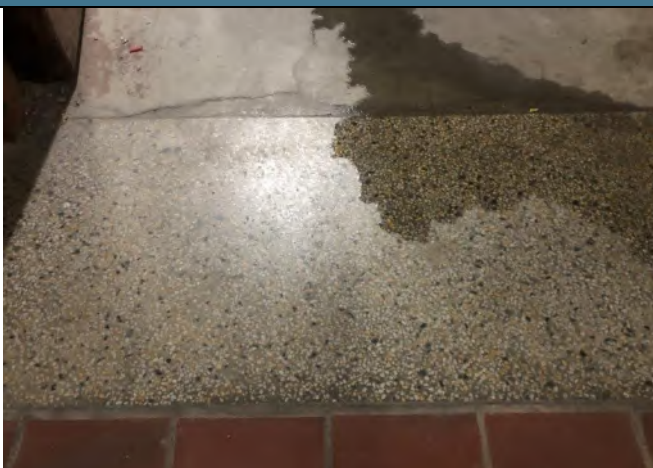
### Photograph #4

HA-4: Terrazzo flooring

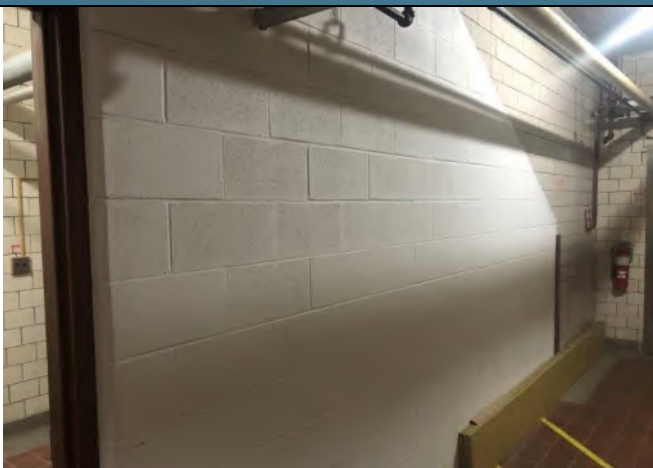
### Photograph #5

HA-5: CMU block mortar

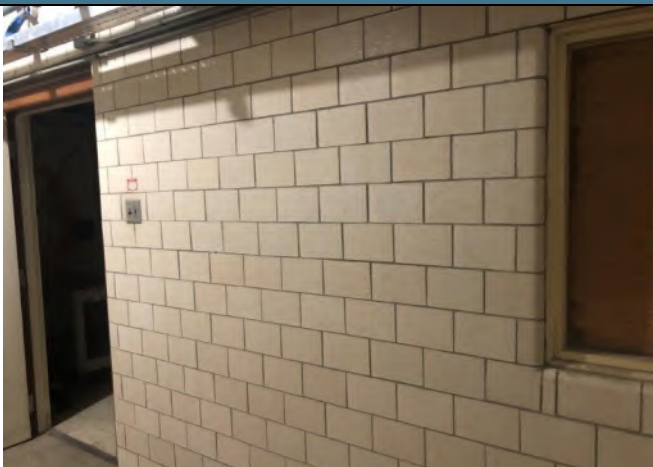
### Photograph #6

HA-6: Grey glazed ceramic block mortar

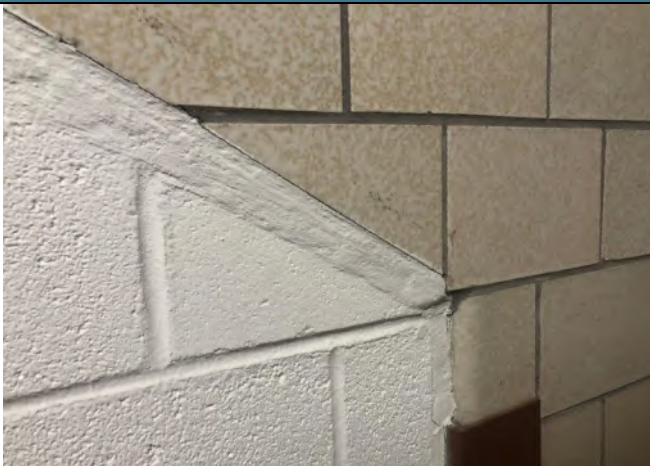
### Photograph #7

HA-7: Skim coat on CMU block

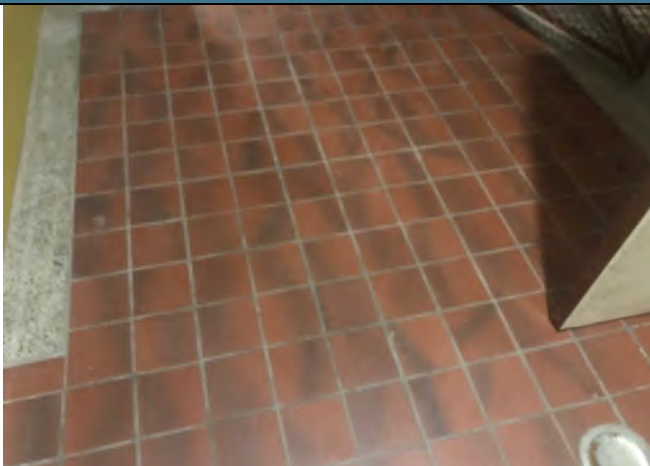
### Photograph #8

HA-8: Red ceramic floor tile, grout, mortar

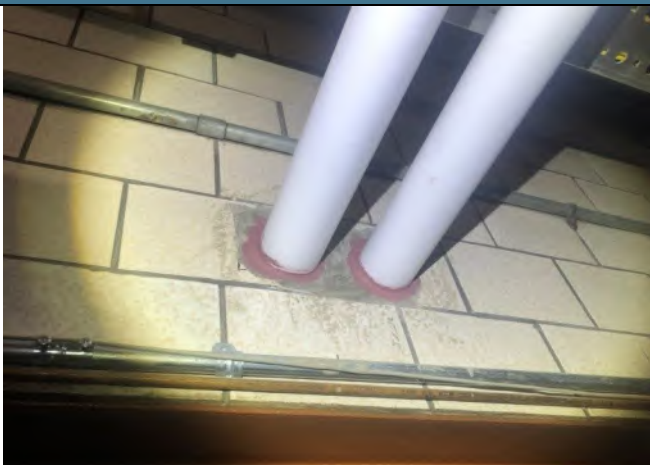
### Photograph #9

HA-9: Red penetration caulk

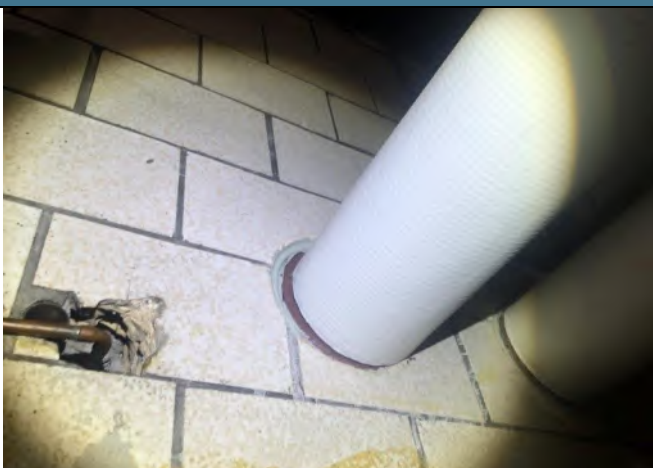
### Photograph #10

Homogenous Material Description
HA-10: Grey penetration caulk
Asbestos Present (Yes/No/Assumed)
No
Total Quantity Present
57 LF
Additional Notes

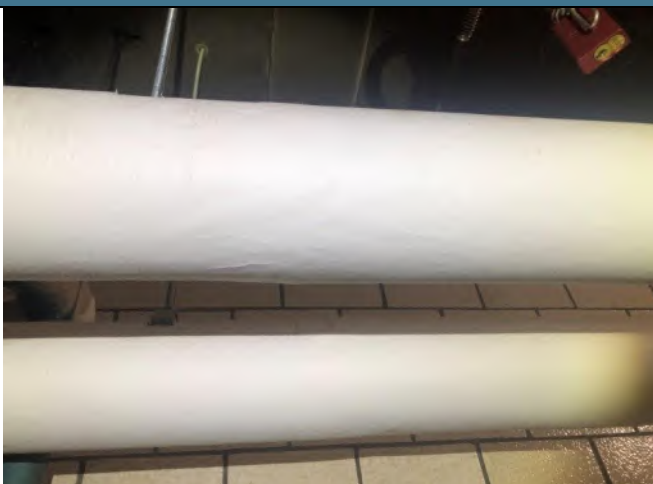
### Photograph #12

Homogenous Material Description
HA-12: White paper wrapped fiberglass pipe insulation
Asbestos Present (Yes/No/Assumed)
No
Total Quantity Present
3410 LF
Additional Notes

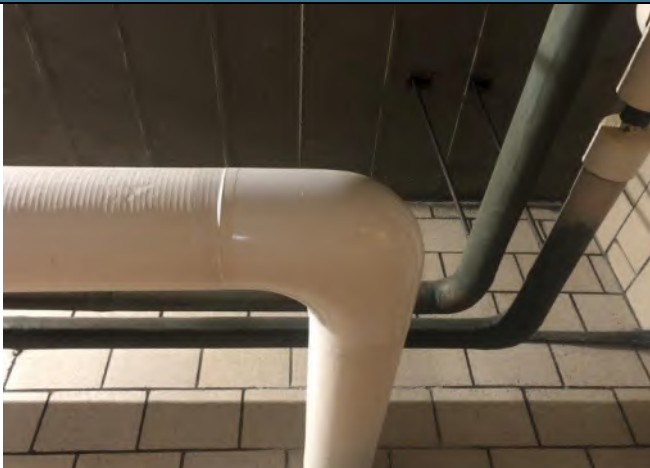
### Photograph #13

HA-13: Plastic covered fiberglass pipe fitting

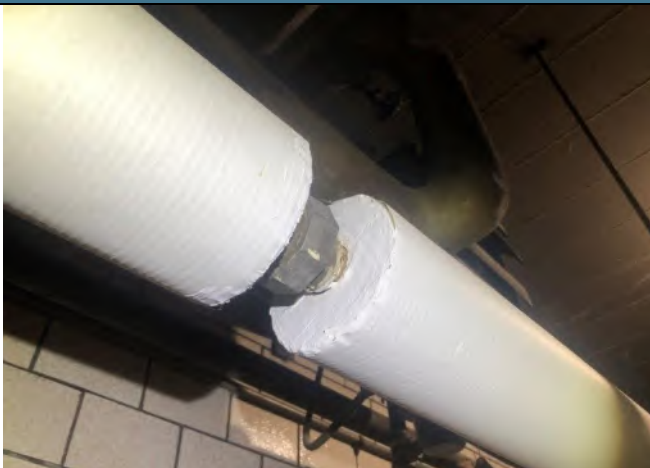
### Photograph #14

HA-14: White caulk on HA-12

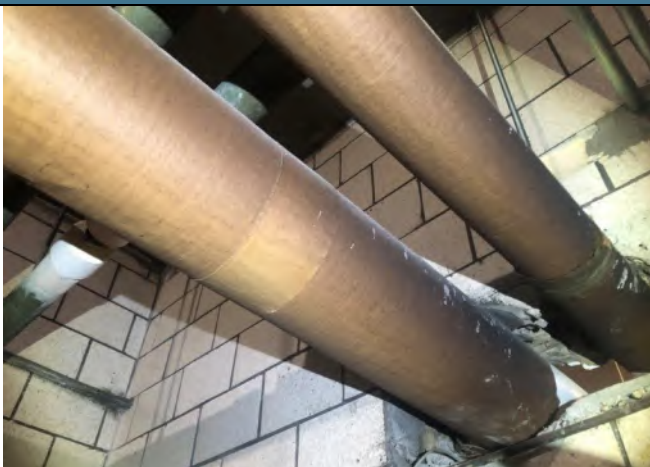
### Photograph #15

HA-15: Brown paper wrapped pipe insulation

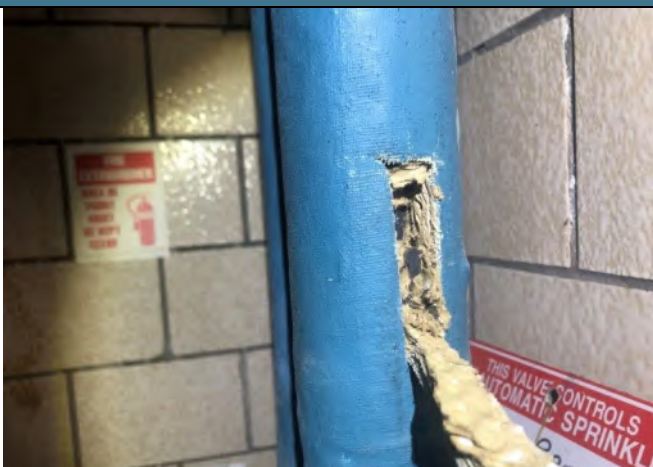
### Photograph #18

Homogenous Material Description
HA-18: Wool felt pipe insulation
Asbestos Present (Yes/No/Assumed)
Yes, 35% Chrysotile
Total Quantity Present
875 LF
Additional Notes

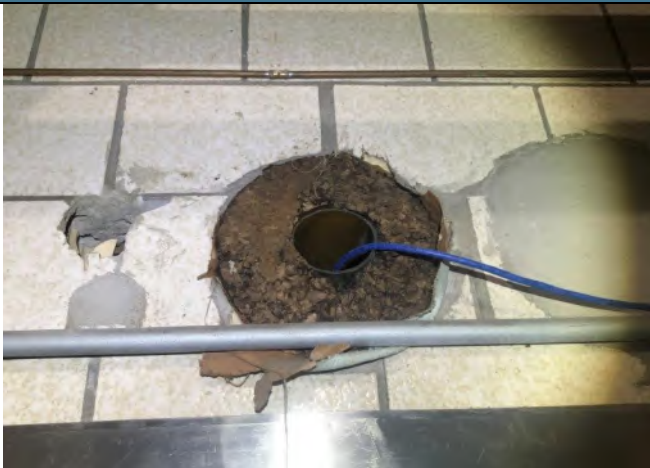
### Photograph #22

HA-22: Cork pipe insulation

Per MSU, mag layer may be hidden under cork

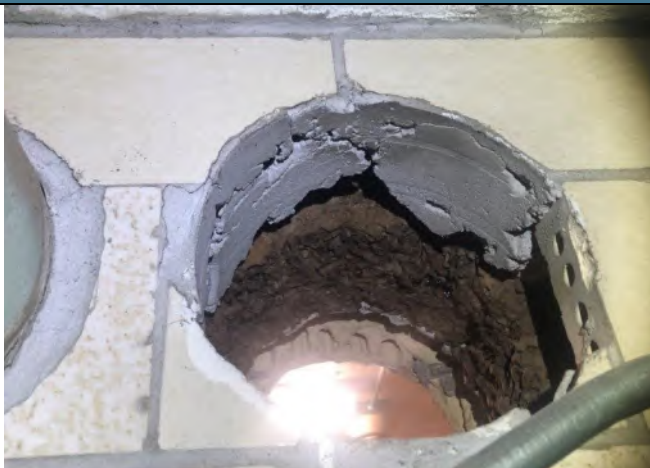
### Photograph #23

HA-23: Cork insulation – wall insulation

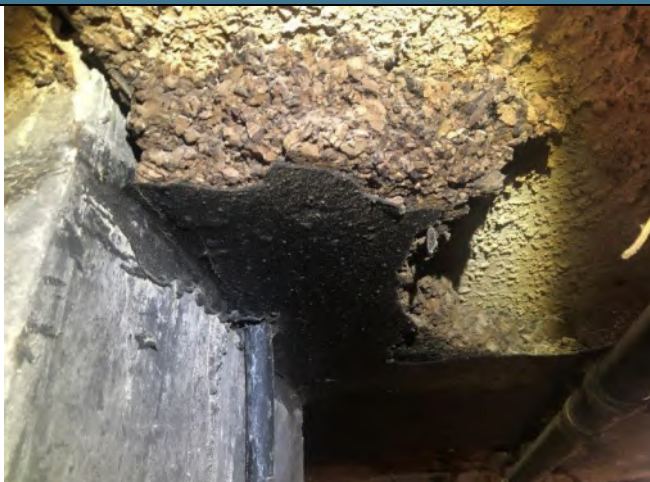
### Photograph #24

HA-24: Remnants of original cork ceiling insulation with outer black paper layer adhered to concrete ceiling (assoc. with HA-32)

Basement Mechanical Room. Associated with HA-32.

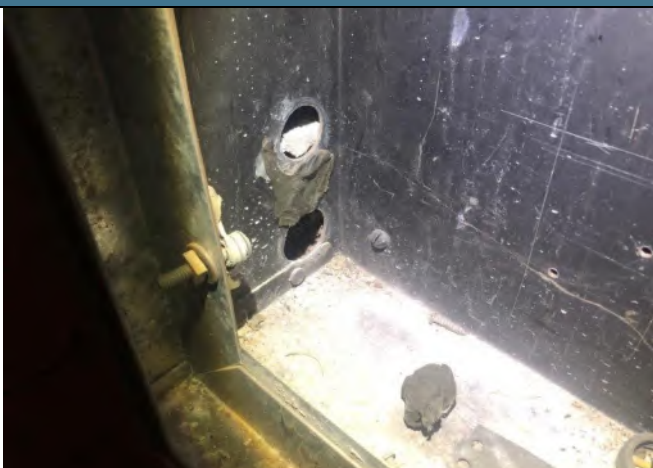
### Photograph #25

Homogenous Material Description
HA-25: Green caulk in electrical box
Asbestos Present (Yes/No/Assumed)
Yes, 10% Chrysotile
Total Quantity Present
10 LF
Additional Notes

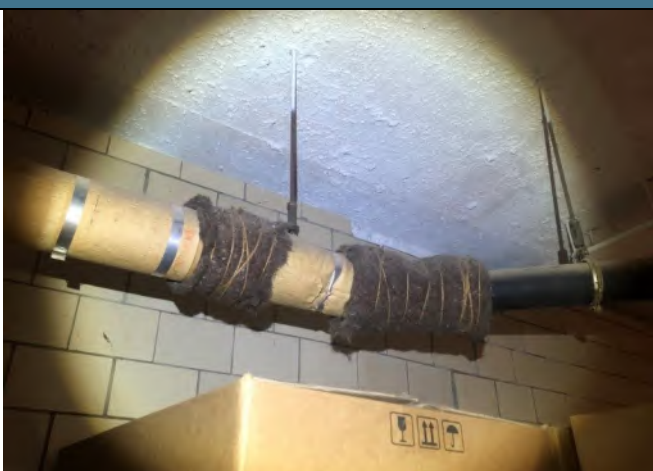
### Photograph #26

Homogenous Material Description
HA-26: Pipe insulation – horse hair
Asbestos Present (Yes/No/Assumed)
No
Total Quantity Present
5 LF
Additional Notes

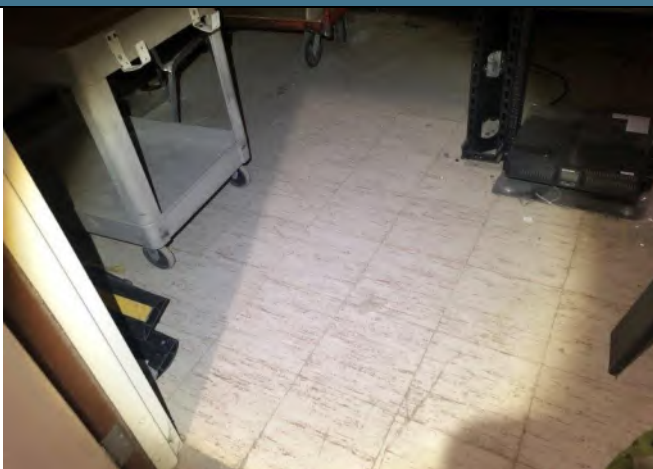
### Photograph #27

Homogenous Material Description
HA-27: 12" beige floor tile, red streaks, mastic
Asbestos Present (Yes/No/Assumed)
No
Total Quantity Present
100 SF
Additional Notes

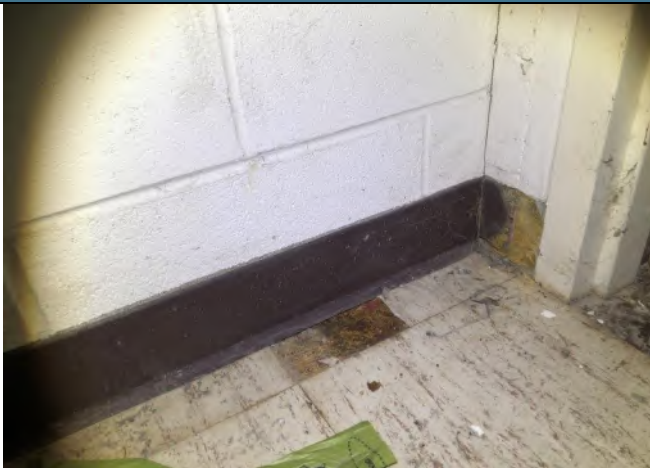
### Photograph #28

HA-28: 4" brown cove base, adhesive

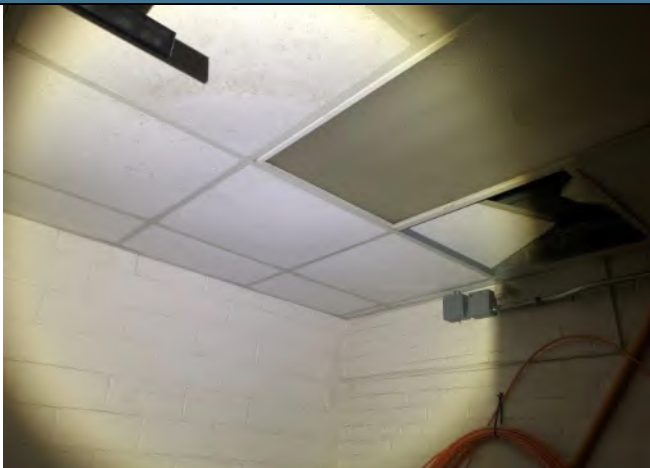
### Photograph #29

HA-29: Ceiling panel – pinhole/fissure

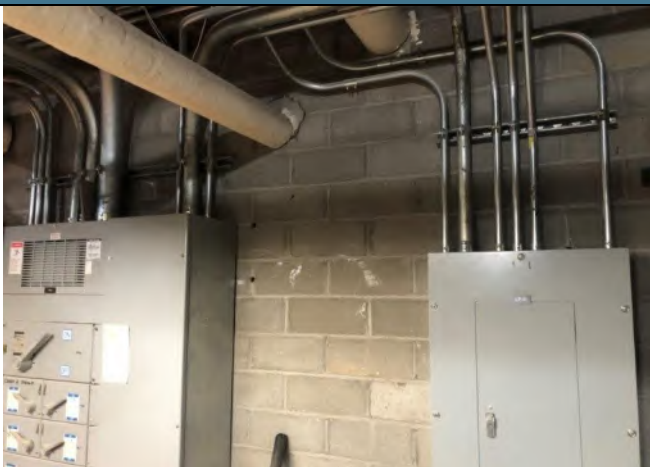
### Photograph #30

HA-30: Brick mortar – 12"x4" concrete brick

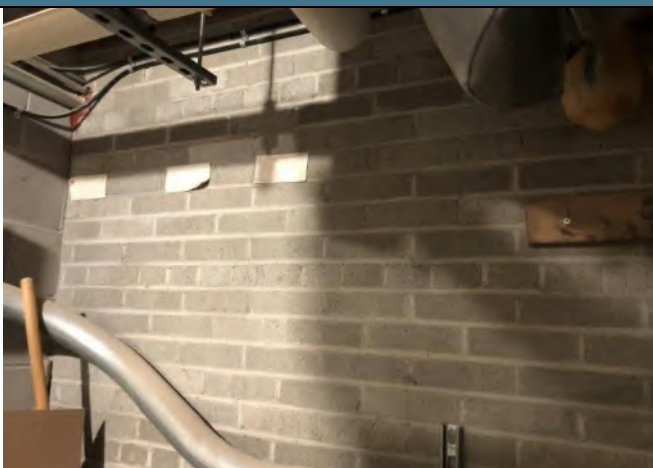
### Photograph #31

Homogenous Material Description
HA-31: Brick mortar – 2"x6" concrete bricks
Asbestos Present (Yes/No/Assumed)
No
Total Quantity Present
200 SF
Additional Notes

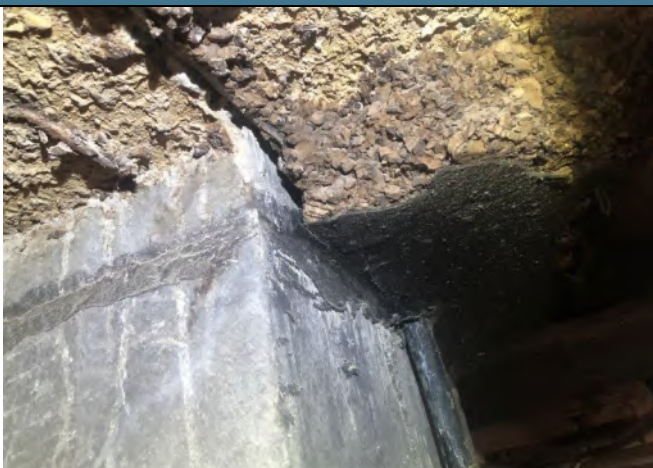
### Photograph #32

Homogenous Material Description
HA-32: Interior caulk (tar), black, perimeter of cork insulation (associated with HA-24)
Asbestos Present (Yes/No/Assumed)
Yes, 3% Chrysotile
Total Quantity Present
160 LF
Additional Notes
Associated with HA-24

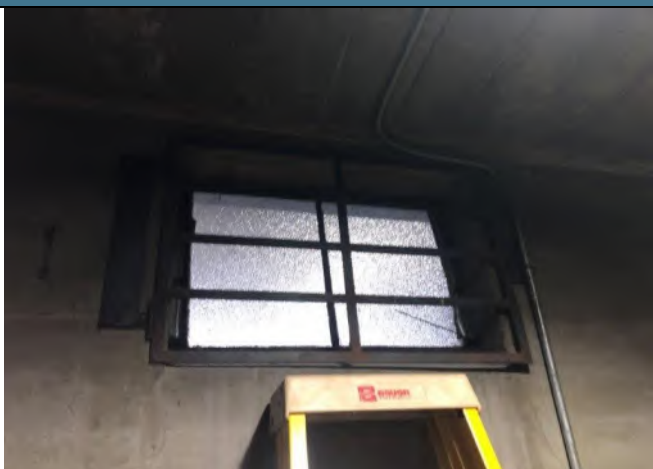
### Photograph #33

Homogenous Material Description
HA-33: Window glaze - grey
Asbestos Present (Yes/No/Assumed)
No
Total Quantity Present
1 Window
Additional Notes

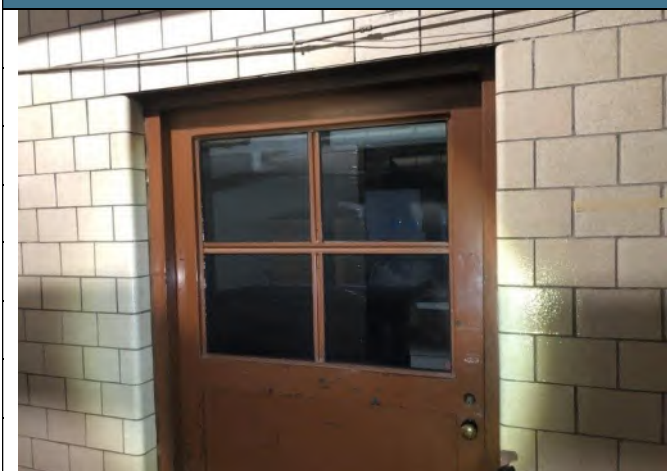
### Photograph #35

Homogenous Material Description
HA-35: Black window glaze
Asbestos Present (Yes/No/Assumed)
No
Total Quantity Present
2 Windows
Additional Notes

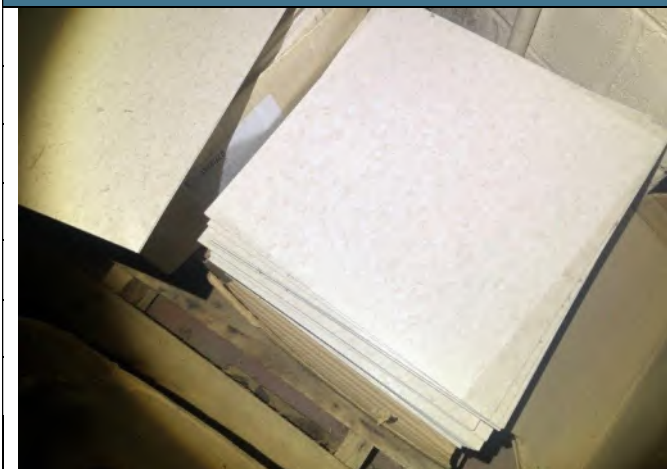
### Photograph #36

Homogenous Material Description
HA-36: 12" brown mottle
Asbestos Present (Yes/No/Assumed)
No
Total Quantity Present
4 boxes
Additional Notes

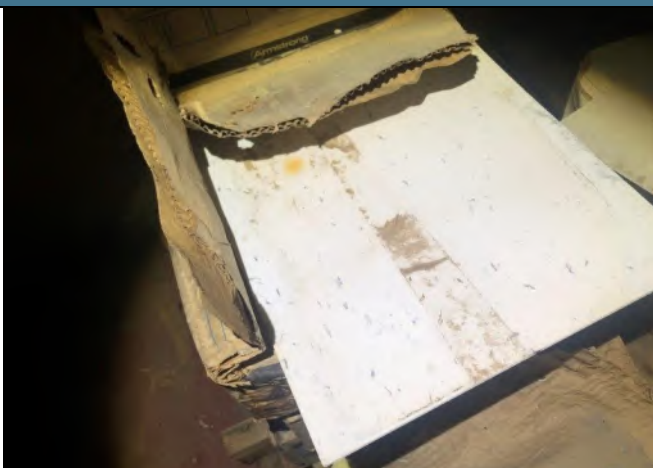
### Photograph #37

Homogenous Material Description
HA-37: 12" white with black streaks floor tile
Asbestos Present (Yes/No/Assumed)
No
Total Quantity Present
6 Boxes
Additional Notes

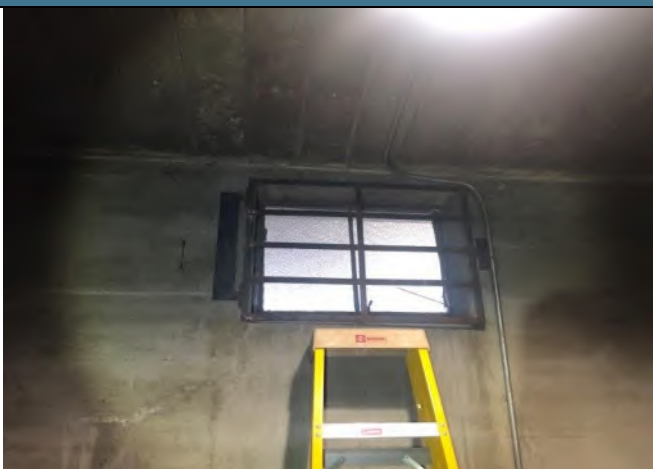
### Photograph #39

Homogenous Material Description
HA-39: Soft grey window glaze
Asbestos Present (Yes/No/Assumed)
No
Total Quantity Present
1 Window
Additional Notes

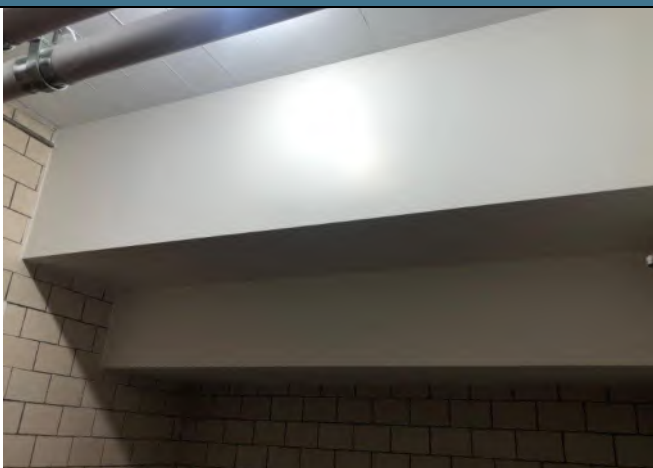
### Photograph #40

Homogenous Material Description
HA-40: Wallboard system
Asbestos Present (Yes/No/Assumed)
No
Total Quantity Present
2535 SF
Additional Notes

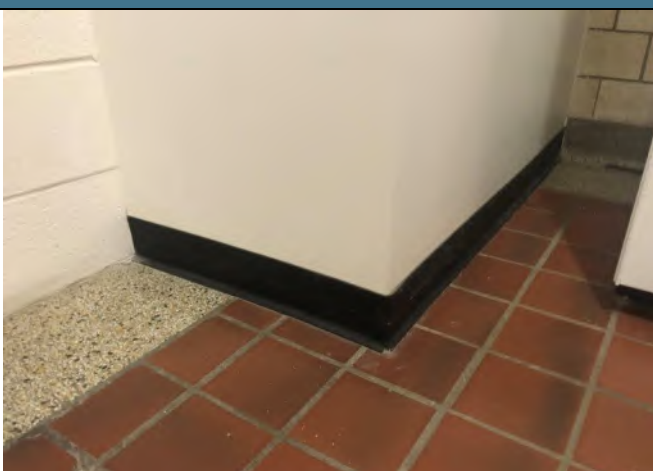
### Photograph #41

Homogenous Material Description
HA-41: 4" black cove base, adhesive
Asbestos Present (Yes/No/Assumed)
No
Total Quantity Present
1315 LF
Additional Notes

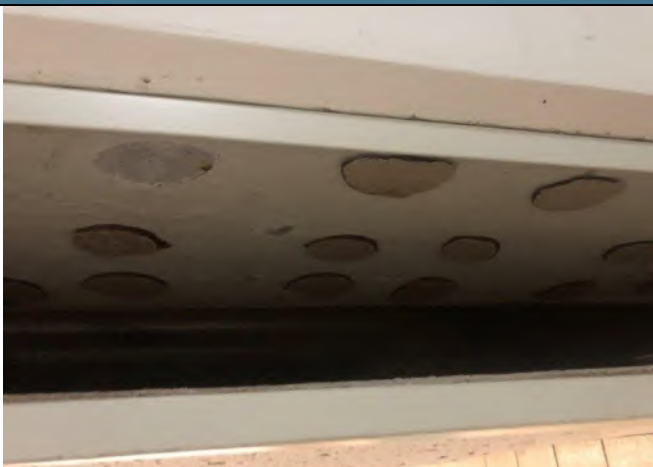
### Photograph #42

Homogenous Material Description
HA-42: Glue pod, brown
Asbestos Present (Yes/No/Assumed)
No
Total Quantity Present
285 SF
Additional Notes

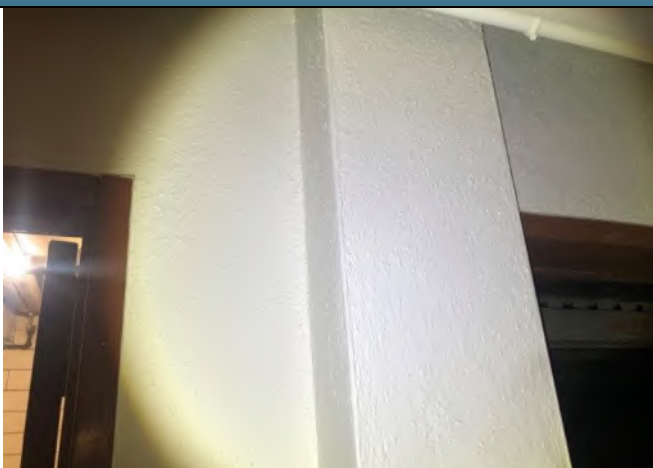
### Photograph #43

Homogenous Material Description
HA-43: Textured plaster - walls
Asbestos Present (Yes/No/Assumed)
No
Total Quantity Present
4470 SF
Additional Notes

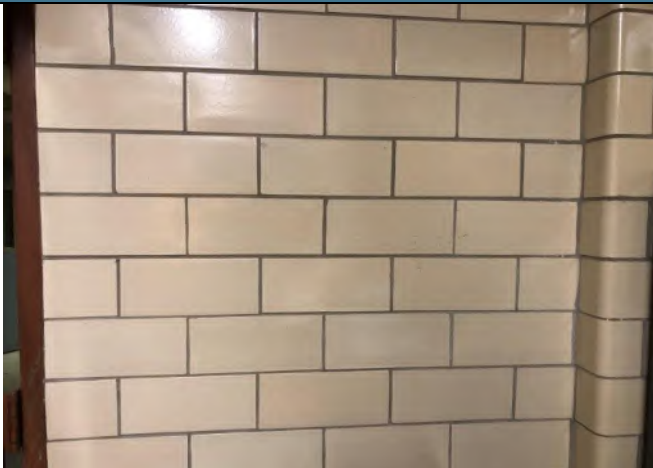
### Photograph #46

HA-46: Beige ceramic block mortar

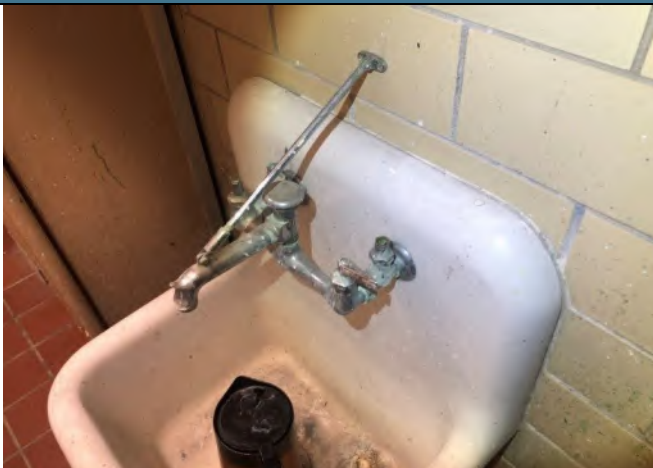
### Photograph #47

HA-47: White caulk on restroom fixtures

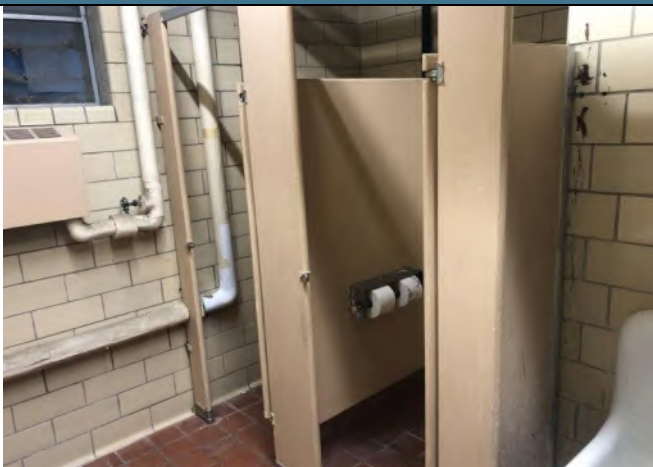
### Photograph #48

HA-48: Bathroom partition insulation, paper

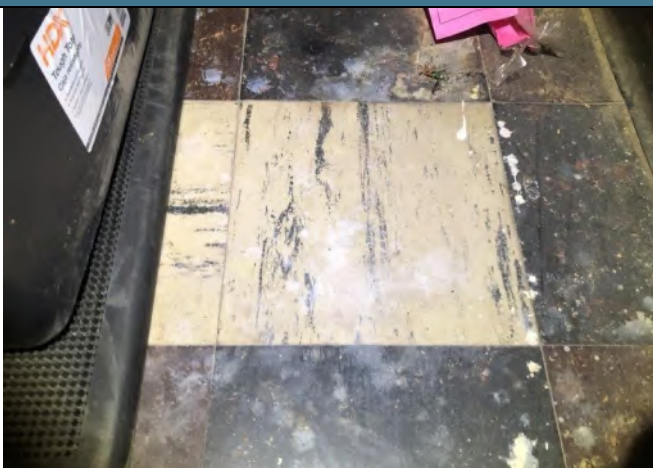
### Photograph #52

Homogenous Material Description
HA-52: 9" grey floor tile, black mastic
Asbestos Present (Yes/No/Assumed)
Yes, FT: 7% Chrysotile Mastic: ND
Total Quantity Present
210 SF
Additional Notes

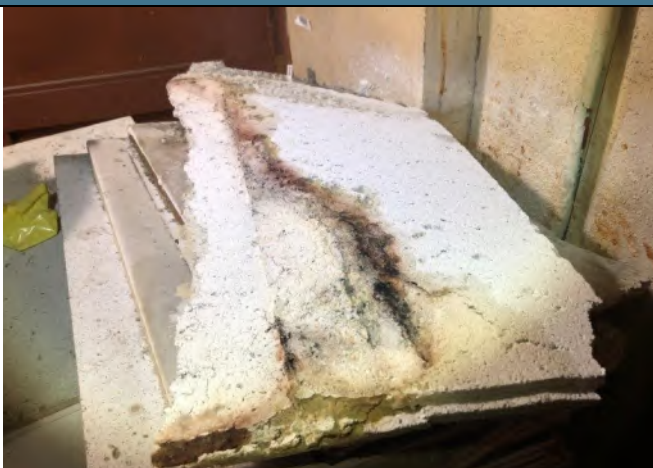
### Photograph #53

Homogenous Material Description
HA-53: rough texture ceiling panel
Asbestos Present (Yes/No/Assumed)
No
Total Quantity Present
45 SF
Additional Notes

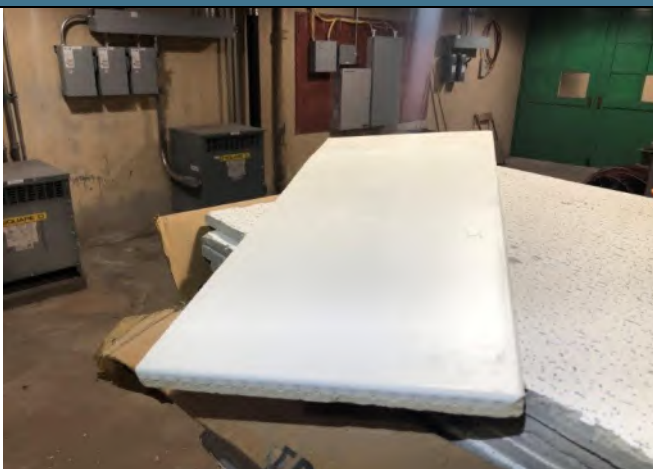
### Photograph #54

Homogenous Material Description
HA-54: Metal covered ceiling panel
Asbestos Present (Yes/No/Assumed)
No
Total Quantity Present
10 SF
Additional Notes

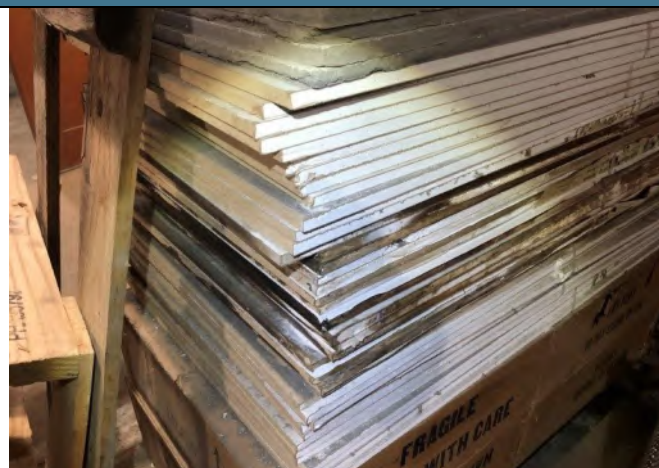
### Photograph #55

Homogenous Material Description
HA-55: vinyl covered wallboard ceiling panel
Asbestos Present (Yes/No/Assumed)
No
Total Quantity Present
956 SF
Additional Notes

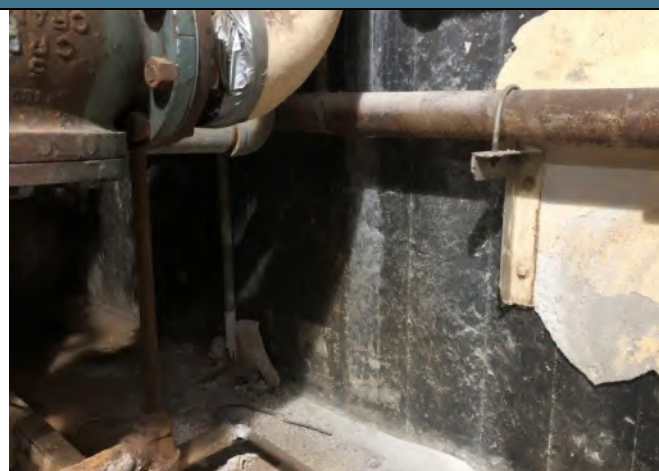
### Photograph #56

Homogenous Material Description
HA-56: Waterproofing spray-on
Asbestos Present (Yes/No/Assumed)
No
Total Quantity Present
1360 SF
Additional Notes

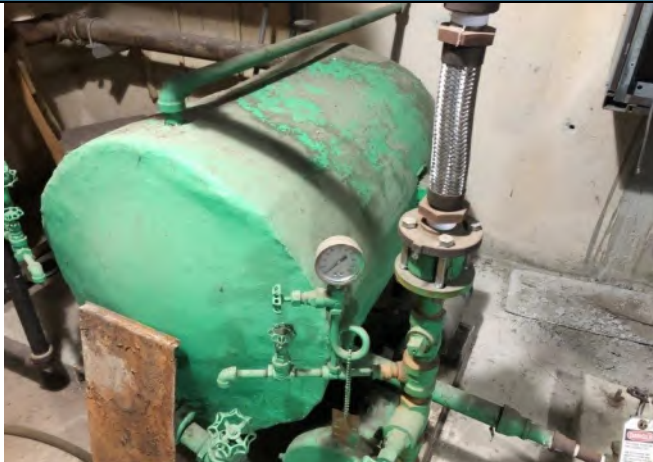
### Photograph #59

Homogenous Material Description
	HA-59: Tank insulation
	Asbestos Present (Yes/No/Assumed)
	Yes, 30% Chrysotile
	Total Quantity Present
	1 Tank (45 SF)
	Additional Notes

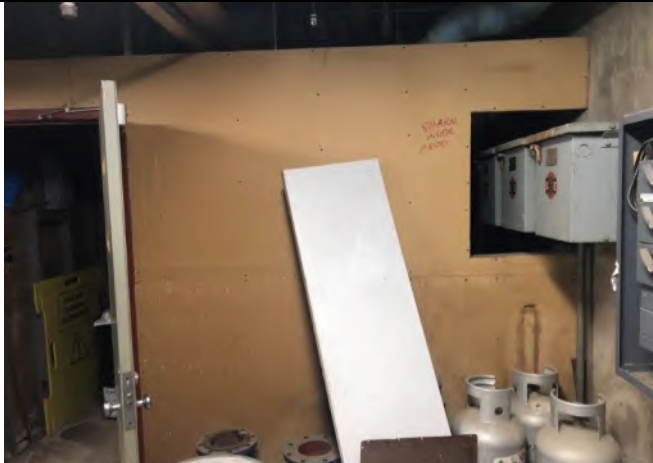
### Photograph #60

Homogenous Material Description
	HA-60: Wallboard walls
	Asbestos Present (Yes/No/Assumed)
	No
	Total Quantity Present
	135 SF
	Additional Notes

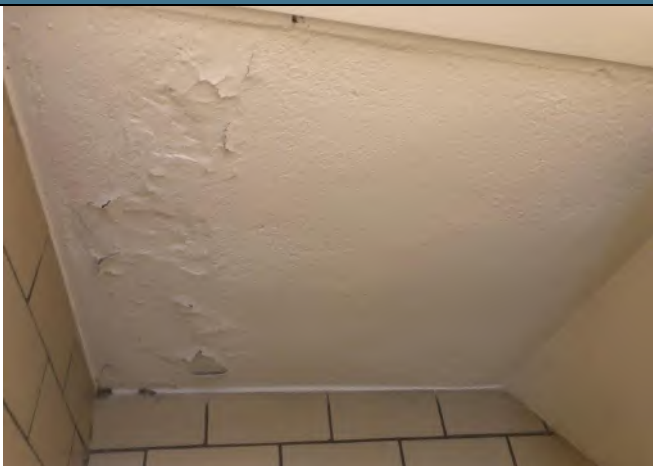
### Photograph #61

Homogenous Material Description
HA-61: Textured plaster – rough ceiling
Asbestos Present (Yes/No/Assumed)
Yes, 3% Chrysotile
Total Quantity Present
180 SF
Additional Notes

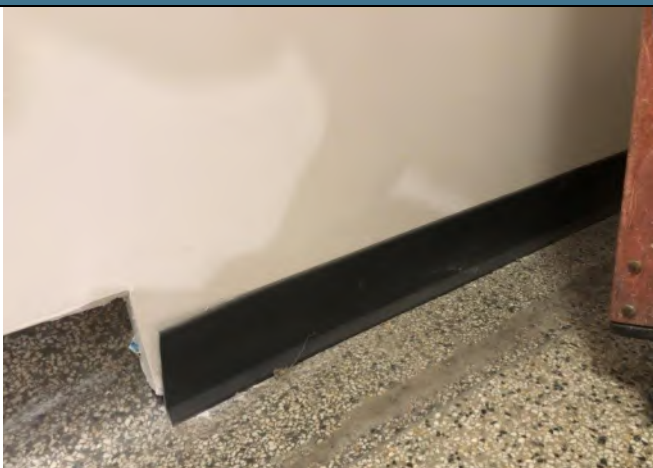
### Photograph #62

Homogenous Material Description
HA-62: 4" grey cove base, adhesive
Asbestos Present (Yes/No/Assumed)
No
Total Quantity Present
20 LF
Additional Notes

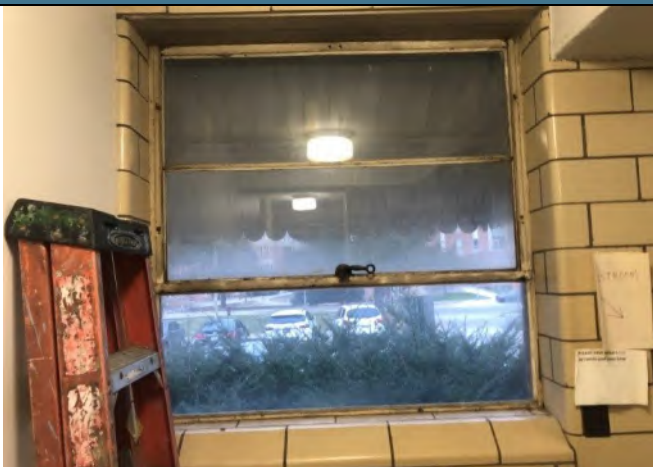
### Photograph #63

Homogenous Material Description
HA-63: Grey caulk, window frame perimeter
Asbestos Present (Yes/No/Assumed)
Point Count: 2.25% Chrysotile
Total Quantity Present
570 LF
Additional Notes

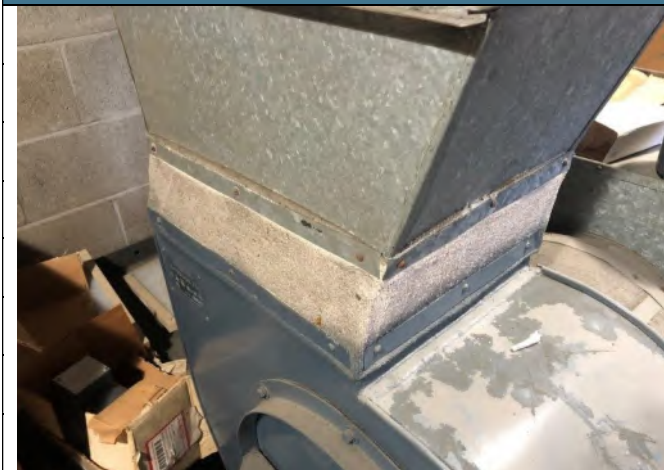
### Photograph #64

HA-64: Vibration dampener – white canvas

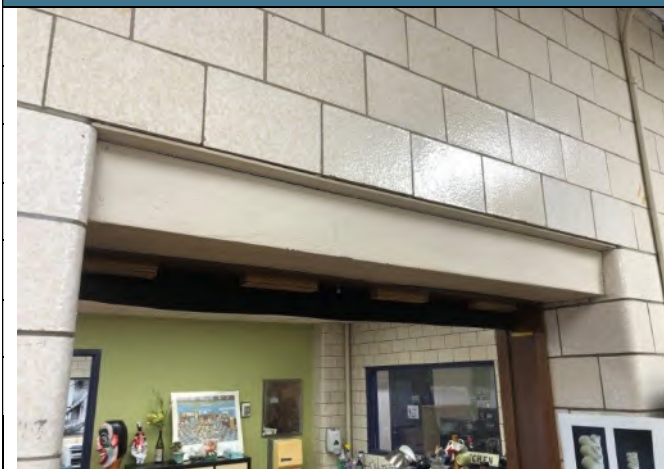
### Photograph #66

HA-66: Textured plaster, door frame

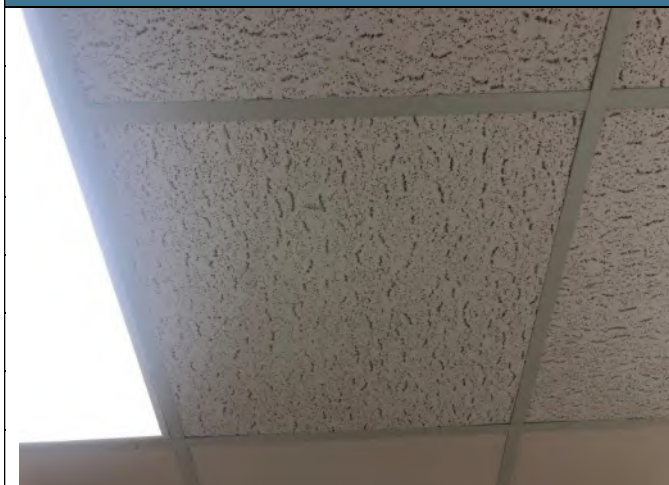
### Photograph #67

Homogenous Material Description
HA-67: Off-white pinhole/large fissure ceiling panel
Asbestos Present (Yes/No/Assumed)
No
Total Quantity Present
1110 SF
Additional Notes

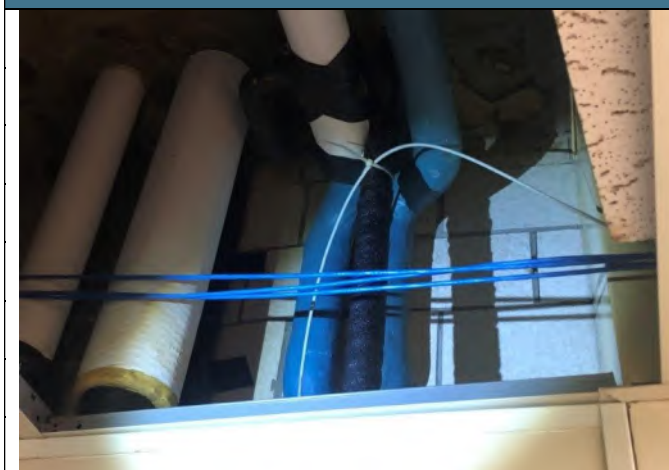
### Photograph #68

Homogenous Material Description
HA-68: Pipe insulation, black tar tape
Asbestos Present (Yes/No/Assumed)
No
Total Quantity Present
5 LF
Additional Notes

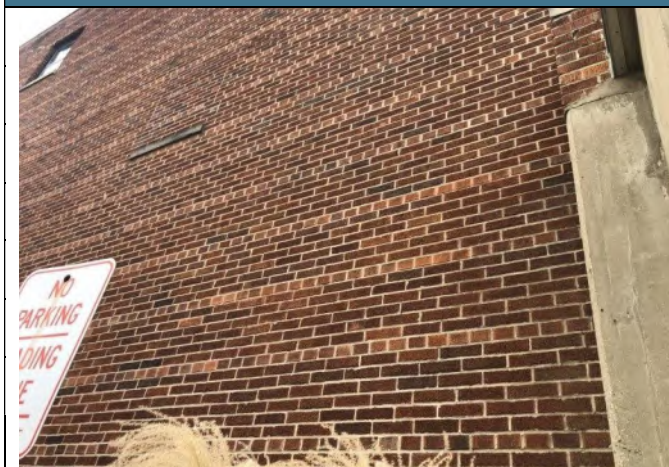
### Photograph #69

Homogenous Material Description
HA-69: Brick mortar – red brick siding
Asbestos Present (Yes/No/Assumed)
No
Total Quantity Present
20305 SF
Additional Notes

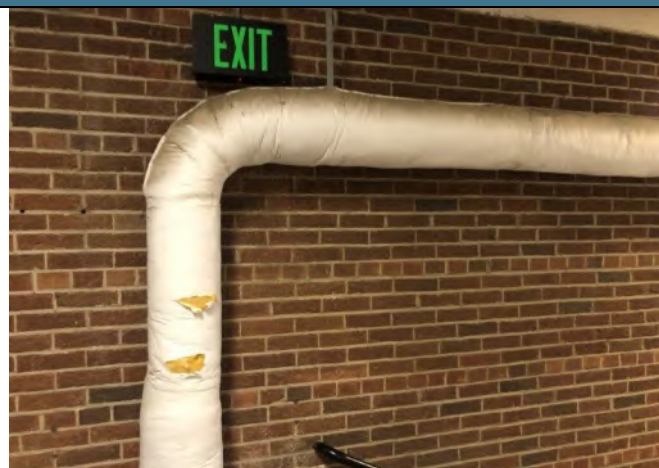
### Photograph #70

Homogenous Material Description
HA-70: Plastic wrapped fiberglass insulation
Asbestos Present (Yes/No/Assumed)
No
Total Quantity Present
1100 SF
Additional Notes

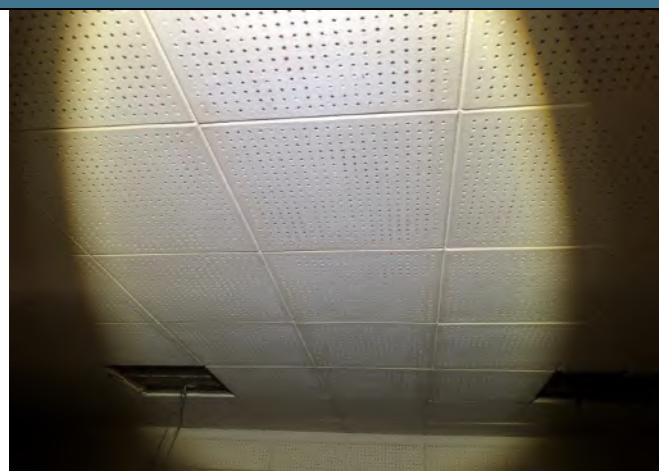
### Photograph #71

Homogenous Material Description
HA-71: Ceiling tile, pinholes
Asbestos Present (Yes/No/Assumed)
No
Total Quantity Present
560 SF
Additional Notes

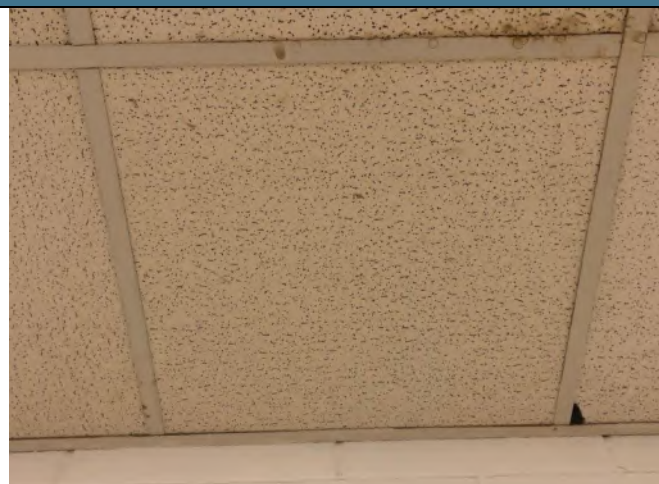
### Photograph #72

Homogenous Material Description
HA-72: Ceiling panel – yellowish pinhole/fissure, grey composite material
Asbestos Present (Yes/No/Assumed)
No
Total Quantity Present
40 SF
Additional Notes

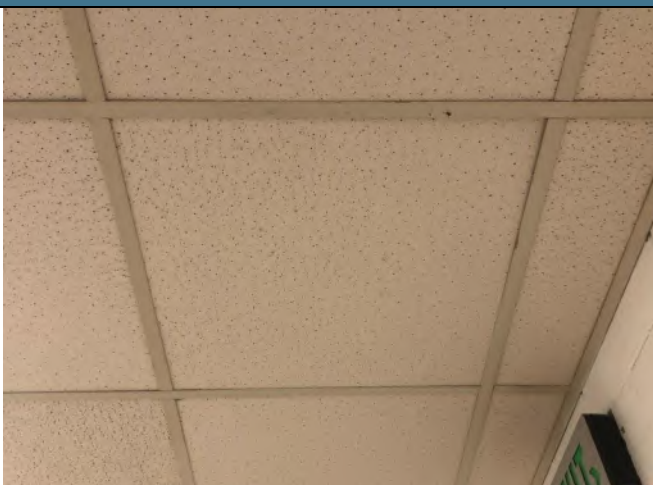
### Photograph #73

Homogenous Material Description
HA-73: White pinhole ceiling panel, beige composite material
Asbestos Present (Yes/No/Assumed)
No
Total Quantity Present
5323 SF
Additional Notes

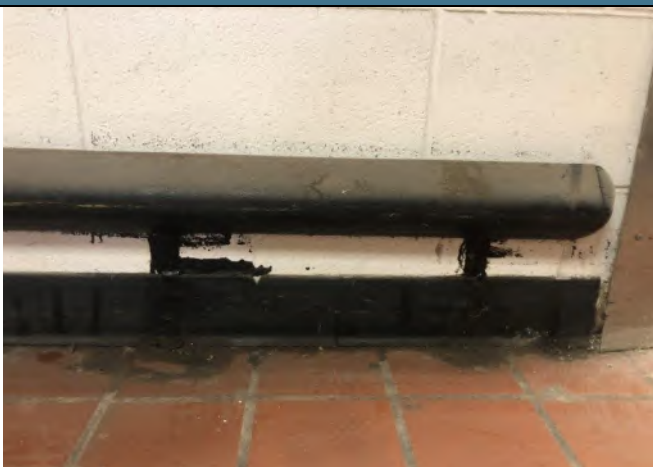
### Photograph #74

Homogenous Material Description
HA-74: Black adhesive behind rubber guard
Asbestos Present (Yes/No/Assumed)
No
Total Quantity Present
245 SF
Additional Notes

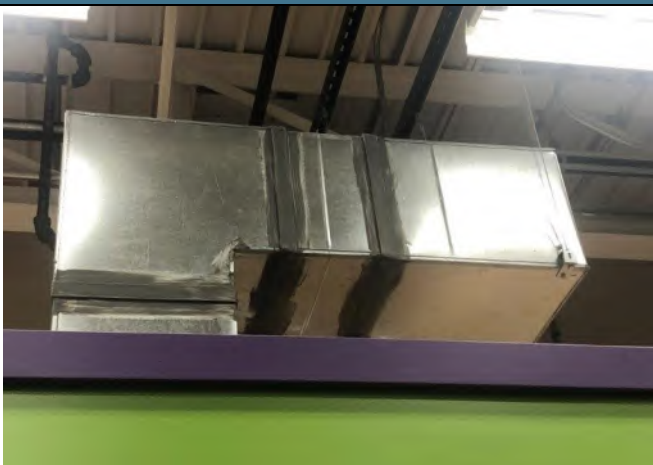
### Photograph #75

Homogenous Material Description
HA-75: Grey duct caulk
Asbestos Present (Yes/No/Assumed)
No
Total Quantity Present
18 SF
Additional Notes

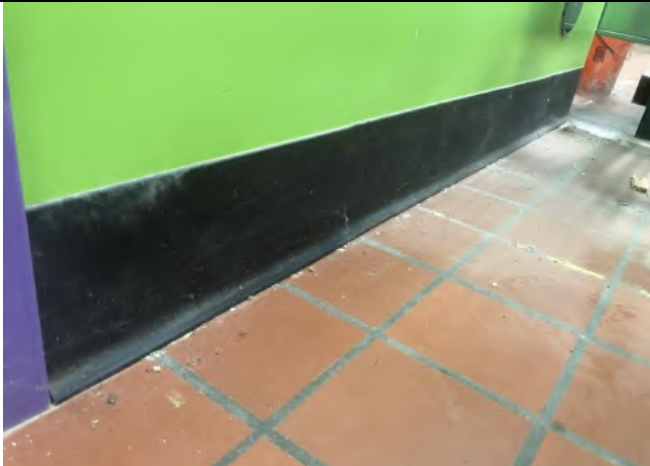
### Photograph #76

HA-76: 6" black cove base, adhesive

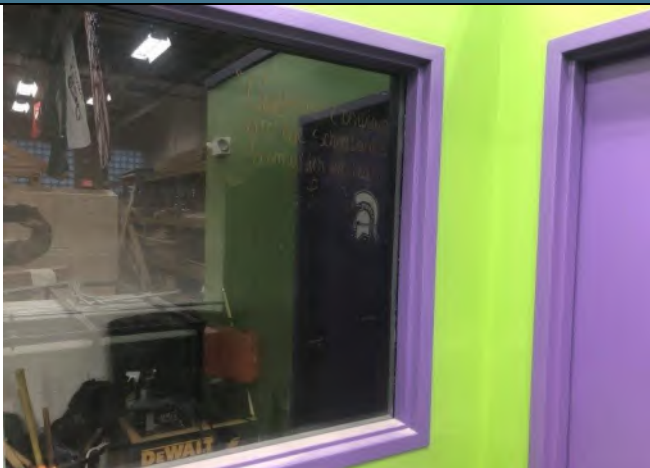
### Photograph #77

HA-77: black window glaze, office window

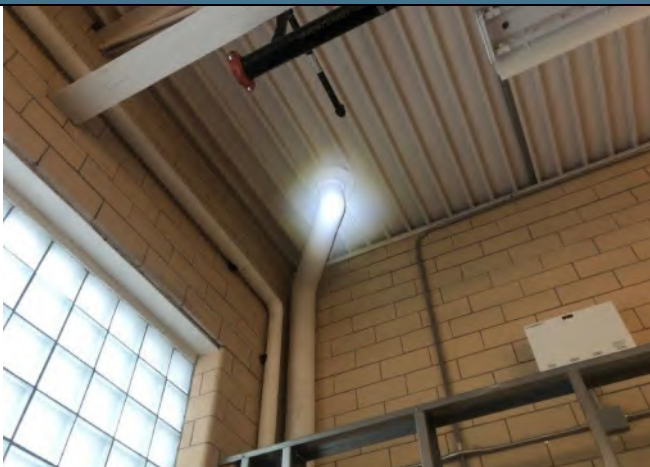
### Photograph #78

HA-78: Roof drain fitting

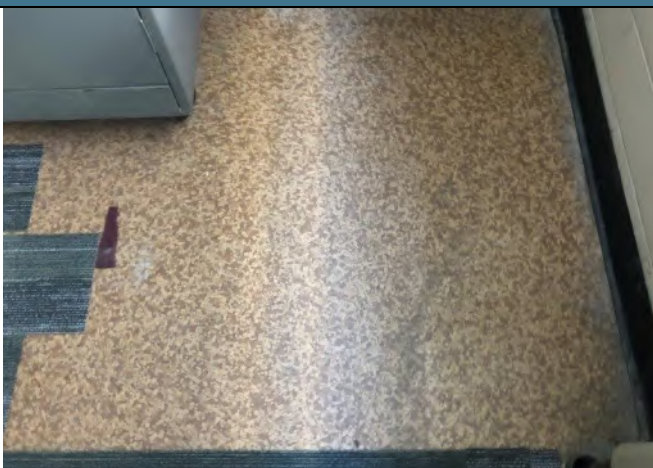
### Photograph #79

Homogenous Material Description
HA-79: Floor sheeting, brown vinyl
Asbestos Present (Yes/No/Assumed)
Yes, 15% Chrysotile
Total Quantity Present
265 SF
Additional Notes

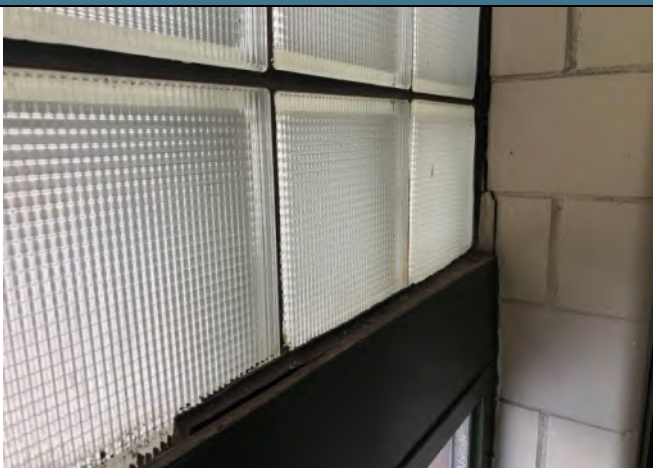
### Photograph #80

Homogenous Material Description
HA-80: Brown caulk, perimeter of glass block
Asbestos Present (Yes/No/Assumed)
Point Count: 1.75% Chrysotile
Total Quantity Present
390 LF
Additional Notes

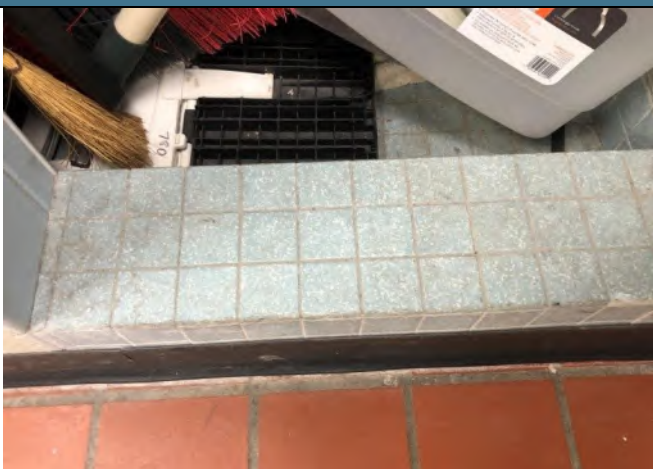
### Photograph #81

Homogenous Material Description
HA-81: 2" blue ceramic floor tile, grout, mortar
Asbestos Present (Yes/No/Assumed)
No
Total Quantity Present
25 SF
Additional Notes

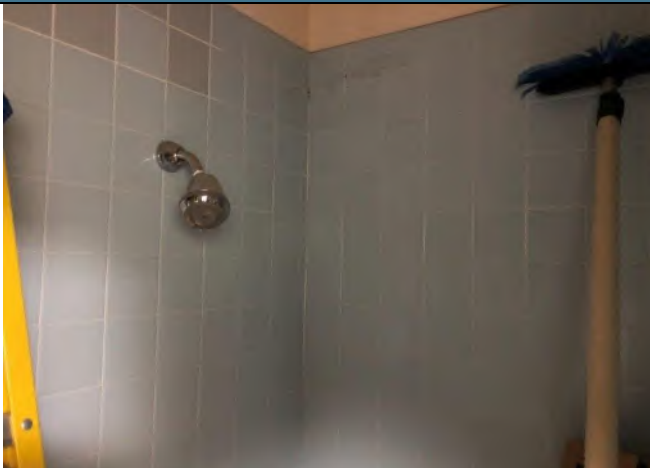
## Photograph #82

HA-82: 4" blue ceramic wall tile, grout, mortar

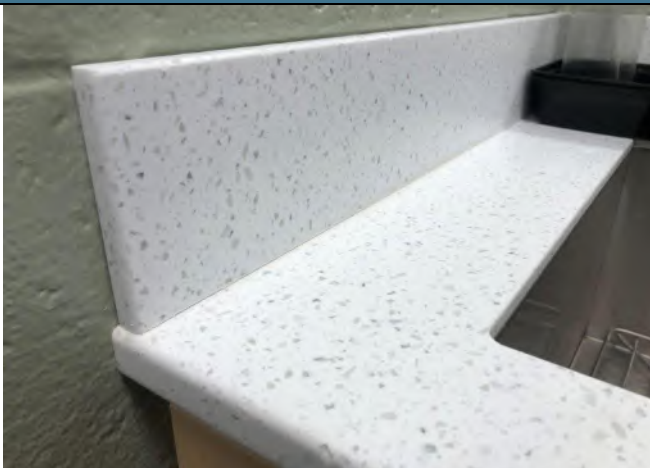
## Photograph #83

HA-83: White caulk on backsplash
