ADDENDUM  
PAGE 1 OF 1

# **PRE-DEMOLITION HAZARDOUS MATERIALS SURVEY REPORT**

## **CENTRAL SERVICES**

570 Red Cedar Road  
East Lansing, MI 48823

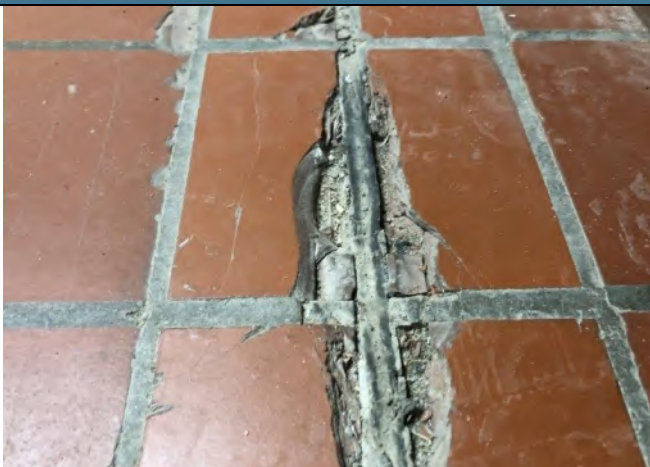
## Photograph #84

HA-84: Concrete slab expansion joint

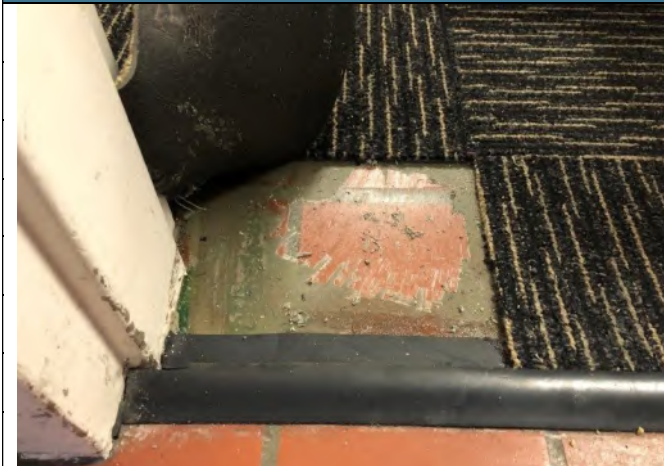
### Photograph #85

HA-85: Carpet mastic, green

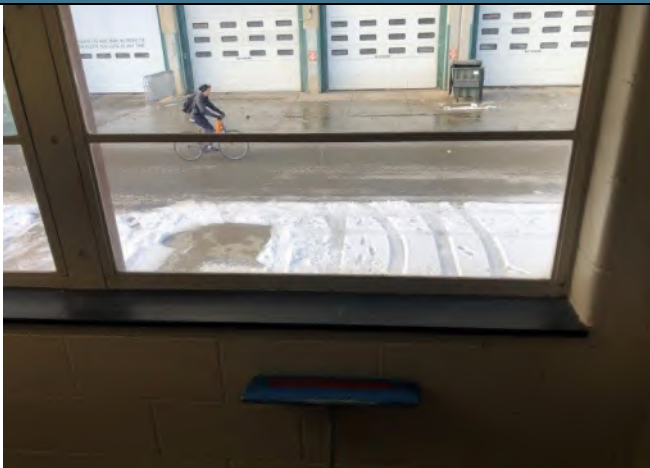
### Photograph #86

HA-86: Transite window sill

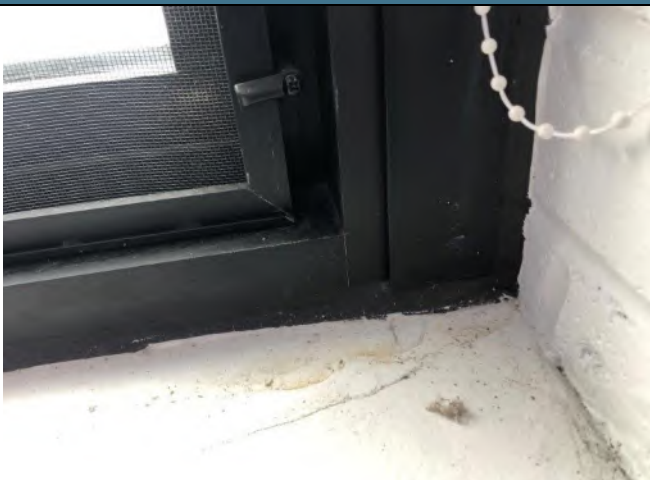
### Photograph #87

HA-87: Black caulk, perimeter of aluminum window frame

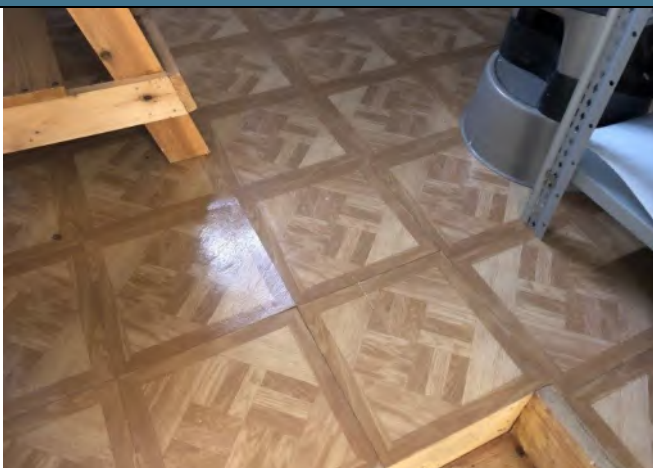
### Photograph #88

Homogenous Material Description
HA-88: 12" wood pattern stick-on floor tile
Asbestos Present (Yes/No/Assumed)
No
Total Quantity Present
100 SF
Additional Notes

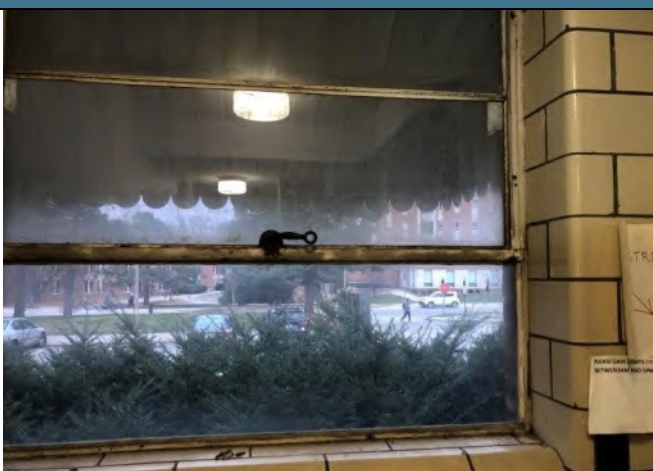
### Photograph #89

Homogenous Material Description
HA-89: Beige window glaze, window interior
Asbestos Present (Yes/No/Assumed)
No
Total Quantity Present
6 Windows
Additional Notes

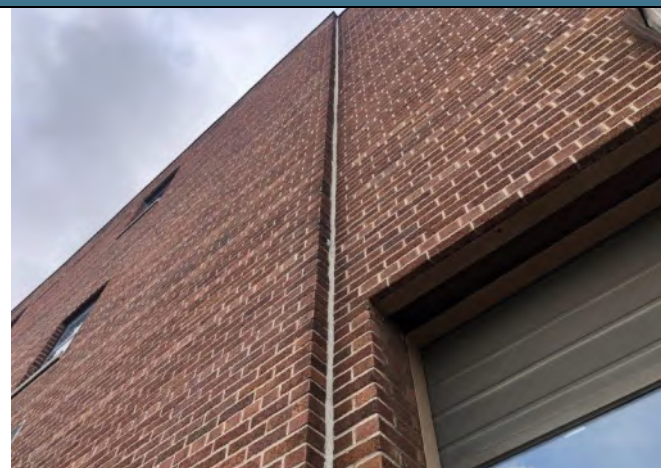
### Photograph #91

HA-91: Red brick expansion joint

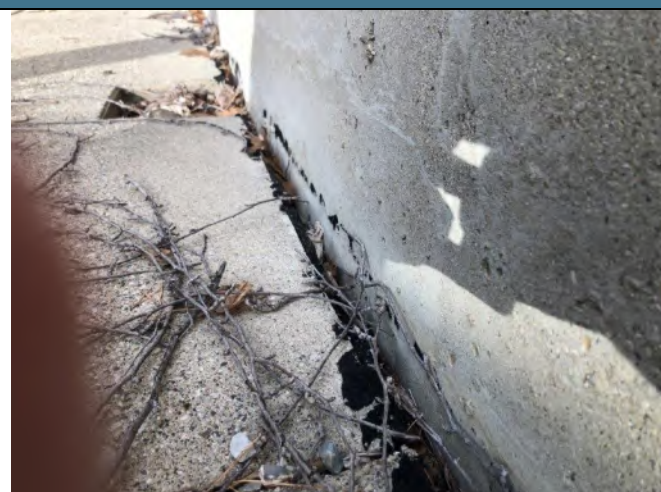
### Photograph #92

HA-92: Black expansion joint between foundation wall and walkway

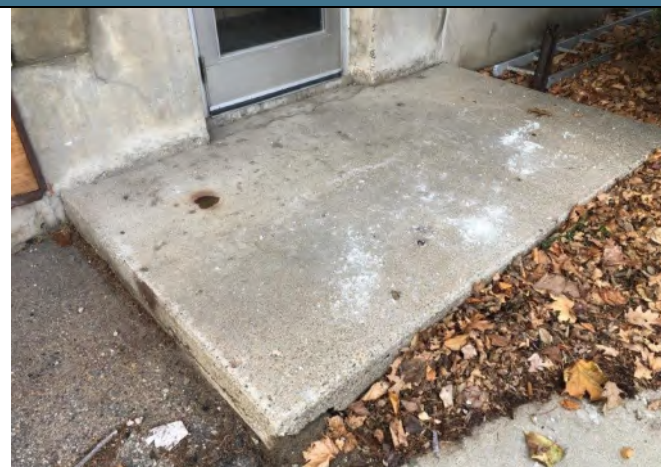
### Photograph #93

HA-93: Exterior concrete

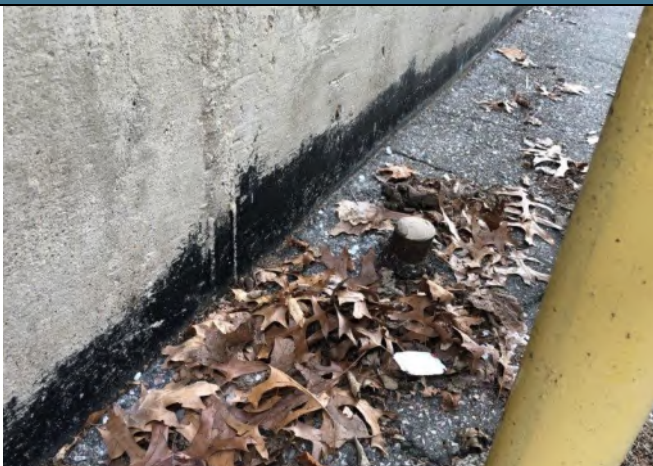
### Photograph #94

Homogenous Material Description
HA-94: Black spray-on waterproofing
Asbestos Present (Yes/No/Assumed)
No
Total Quantity Present
715 LF
Additional Notes

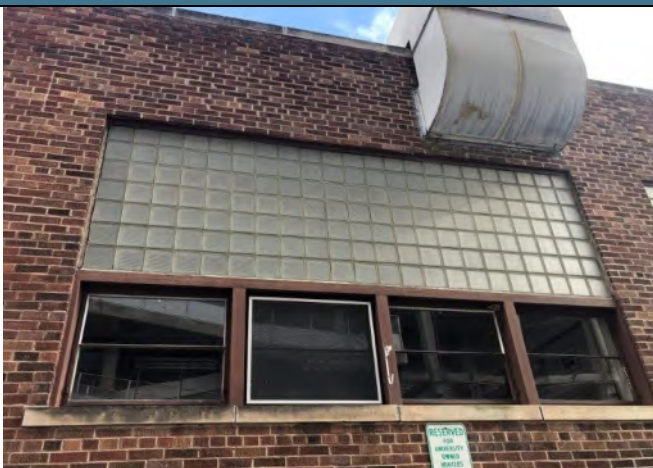
### Photograph #95

Homogenous Material Description
HA-95: Glass block mortar
Asbestos Present (Yes/No/Assumed)
No
Total Quantity Present
1050 LF
Additional Notes

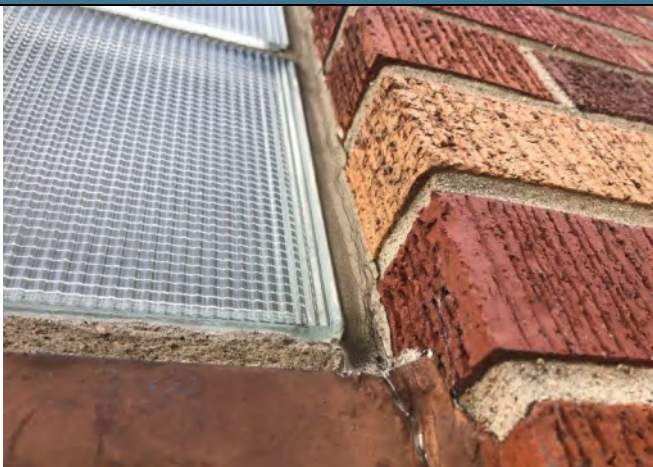
### Photograph #96

Homogenous Material Description
HA-96: Grey caulk, perimeter of glass block
Asbestos Present (Yes/No/Assumed)
No
Total Quantity Present
465 LF
Additional Notes

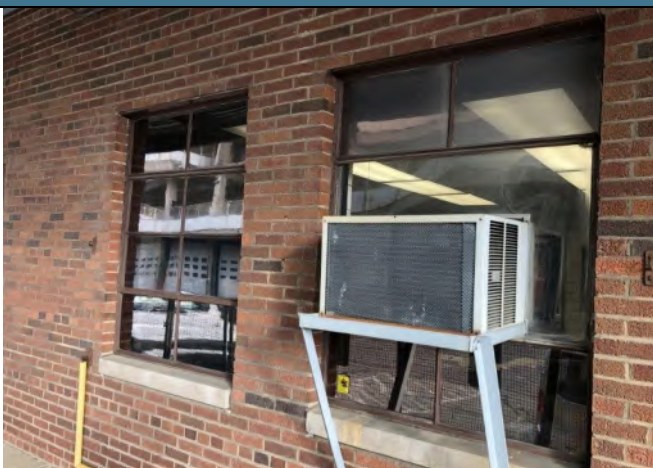
### Photograph #97

Homogenous Material Description
HA-97: Window glaze, multi-pane steel windows
Asbestos Present (Yes/No/Assumed)
Point Count: 0.25% Chrysotile
Total Quantity Present
1060 LF
Additional Notes

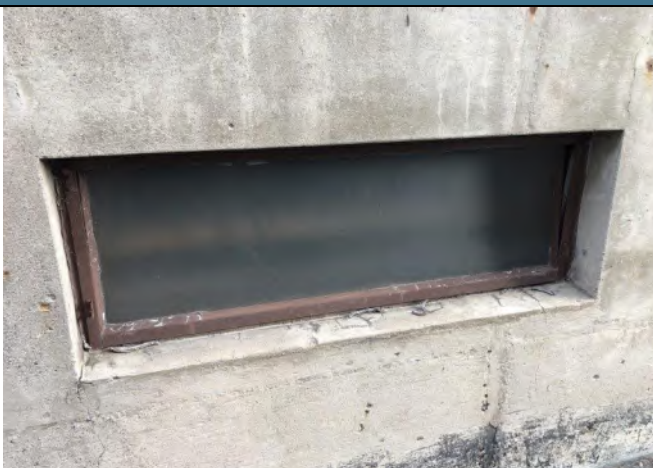
### Photograph #98

Homogenous Material Description
HA-98: Window glaze – basement windows
Asbestos Present (Yes/No/Assumed)
Point Count: 0.25% Chrysotile
Total Quantity Present
375 LF
Additional Notes

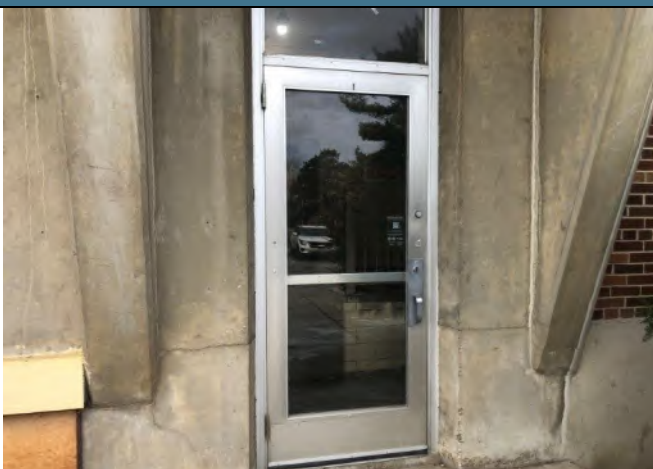
### Photograph #99

Homogenous Material Description
HA-99: Metal door window glaze, grey
Asbestos Present (Yes/No/Assumed)
No
Total Quantity Present
15 LF
Additional Notes

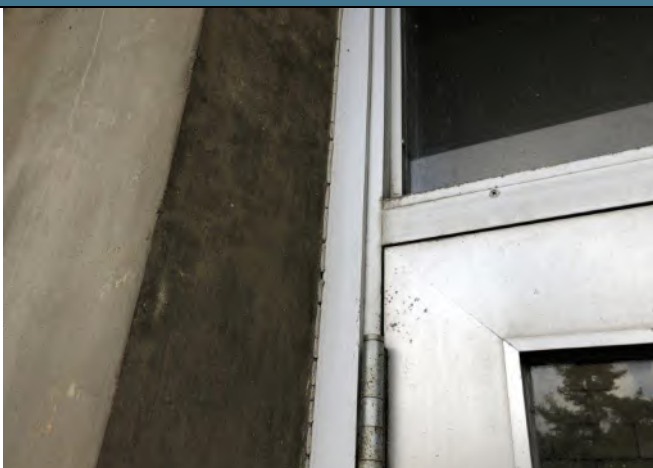
### Photograph #100

Homogenous Material Description
HA-100: Grey caulk, perimeter of door frames
Asbestos Present (Yes/No/Assumed)
Yes, 7% Chrysotile
Total Quantity Present
70 LF
Additional Notes

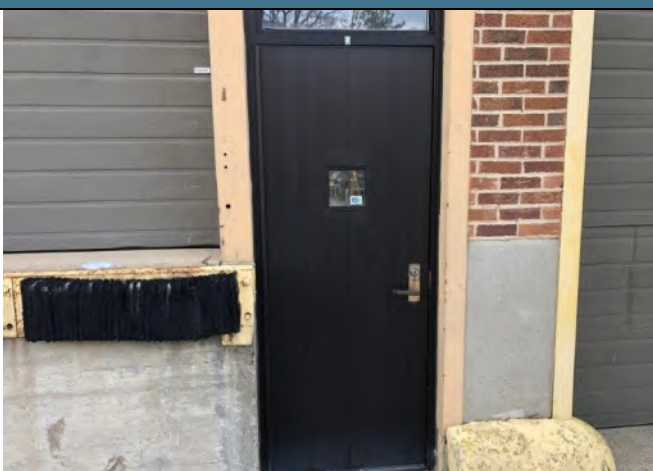
### Photograph #101

Homogenous Material Description
HA-101: Black caulk, perimeter of door frames
Asbestos Present (Yes/No/Assumed)
No
Total Quantity Present
45 LF
Additional Notes

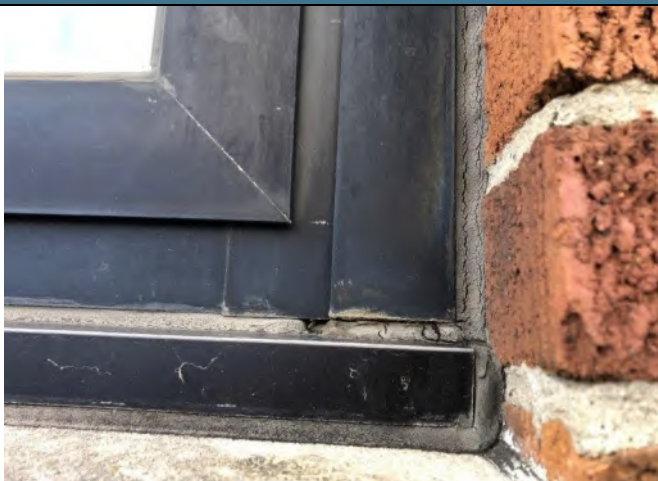
### Photograph #104

Homogenous Material Description
	HA-104: Grey caulk, perimeter of aluminum windows
	Asbestos Present (Yes/No/Assumed)
	No
	Total Quantity Present
	530 LF
	Additional Notes

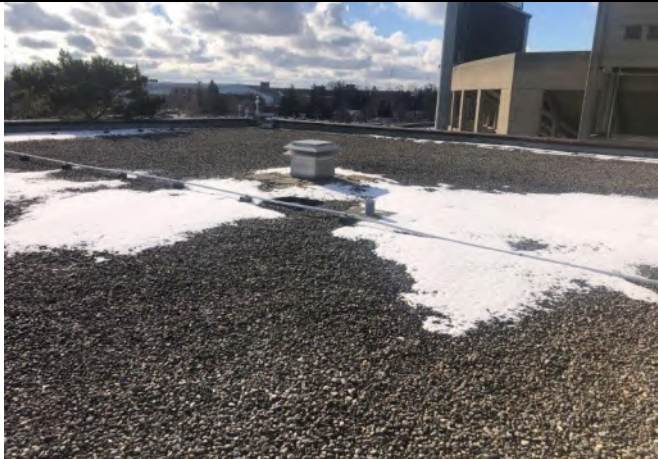
### Photograph #105

Homogenous Material Description
	HA-105: Flat rubber membrane roofing materials
	Asbestos Present (Yes/No/Assumed)
	No
	Total Quantity Present
	24300 SF
	Additional Notes

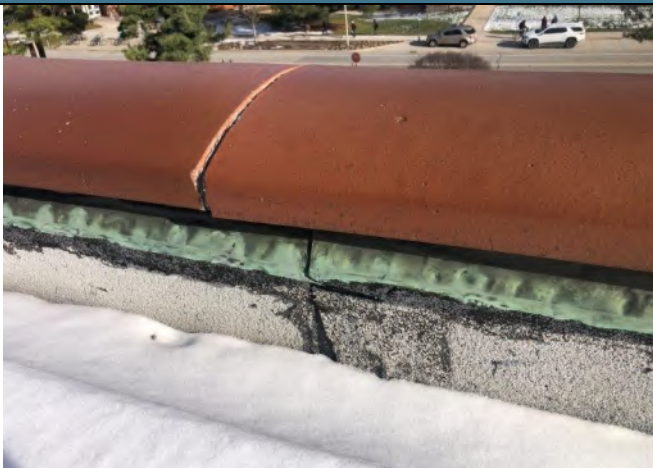
### Photograph #107

HA-107: Terracotta capstone

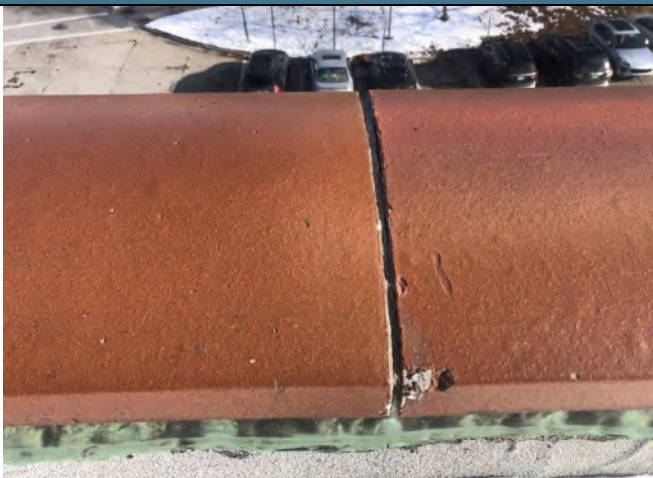
### Photograph #108

HA-108: Grey caulk between terracotta capstones

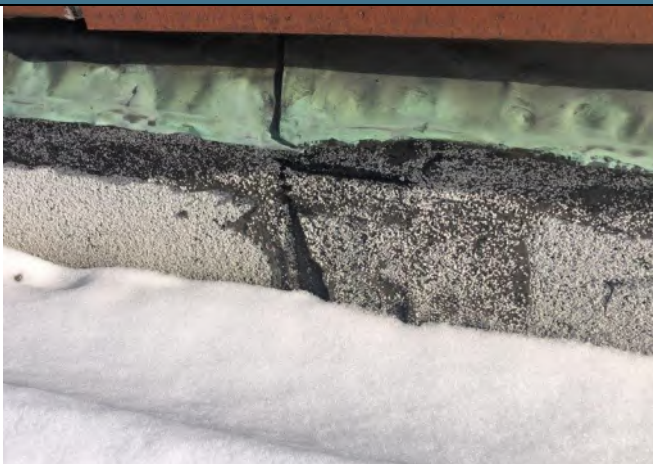
### Photograph #109

Homogenous Material Description
HA-109: Black caulk, on parapet wall
Asbestos Present (Yes/No/Assumed)
No
Total Quantity Present
780 SF
Additional Notes

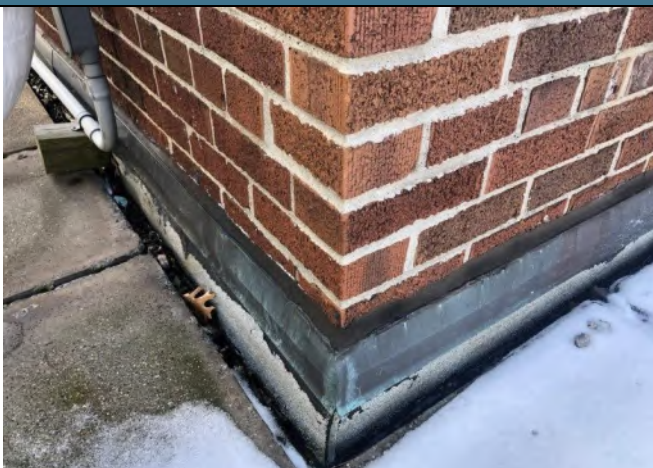
### Photograph #110

Homogenous Material Description
HA-110: Black caulk on penthouse flashing
Asbestos Present (Yes/No/Assumed)
No
Total Quantity Present
60 LF
Additional Notes

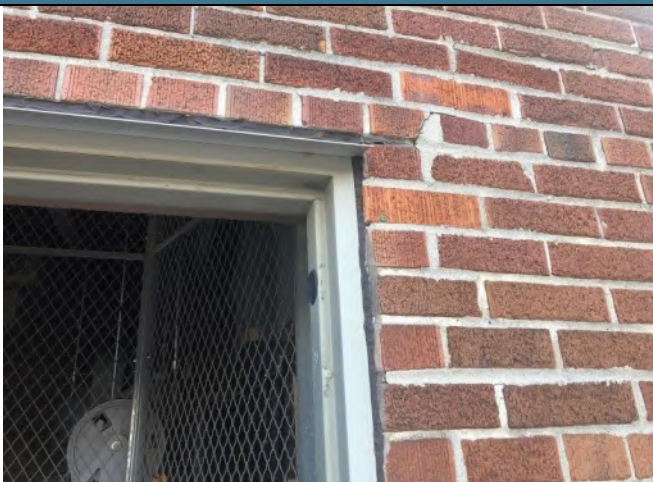
### Photograph #111

Homogenous Material Description
HA-111: dark grey caulk, perimeter of door frame
Asbestos Present (Yes/No/Assumed)
No
Total Quantity Present
20 LF
Additional Notes

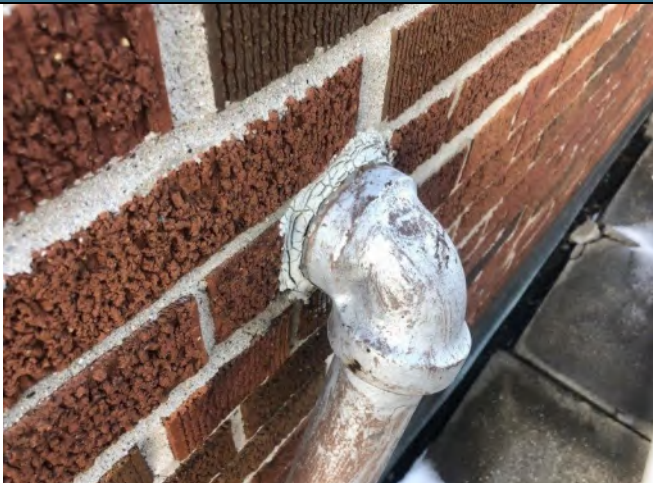
### Photograph #112

Homogenous Material Description
HA-112: Light grey caulk, penthouse penetrations
Asbestos Present (Yes/No/Assumed)
No
Total Quantity Present
5 LF
Additional Notes

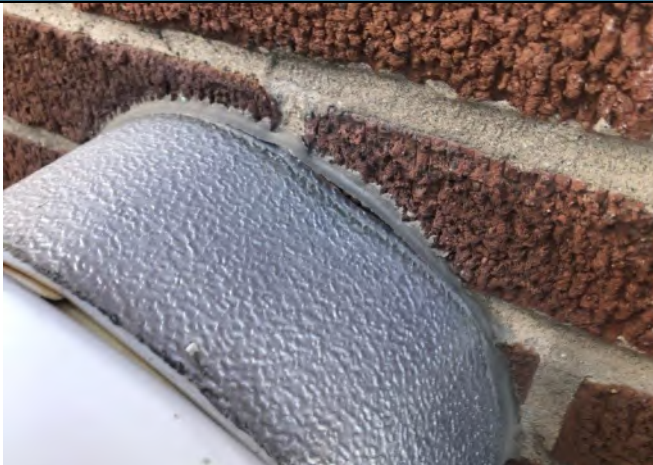
### Photograph #113

Homogenous Material Description
HA-113: grey caulk on metal pipe
Asbestos Present (Yes/No/Assumed)
No
Total Quantity Present
25 LF
Additional Notes

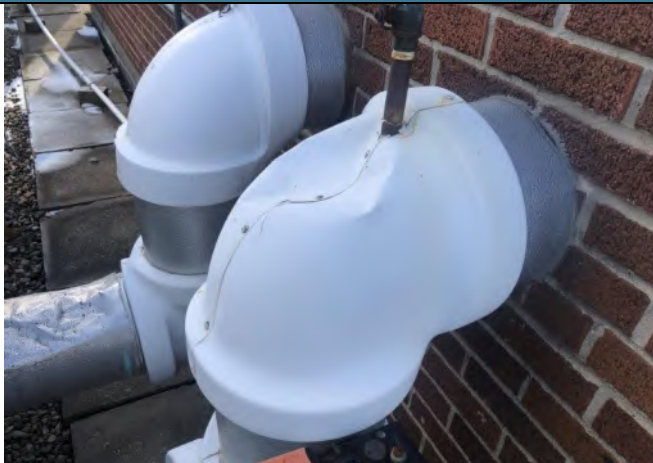
### Photograph #114

Homogenous Material Description
HA-114: white caulk on plastic pipe fittings
Asbestos Present (Yes/No/Assumed)
No
Total Quantity Present
15 LF
Additional Notes

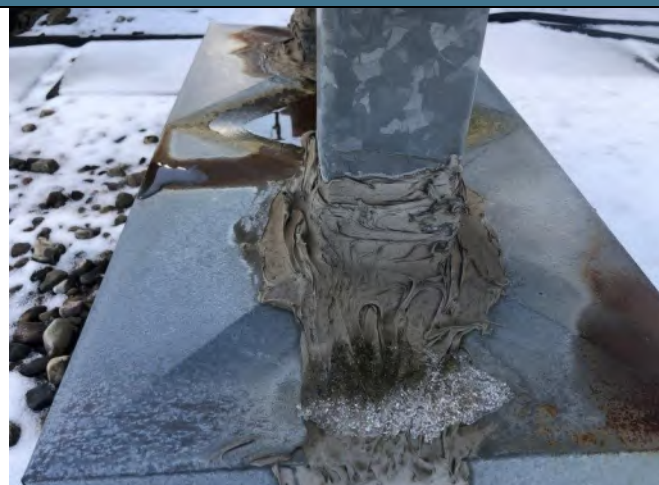
### Photograph #115

Homogenous Material Description
HA-115: Grey caulk, on penetrations, fencing base
Asbestos Present (Yes/No/Assumed)
No
Total Quantity Present
50 SF
Additional Notes

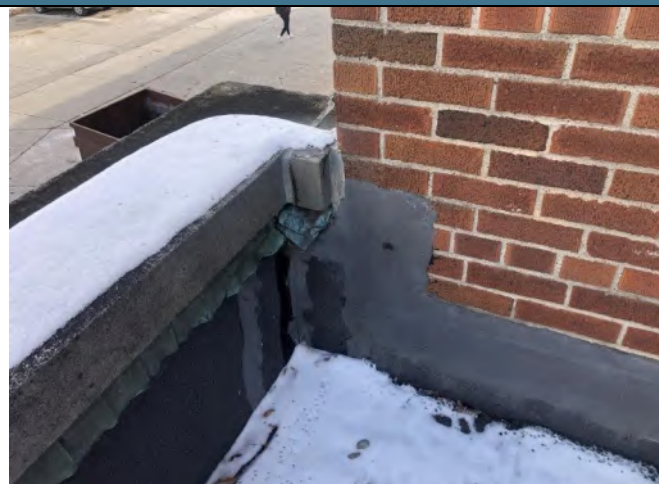
### Photograph #116

Homogenous Material Description
HA-116: Grey caulk, seams of concrete capstone
Asbestos Present (Yes/No/Assumed)
No
Total Quantity Present
200 LF
Additional Notes

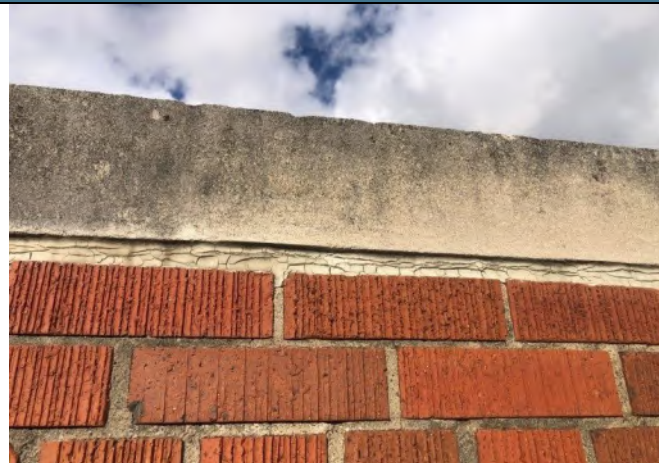
### Photograph #117

Homogenous Material Description
HA-117: Dark grey caulk, under capstone
Asbestos Present (Yes/No/Assumed)
Yes, 10% Chrysotile
Total Quantity Present
400 SF
Additional Notes

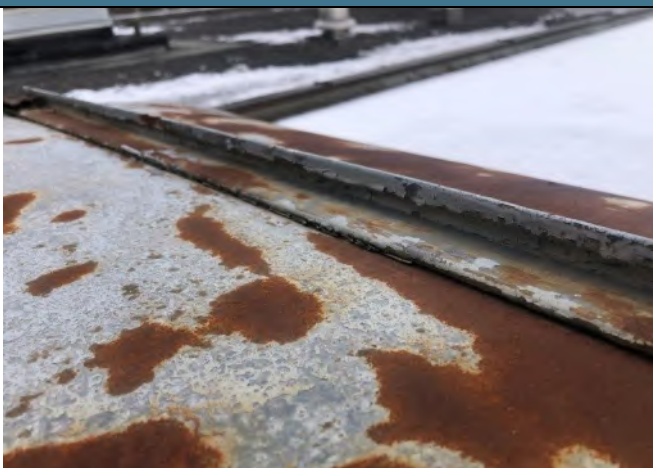
### Photograph #118

Homogenous Material Description
HA-118: Grey caulk, on HVAC seams
Asbestos Present (Yes/No/Assumed)
No
Total Quantity Present
20 LF
Additional Notes

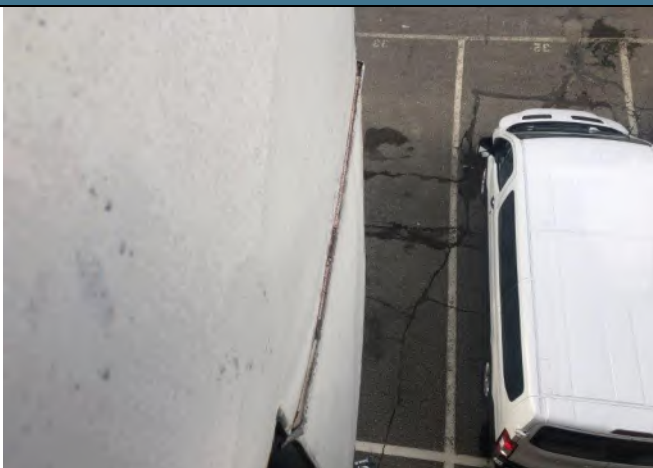
### Photograph #119

Homogenous Material Description
HA-119: Pink caulk, on HVAC seams
Asbestos Present (Yes/No/Assumed)
No
Total Quantity Present
30 LF
Additional Notes

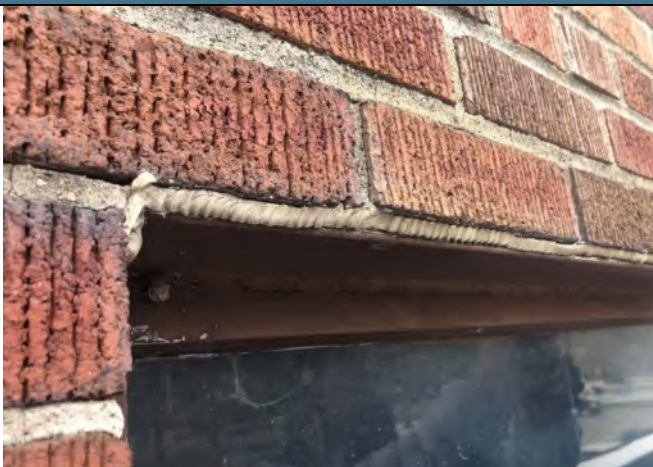
### Photograph #120

Homogenous Material Description
HA-120: white caulk, on window angle iron
Asbestos Present (Yes/No/Assumed)
No
Total Quantity Present
5 LF
Additional Notes

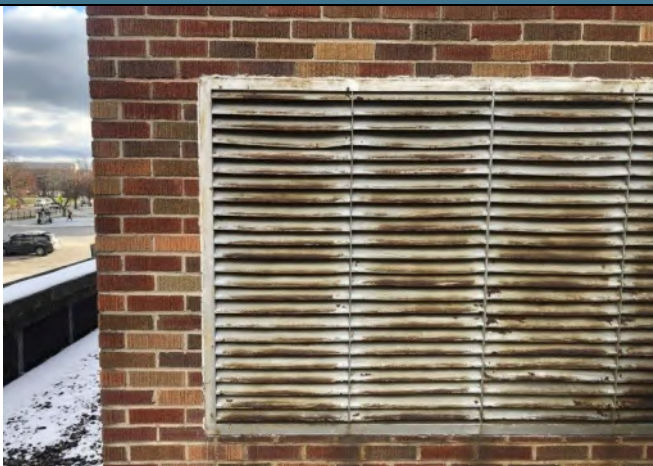
### Photograph #121

Homogenous Material Description
HA-121: grey caulk, on vent perimeter
Asbestos Present (Yes/No/Assumed)
Yes, 5% Chrysotile
Total Quantity Present
35 LF
Additional Notes

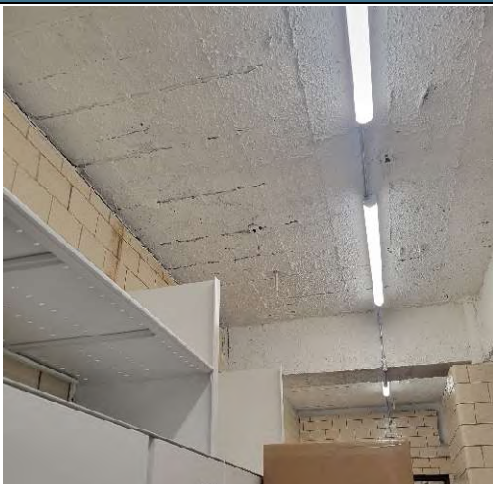
### Photograph #123

Homogenous Material Description
HA-123: Cork insulation, remnants (cork & cork adhesive on concrete).
Asbestos Present (Yes/No/Assumed)
No
Total Quantity Present
14106 SF
Additional Notes
Black paper layer (ACM layer) & several inches of cork (HA-24) were previously removed in abatement project.

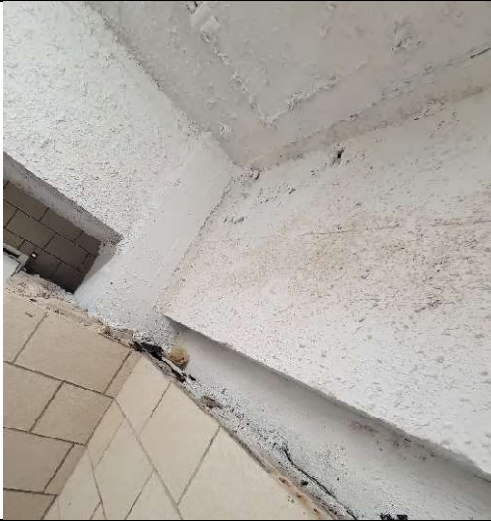
Photograph #124

HA-124: Black asphaltic layer, remnant pieces,  
at top of interior perimeter walls in select  
areas
