**PRE-DEMOLITION LIMITED ASBESTOS AND HAZARDOUS MATERIAL SURVEY  
IM SPORTS - WEST BUILDING**

393 CHESTNUT ROAD  
EAST LANSING, MI 48824

Project #188BS25645 and 188BS26401

October 5, 2026

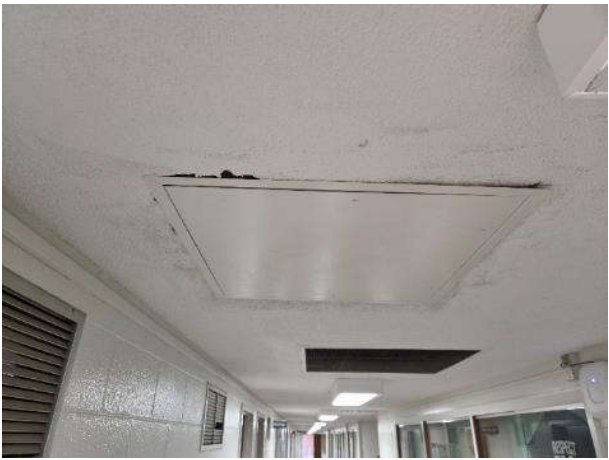
| <b>View Of:</b> | HA-20 – Textured Plaster | <b>View Of:</b> | HA-21 Cove Base and Green Turf |
| <b>Asbestos %</b> | 0.75% Chrysotile | <b>Asbestos %</b> | ND |

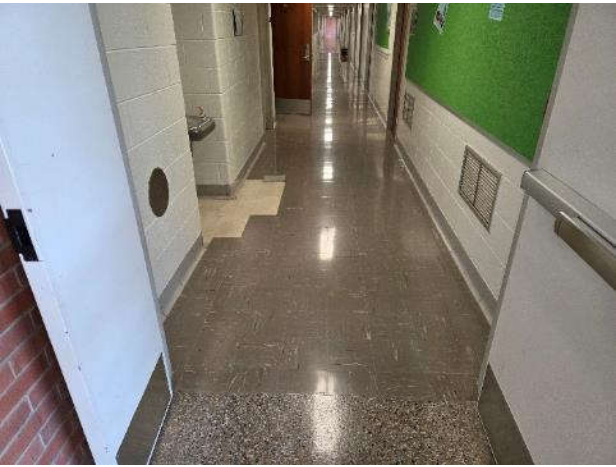
| <b>View Of:</b> | HA-40 Terrazzo Flooring (black, red, white, and tan pebbles) | <b>View Of:</b> | HA-41 Cove Base – Terrazzo Perimeter of hallway |
| <b>Asbestos %</b> | ND | <b>Asbestos %</b> | ND |

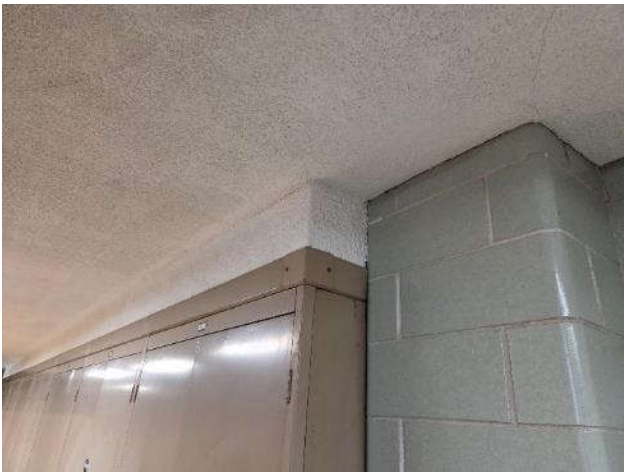
| <b>View Of:</b> | HA-42 Block Mortar (6"x12" block w/green glazing) | <b>View Of:</b> | HA-43 Plaster (smooth finish) |
| <b>Asbestos %</b> | ND | <b>Asbestos %</b> | 1.5% Chrysotile |

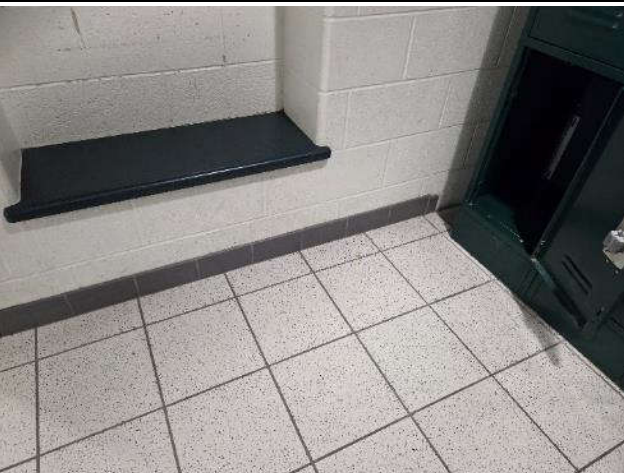
| <b>View Of:</b> | HA-44 Grout/mortar associated with ceramic tile (12"x12" white w/speckles) | <b>View Of:</b> | HA-45 Ceramic tile (12"x12" dark brown with speckles) with mortar (grey) and cementitious material (white)- Sample collected on September 23, 2026. |
| <b>Asbestos %</b> | ND | <b>Asbestos %</b> | ND |

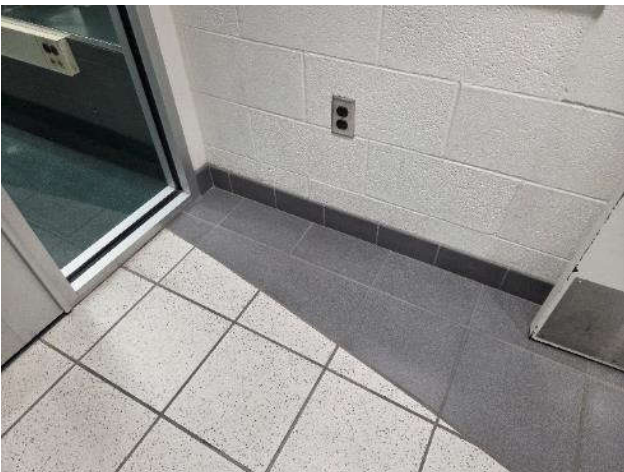
| <b>View Of:</b> | HA-46 Ceramic Tile (8"x4" & 4"x4" tile) - Dark Gray (used as cove base with same mortar as HA-45) | <b>View Of:</b> | HA-47 Ceiling Panel (2'x2', white, textured, no pinholes) |
| <b>Asbestos %</b> | ND | <b>Asbestos %</b> | ND |

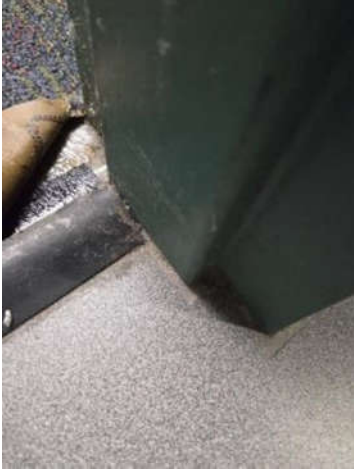
| <b>View Of:</b> HA-48 Carpet Adhesive (green carpet – w/yellow adhesive) | <b>View Of:</b> HA-49 Cove Base (4" dark green) |
| <b>Asbestos %</b> ND | <b>Asbestos %</b> ND |

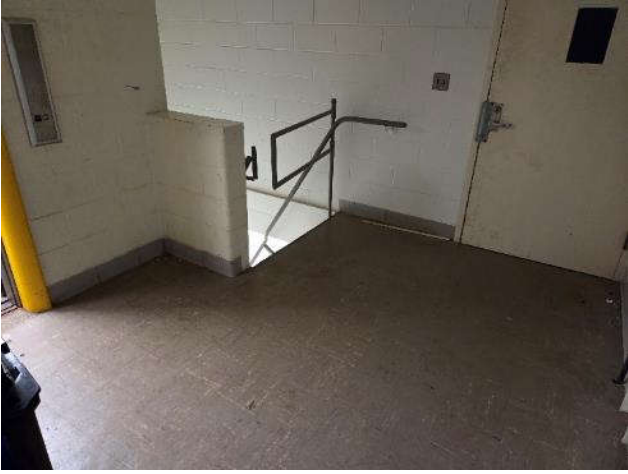
| <b>View Of:</b> HA-50 Floor Tile (9"x9" gray with white and peach streaks) | <b>View Of:</b> HA-51 Carpet Adhesive (gray carpet w/green streaks & clear adhesive) |
| <b>Asbestos %</b> 3% Chrysotile (floor tile); ND (mastic) | <b>Asbestos %</b> ND |

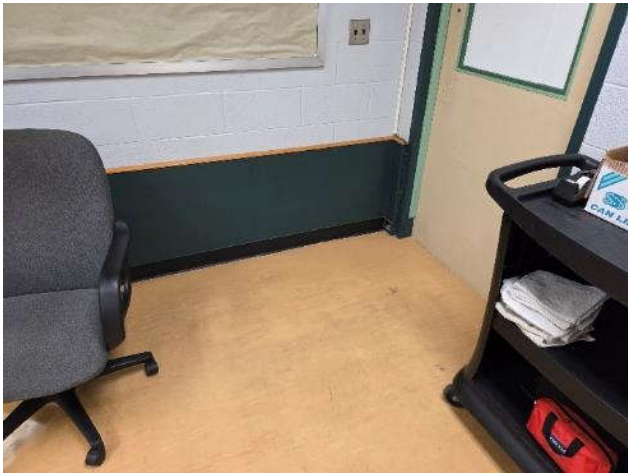
| <b>View Of:</b> HA-52 Cove base (4" black) | <b>View Of:</b> HA-53 Interior Caulk (white around counter backsplash) |
| <b>Asbestos %</b> ND | <b>Asbestos %</b> ND |

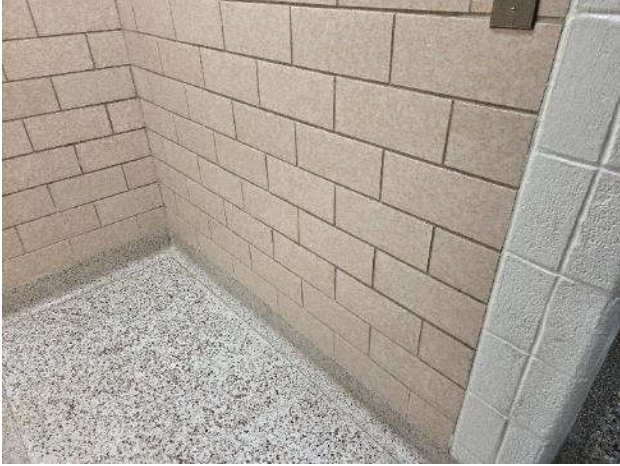
| <b>View Of:</b> | HA-54 Terrazzo Flooring (white, tan pebbles) | <b>View Of:</b> | HA-55 Ceramic Tile (4"x4" white used as wall accent) |
| <b>Asbestos %</b> | ND | <b>Asbestos %</b> | ND |

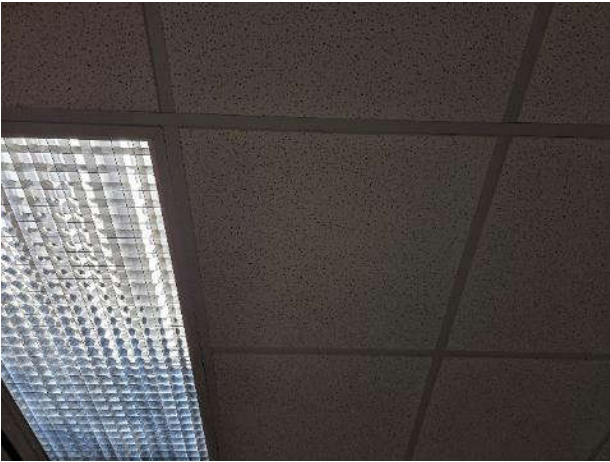
| <b>View Of:</b> | HA-56 Ceiling Panel (2'x2' white with pinholes and gouges) | <b>View Of:</b> | HA-57 Block Mortar (12"x6" wall block w/pink glazing) |
| <b>Asbestos %</b> | ND | <b>Asbestos %</b> | ND |

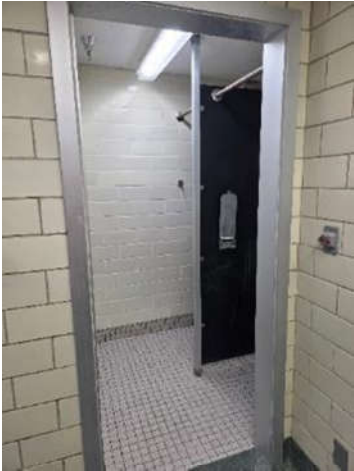
| <b>View Of:</b> | HA-58 Block Mortar (12"x6" wall block w/white glazing) | <b>View Of:</b> | HA-59 Ceramic Floor Tile (2"x2' and 1'x1' light brown and tan rectangles and squares) |
| <b>Asbestos %</b> | ND | <b>Asbestos %</b> | ND |

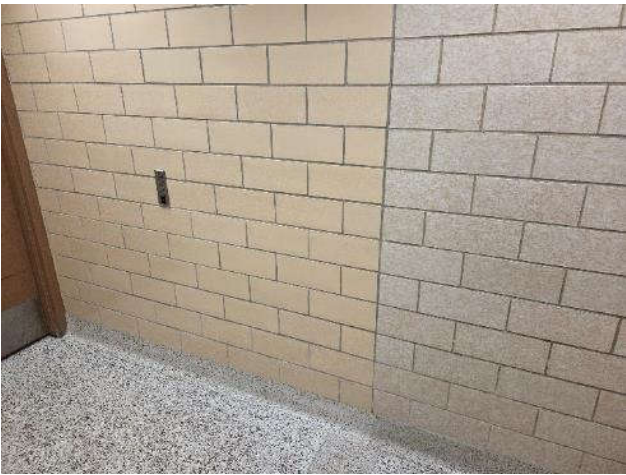
| <b>View Of:</b> | HA-60 Cove Base (terrazzo) | <b>View Of:</b> | HA-61 Pipe Insulation (fiberglass with cream wrap) |
| <b>Asbestos %</b> | ND | <b>Asbestos %</b> | ND |

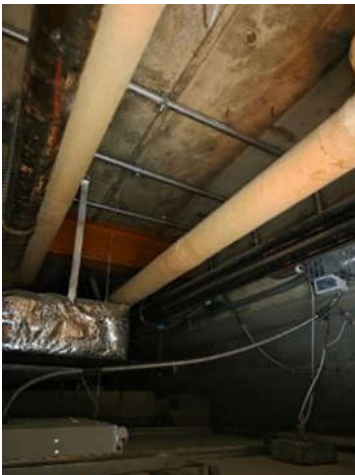
| <b>View Of:</b> | HA-62 Pipe Insulation (magnesia fitting on fiberglass runs) | <b>View Of:</b> | HA-63 Waterproofing (green flooring) |
| <b>Asbestos %</b> | 10% Chrysotile | <b>Asbestos %</b> | ND |

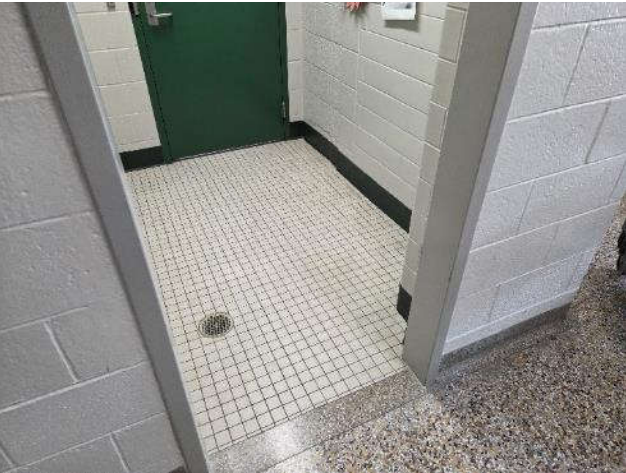
| <b>View Of:</b> | HA-64 Ceramic Floor Tile (2"x2" white) | <b>View Of:</b> | HA-65 Ceramic Floor Tile (1"x1" green) |
| <b>Asbestos %</b> | ND | <b>Asbestos %</b> | ND |

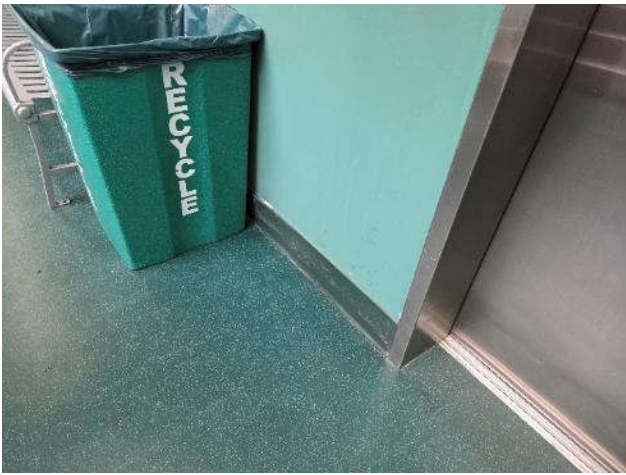
| <b>View Of:</b> | HA-66 Cove Base (6" Green) | <b>View Of:</b> | HA-67 Concrete (dark gray floor leveler on terrazzo) |
| <b>Asbestos %</b> | ND | <b>Asbestos %</b> | ND |

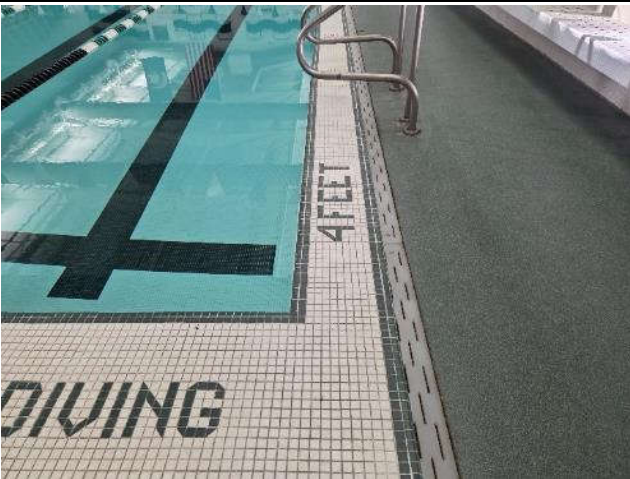
| <b>View Of:</b> | HA-68 Ceramic Tile (1"x1" white) | <b>View Of:</b> | HA-69 Interior Caulk (white in corners of shower walls) |
| <b>Asbestos %</b> | ND | <b>Asbestos %</b> | ND |

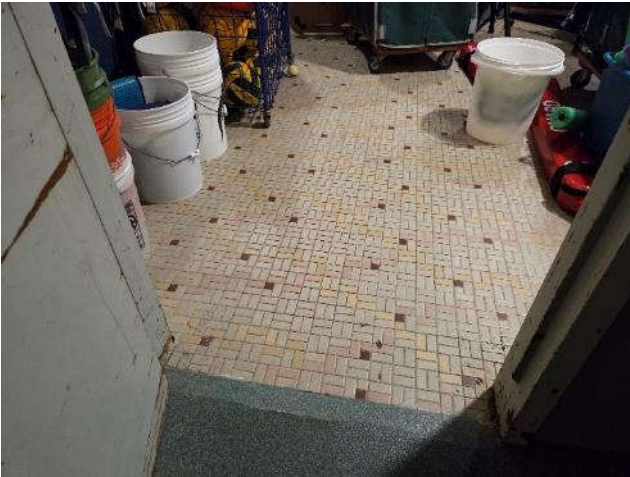
| <b>View Of:</b> | HA-70 Ceramic Floor Tile (2"x1" rectangle hatch with red 1"x1" maroon squares) | <b>View Of:</b> | HA-71 Construction Adhesive (cream/tan/blue carpet with light brown adhesive) |
| <b>Asbestos %</b> | ND | <b>Asbestos %</b> | ND |

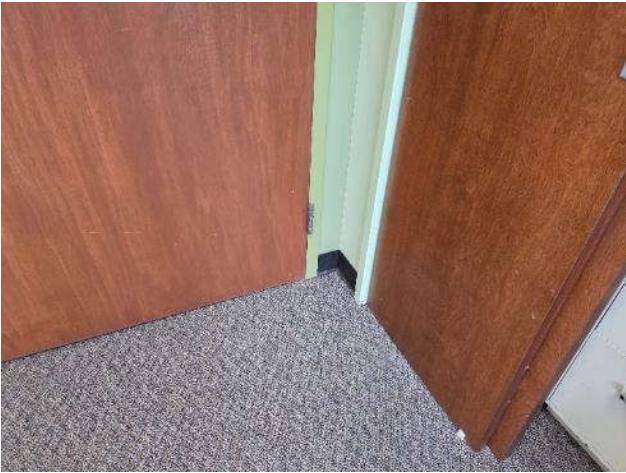
| <b>View Of:</b> | HA-72 Cove Base (4" dark gray) | <b>View Of:</b> | HA-73 Construction Adhesive on wallpaper (light green cross hatch patterned) |
| <b>Asbestos %</b> | ND | <b>Asbestos %</b> | ND |

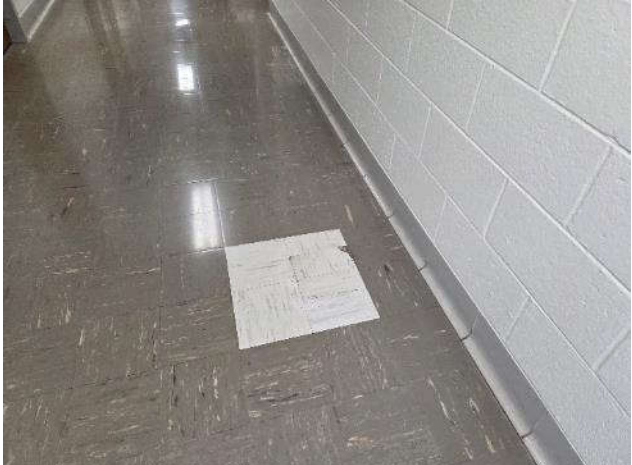
| <b>View Of:</b> | HA-110 Caulk (thick tan bead in corners of room) | <b>View Of:</b> | HA-111 Floor Tile (12"x12" black) |
| <b>Asbestos %</b> | ND | <b>Asbestos %</b> | 0.25% Chrysotile (floor tile); ND (mastic & other materials) |

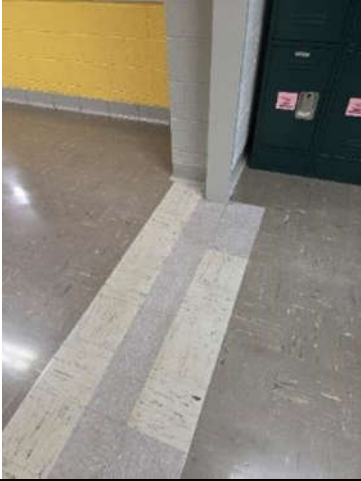
| <b>View Of:</b> | HA-116 Floor Tile (off-white 12"x12" with black streaks) | <b>View Of:</b> | HA-117 Floor Tile (beige 12"x12" w/brown and white mottles) |
| <b>Asbestos %</b> | ND | <b>Asbestos %</b> | ND |

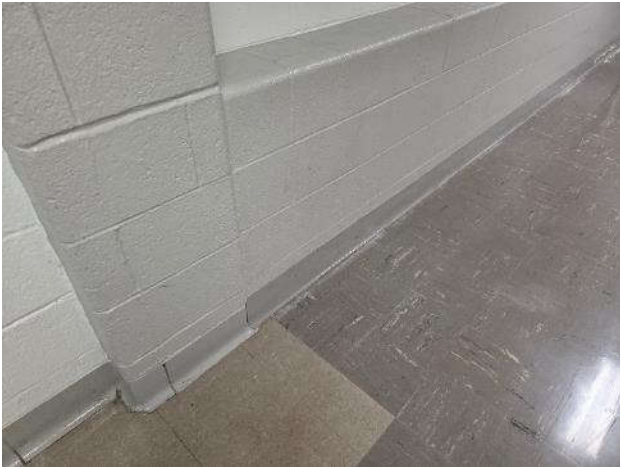
| <b>View Of:</b> | HA-118 Cove Base (6" light gray) | <b>View Of:</b> | HA-119 Floor Tile (white 9"x9" with blue and red streaks) |
| <b>Asbestos %</b> | ND | <b>Asbestos %</b> | ND |

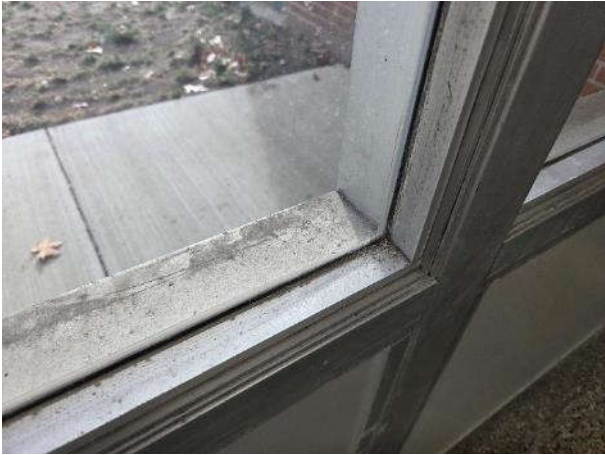
| <b>View Of:</b> | HA-120 Window Glaze (gray and brittle) | <b>View Of:</b> | HA-121 Caulk (white between block wall and aluminum rails for netting in racquetball courts) |
| <b>Asbestos %</b> | Trace | <b>Asbestos %</b> | ND |

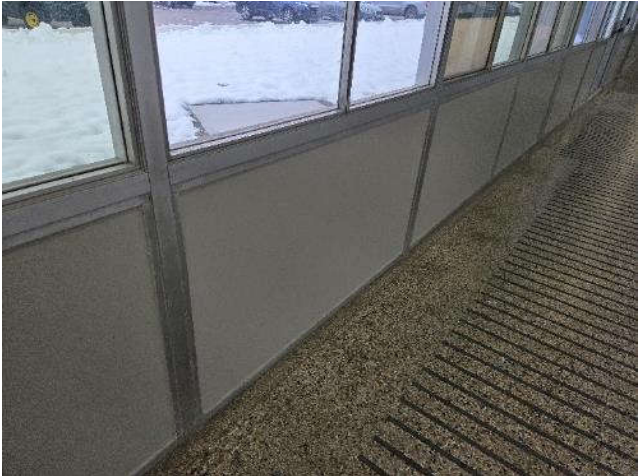
| <b>View Of:</b> | HA-122 Caulk (white around metal panel below 4'x4' exterior windows) | <b>View Of:</b> | HA-123 Construction Adhesive (black tread - 1st floor hallway 1"x4') |
| <b>Asbestos %</b> | ND | <b>Asbestos %</b> | ND |

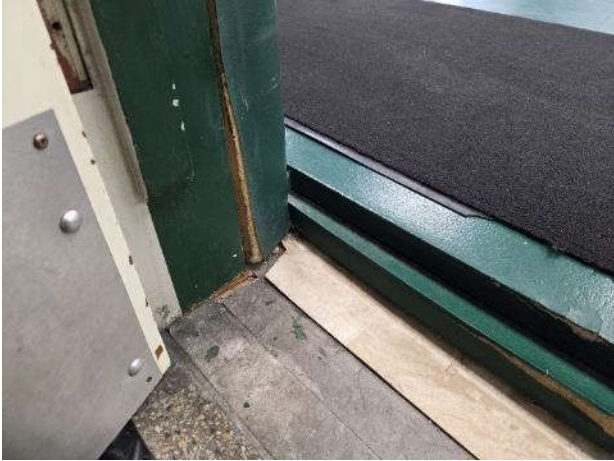
| <b>View Of:</b> | HA-124 Linoleum (multi-sized beige squares) | <b>View Of:</b> | HA-125 Construction Adhesive (on tan carpet with tan horizontal lines) |
| <b>Asbestos %</b> | ND | <b>Asbestos %</b> | ND |

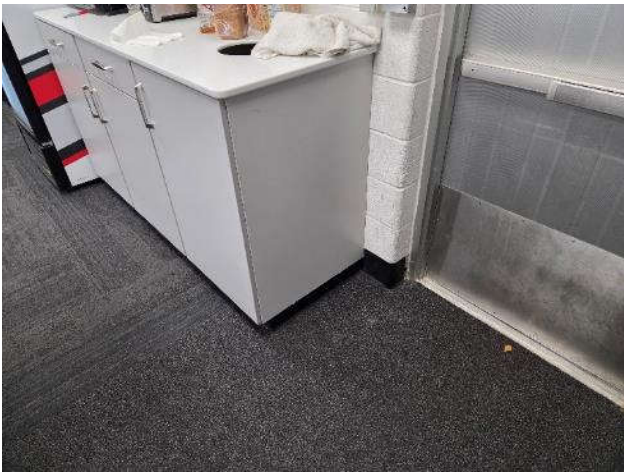
| <b>View Of:</b> | HA-126 Cove Base (6" black) | <b>View Of:</b> | HA-127 Floor Tile (white 12"x12" with tan mottles) |
| <b>Asbestos %</b> | ND | <b>Asbestos %</b> | ND |

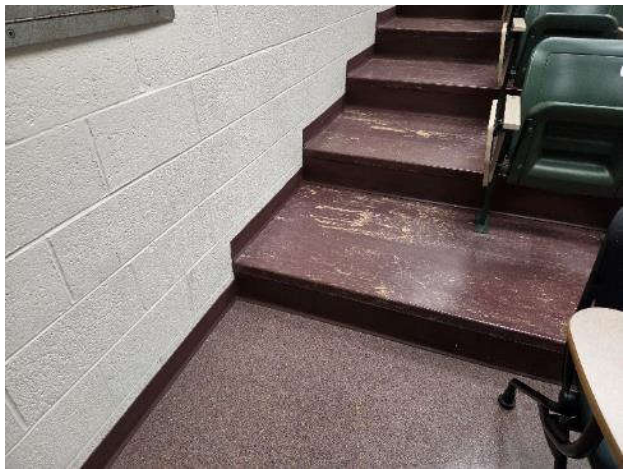
| <b>View Of:</b> | HA-128 Vinyl Floor Sheetting (reddish brown with white streaks on stadium seating) | <b>View Of:</b> | HA-129 Transite Electrical Panels |
| <b>Asbestos %</b> | ND | <b>Asbestos %</b> | Assumed |

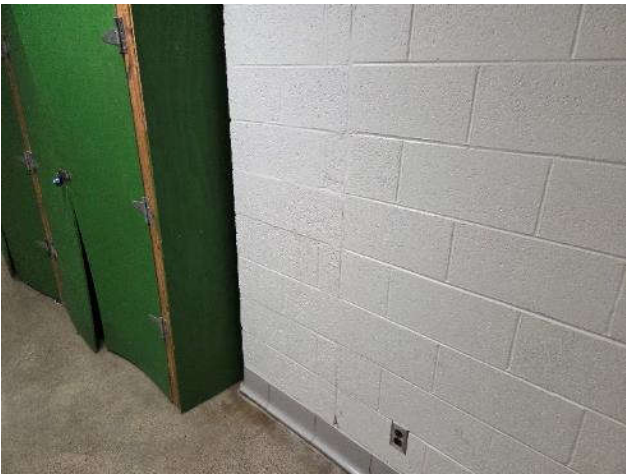
| <b>View Of:</b> | HA-132 Expansion Joint (interior walls between concrete block) | <b>View Of:</b> | HA-133 Penetration mud (dark gray) |
| <b>Asbestos %</b> | 0.25% Chrysotile | <b>Asbestos %</b> | ND |

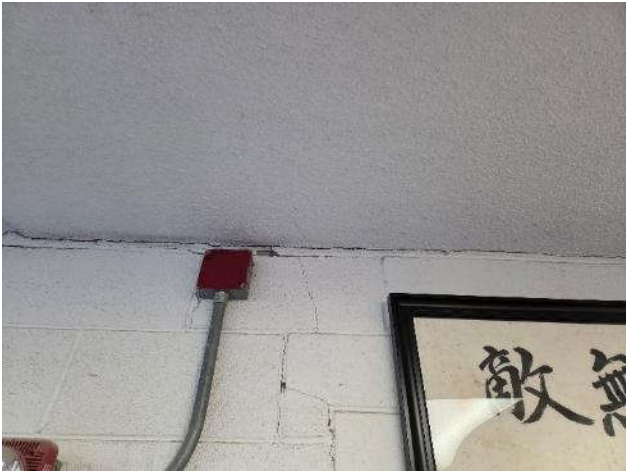
| <b>View Of:</b> | HA-134 Acoustical Plaster (white, textured, on ceiling) | <b>View Of:</b> | HA-135 Construction Adhesive (on maroon carpet) |
| <b>Asbestos %</b> | 6% Chrysotile | <b>Asbestos %</b> | ND |

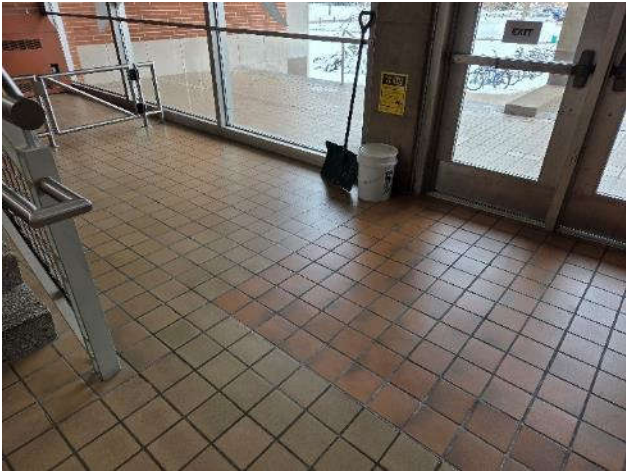
| <b>View Of:</b> | HA-136 Ceramic Floor Tile (light brown 4"x4") | <b>View Of:</b> | HA-137 Ceramic Floor Tile (red 4"x4") |
| <b>Asbestos %</b> | ND | <b>Asbestos %</b> | ND |

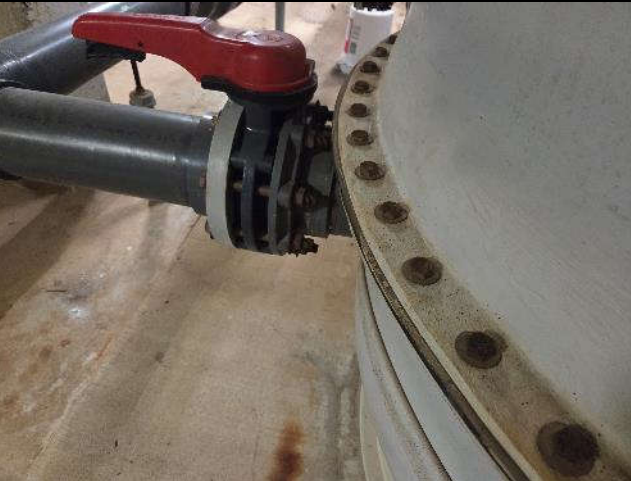
| <b>View Of:</b> | HA-140 Gasket (on gray water tanks) | <b>View Of:</b> | HA-141 White Door Caulk on Block |
| <b>Asbestos %</b> | ND | <b>Asbestos %</b> | ND |

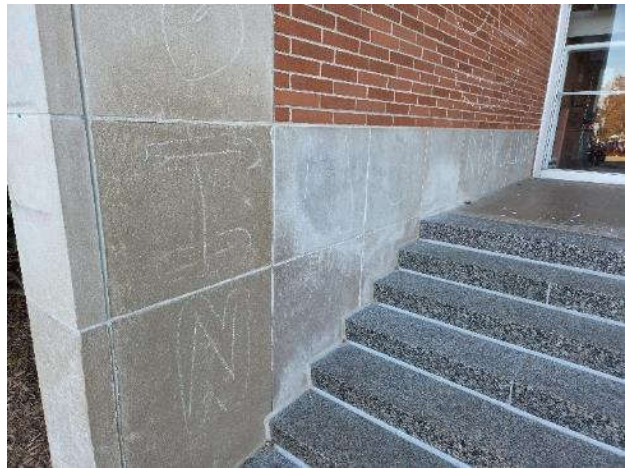
| <b>View Of:</b> | HA-142 Exterior Caulk between step blocks | <b>View Of:</b> | HA-143 Exterior Expansion Joint (black on sidewalks) |
| <b>Asbestos %</b> | ND | <b>Asbestos %</b> | ND |

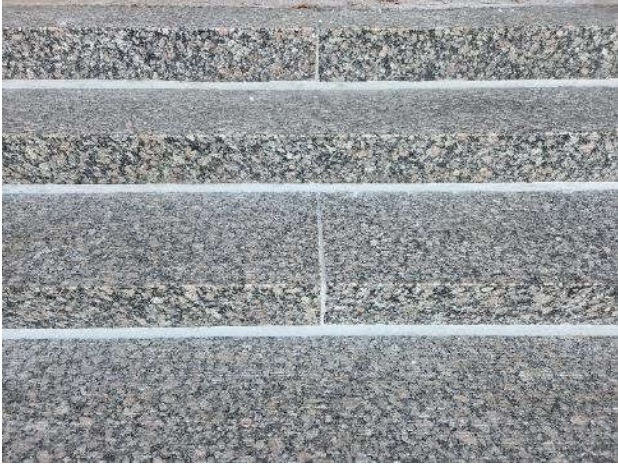
| <b>View Of:</b> | HA-144 Exterior Terrazzo Steps | <b>View Of:</b> | HA-145 Exterior Caulk (silver around entrances) |
| <b>Asbestos %</b> | ND | <b>Asbestos %</b> | ND |

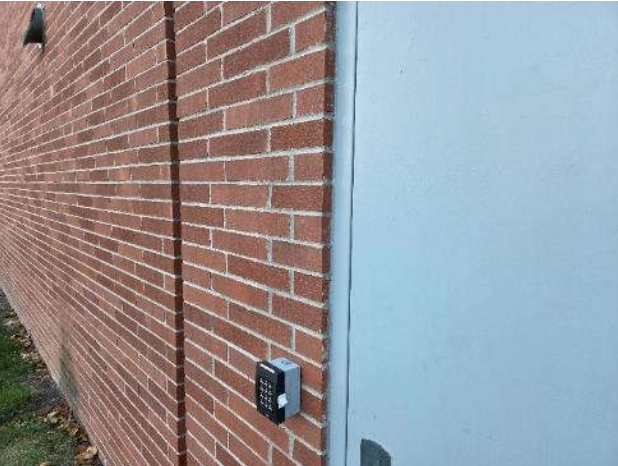
| <b>View Of:</b> | HA-146 Exterior Caulk, gray around doors (north wall) | <b>View Of:</b> | HA-147 Exterior Expansion Joint (red over gray) |
| <b>Asbestos %</b> | ND | <b>Asbestos %</b> | 4% Chrysotile |

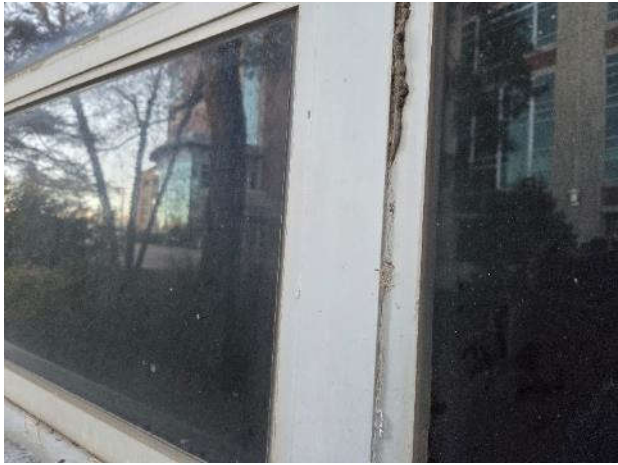
| <b>View Of:</b> | HA-148 Exterior Caulk, gray (between windows) | <b>View Of:</b> | HA-149 Exterior Caulk, gray (window opening perimeter) |
| <b>Asbestos %</b> | 2.25% Chrysotile | <b>Asbestos %</b> | ND |

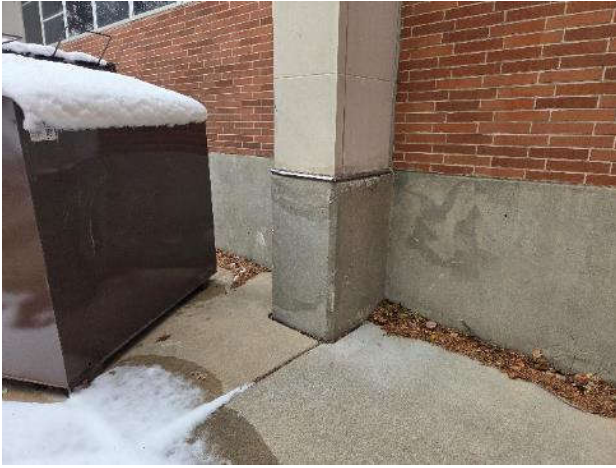
**View Of:** HA-150 Concrete Skim Coat around Columns

**Asbestos %** ND

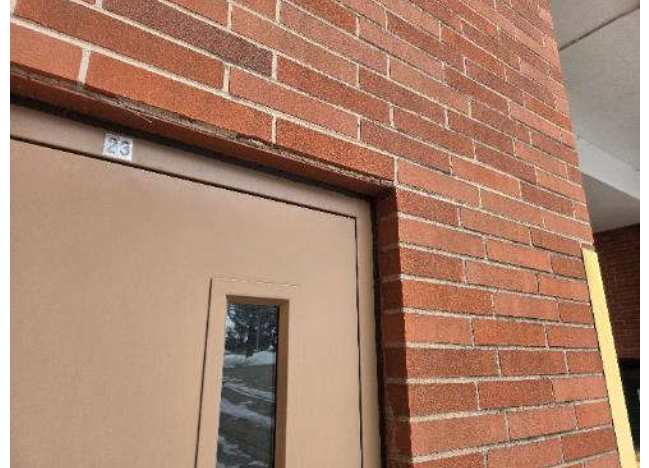
**View Of:** HA-151 Exterior Caulk (black, on doors)

**Asbestos %** ND

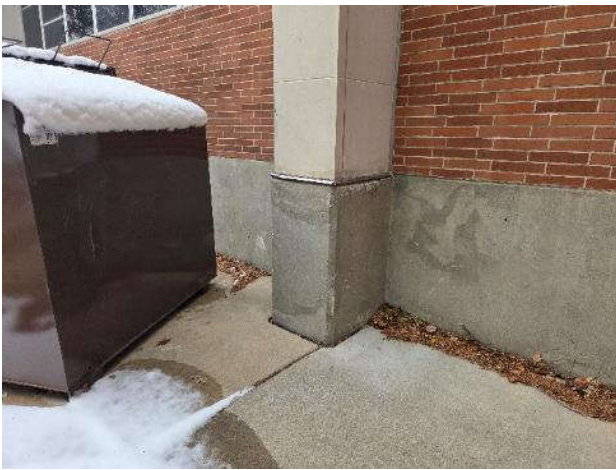
**View Of:** HA-152 Concrete (poured foundation)

**Asbestos %** ND

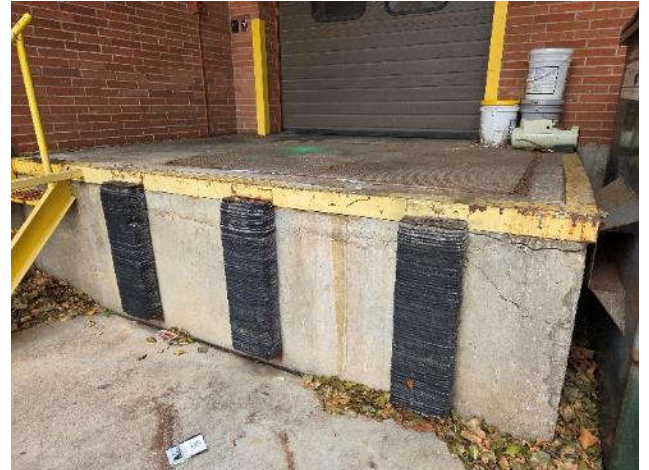
**View Of:** HA-153 Bumper Tread - black (southeast loading dock)

**Asbestos %** ND

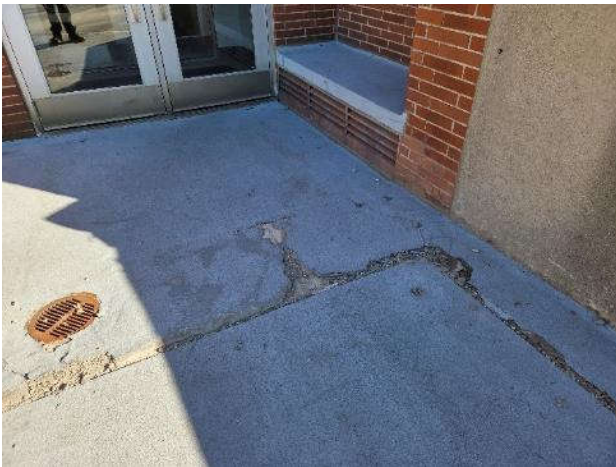
**View Of:** HA-154 Vinyl Flooring (gray on exterior pool deck)

**Asbestos %** ND

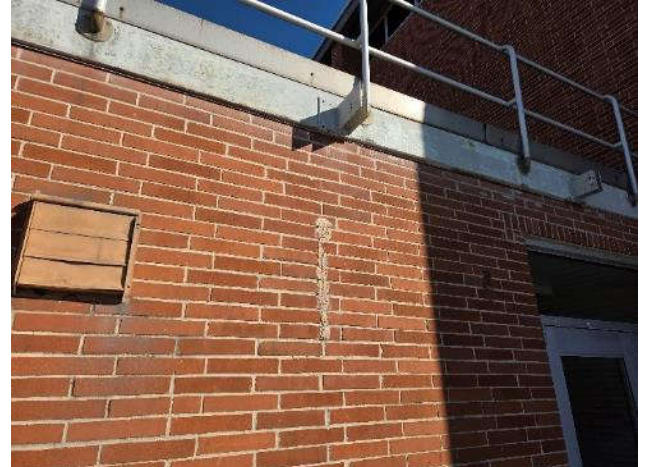
**View Of:** HA-155 Construction Adhesive (glue pod on red brick exterior wall)

**Asbestos %** ND

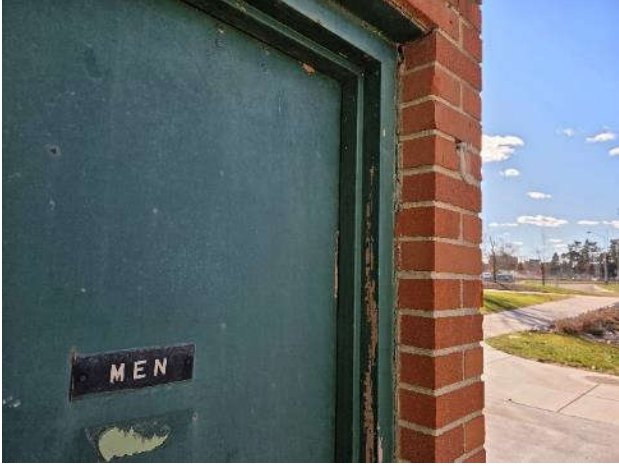
| <b>View Of:</b> | HA-156 Exterior Caulk, gray (on exterior locker doors) | <b>View Of:</b> | HA-157 Exterior Caulk, white (around header of main door and 4'x4' wall panels) |
| <b>Asbestos %</b> | 4% Chrysotile | <b>Asbestos %</b> | ND |

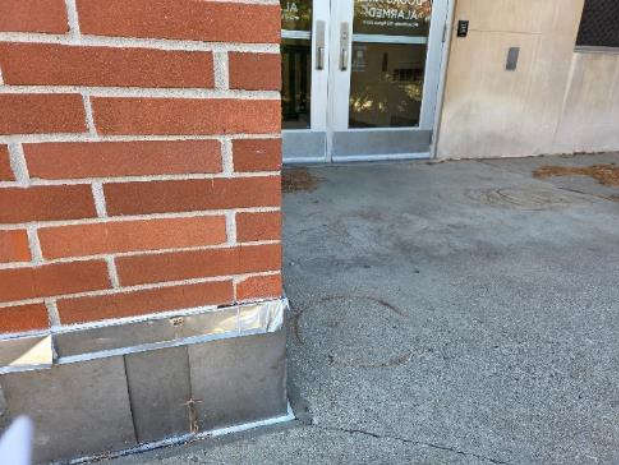
| <b>View Of:</b> | HA-158 Exterior Caulk, white - around flashing and exterior brick (west entrance) | <b>View Of:</b> | HA-159 Bumper Tread - black (west loading dock) |
| <b>Asbestos %</b> | ND | <b>Asbestos %</b> | ND |

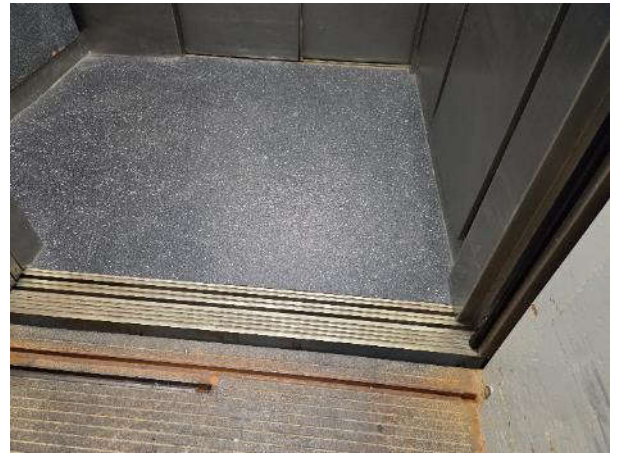
| <b>View Of:</b> | HA-160 Vinyl Flooring - black w/white pebbles (elevator) | | |
| <b>Asbestos %</b> | ND | | |
