TITLE OF PROJECT: Human Ecology – Replace Roofs and Complete Masonry Restoration

ADDENDUM NO: 01

August 6, 2021
Project No. 21-054

RE: BUILDING ENVELOPE STUDY
Human Ecology Building
552 W Circle Dr.
East Lansing, MI 48823

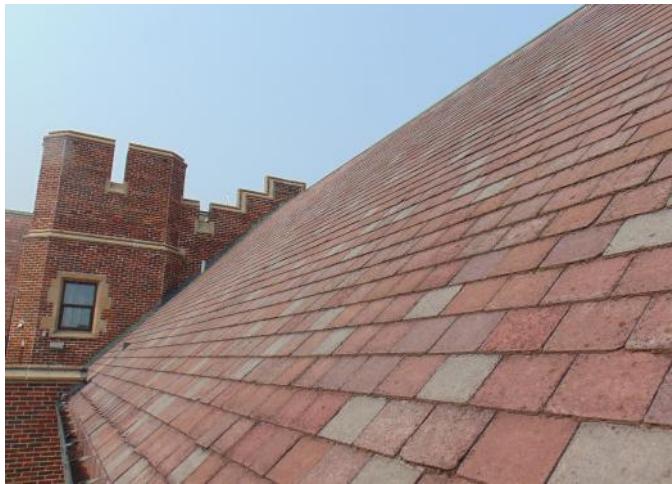
Photo 13: Area 5 - east facing

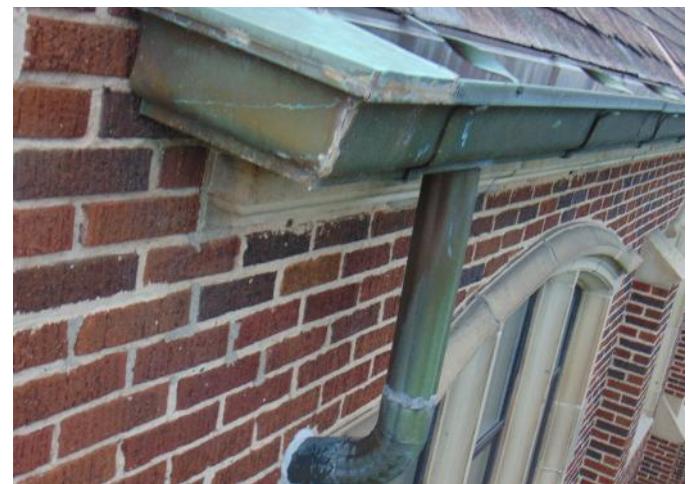
Photo 22: Area 5 - gutter and downspout

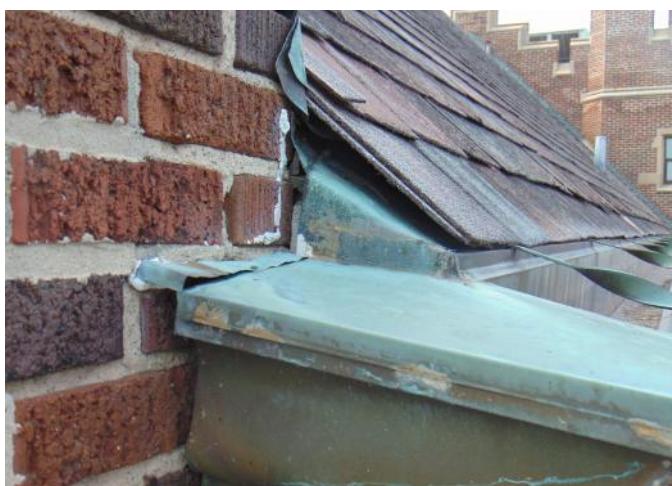
1. Moss is growing between the asbestos tiles (Photo 20).
2. The asbestos tiles are stained and weathered with age (Photos 14 - 19, and 21).
3. There are numerous broken asbestos tiles on the both the east and west facings, as they have become brittle with age (Photos 14 - 19, and 21).
4. The copper gutter is functional but has begun to pull away from the wall in the corner (Photo 23).

Photo 23: Area 5 - gutter corner/transition

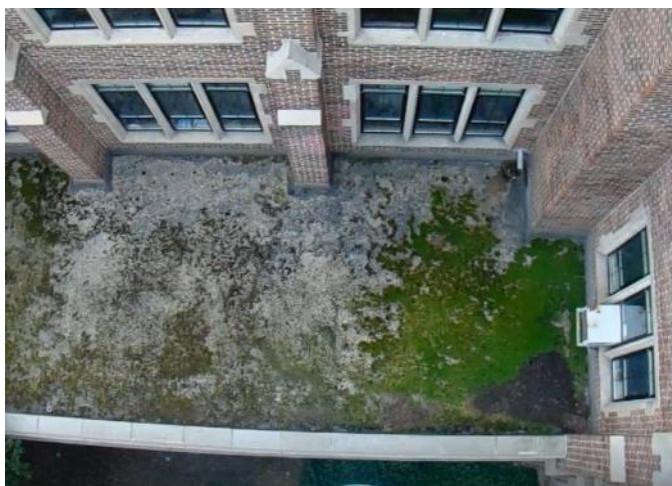
Photo 1: Area 2 - overview

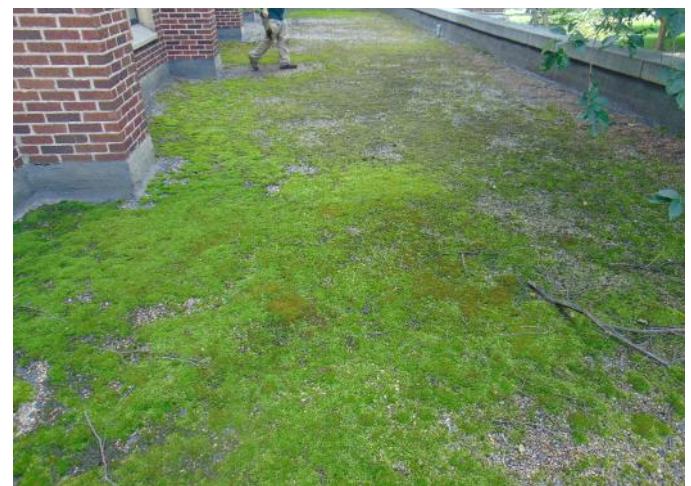
1. The roof surface is covered with widespread vegetation. Due to its low slope and proximity to an overhanging tree, debris and moss have accumulated on the membrane (Photo Report: Low-slope Roofs, Photos 2, 3 and 4).
2. The drain strainer is broken (Photo 6).
3. The surface of the roof and the base flashings are showing signs of age, surface wear (Photo 5).

Photo 2: Area 2 - widespread vegetation

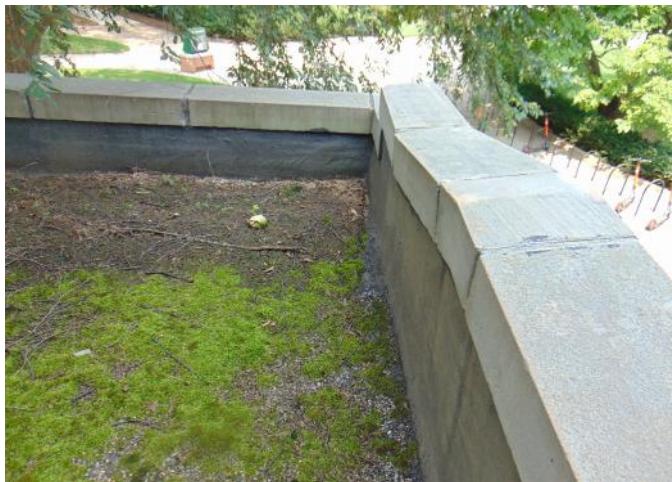
Photo 3: Area 2 - debris/vegetation accumulation in corner

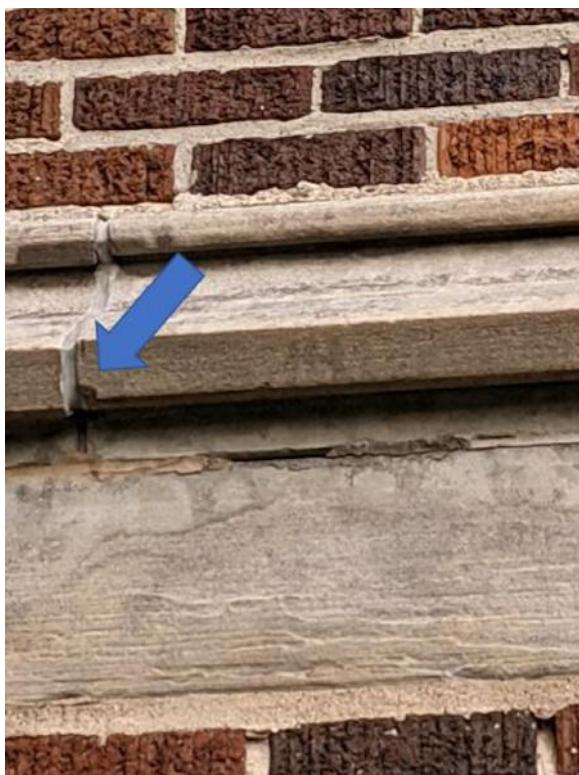
1. Defective caulking around the perimeter windows (Photo Report: Masonry, Photos 1 and 2).
2. Missing caulking (Photo 3)
3. Head joints in need of caulking (Photos 4 through 7).

Photo 5: Typical head joint

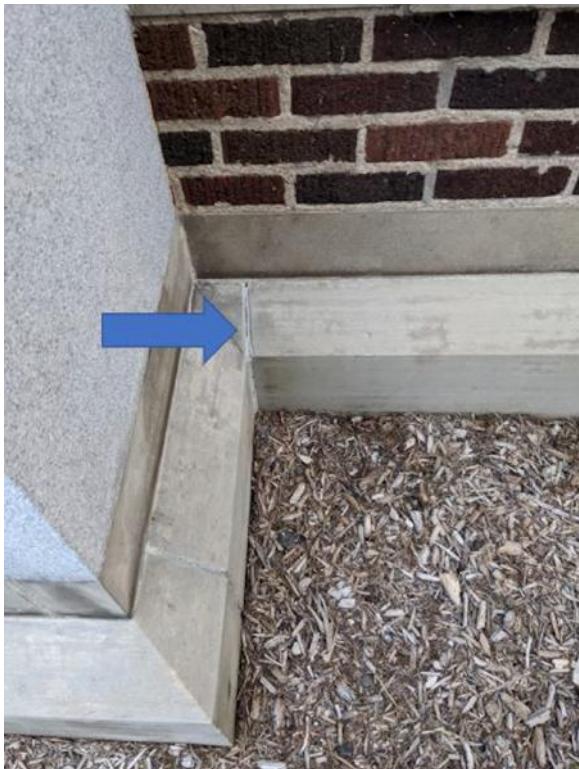
Photo 7: Typical head joint

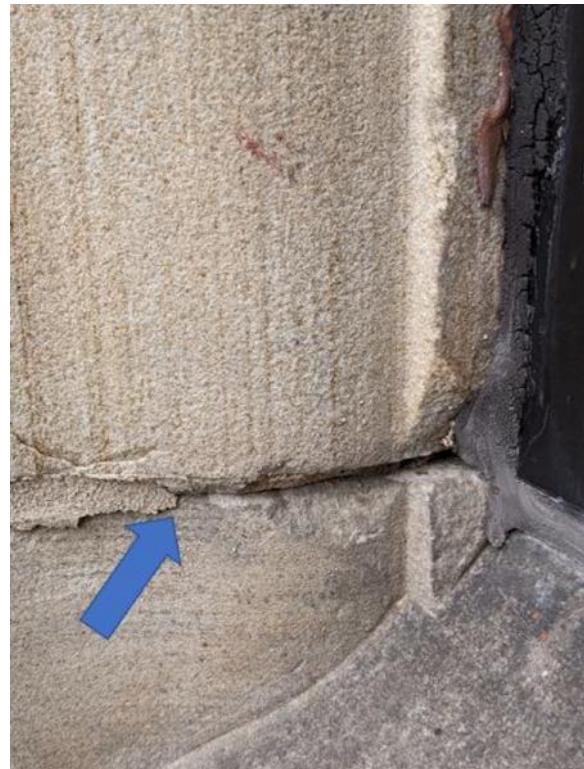
1. Defective mortar joints: mortar is loose, eroded or powdered, broken, hollow, unsound or soft (Photos 8 – 14).

Photo 8: Typical tuckpointing

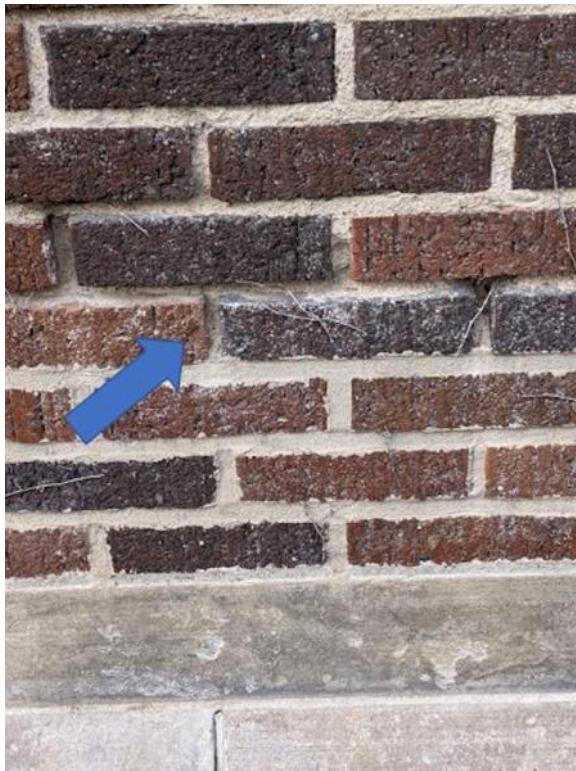
Photo 9: Typical eroded mortar joints

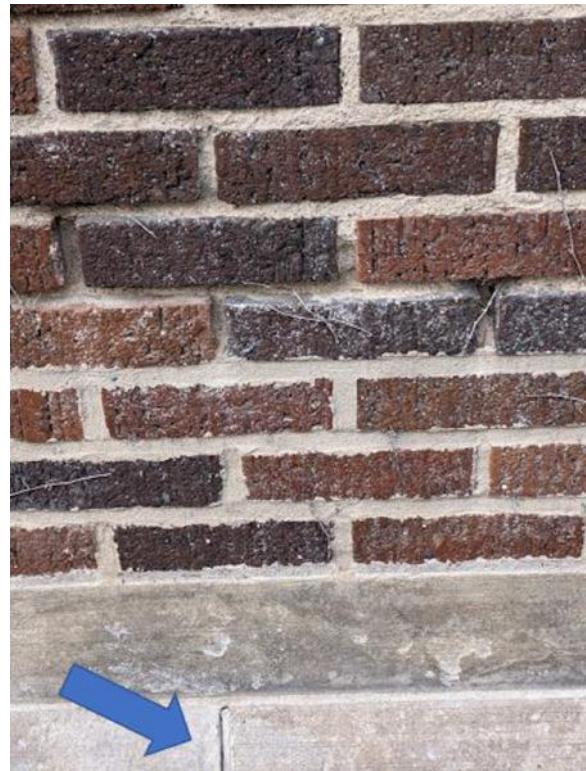
Photo 10: Typical head joint

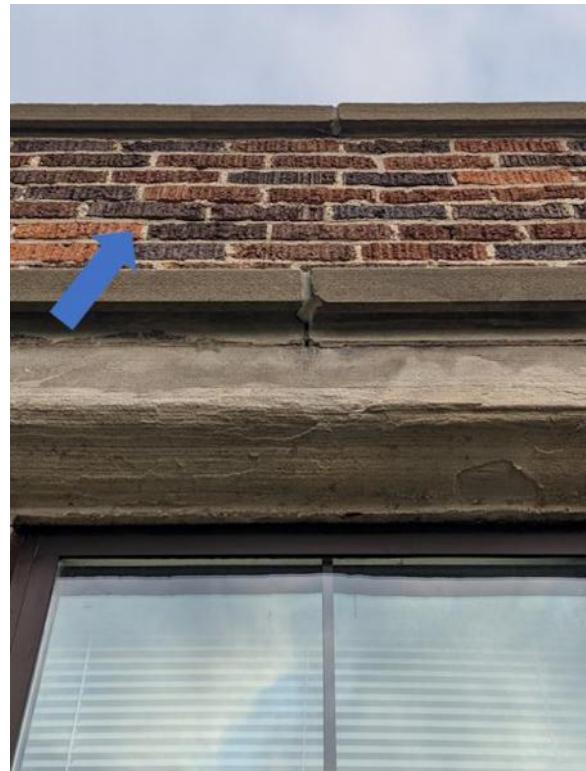
Photo 12: Typical eroded mortar joints

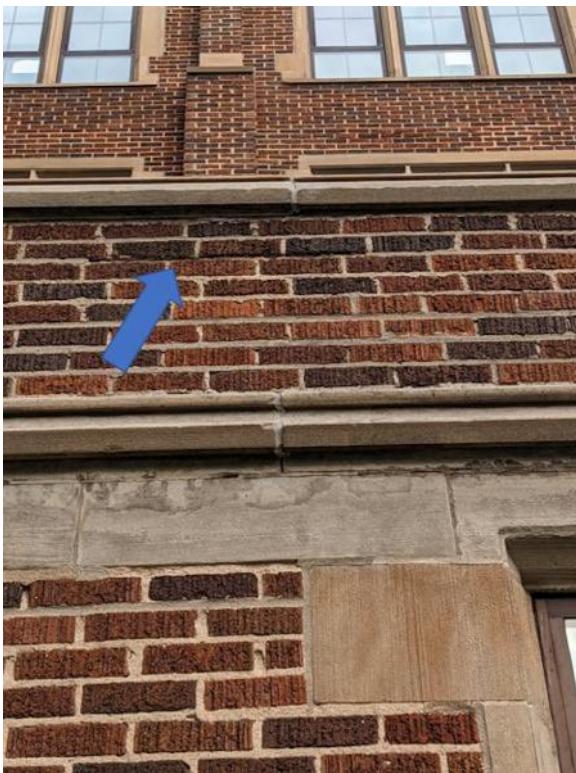
Photo 13: Typical eroded mortar joints

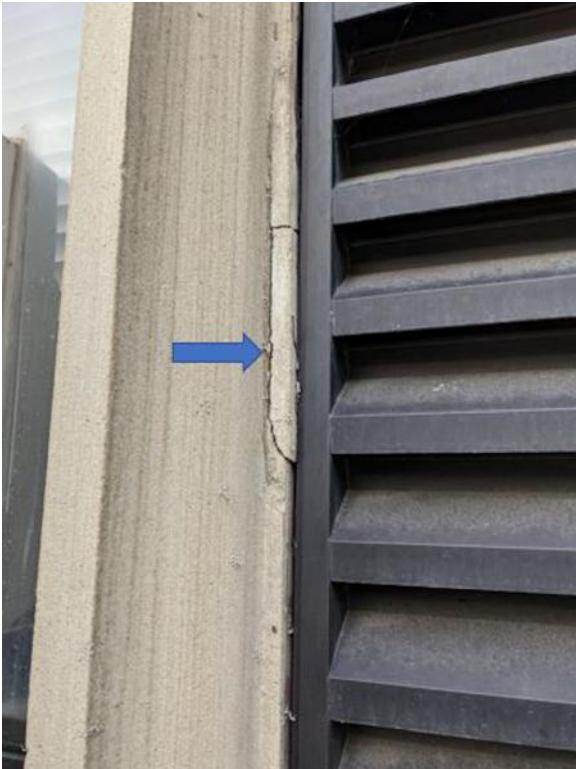
1. Broken or spalled pieces of stone (Photos 15 – 16).

Photo 15: Typical stone patching

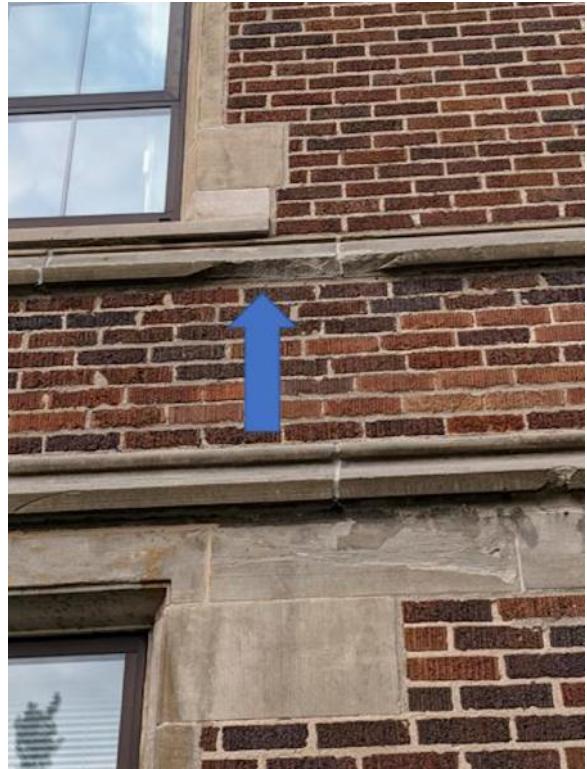
Photo 16: Typical stone patching
